Project Name: 1229 Atlantic Avenue

Project Number: 14CVCP167K

Inspection Date: June 2, 2022

Site Inspection and Certification Letter Report

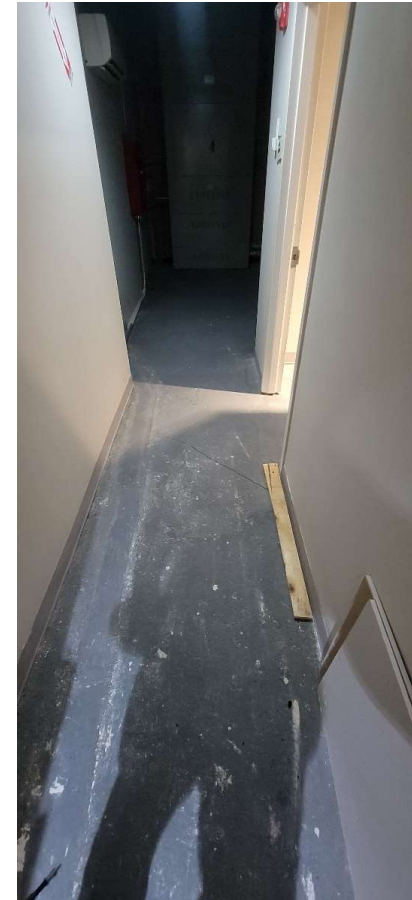
View of fine cracks in slab of sub-basement

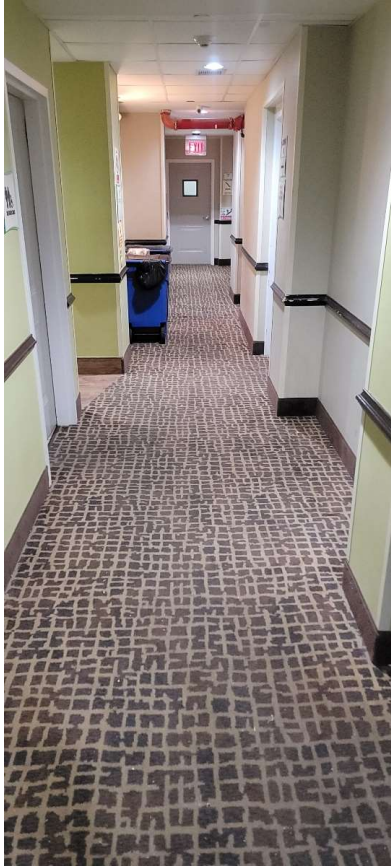
View of carpet in basement

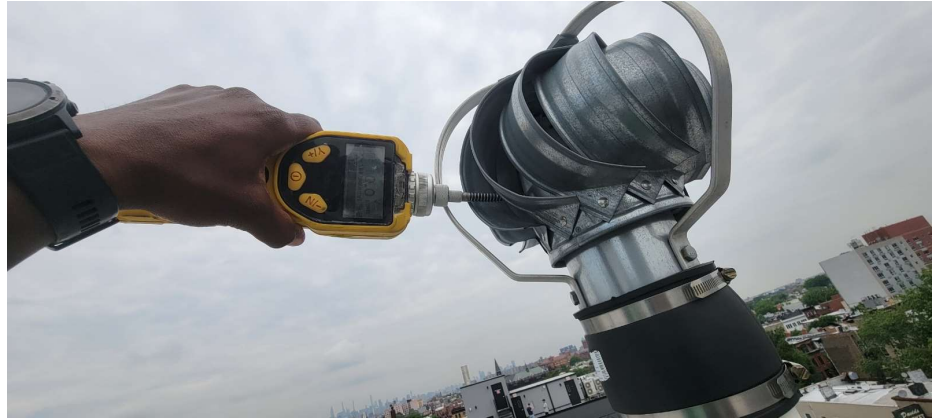
The visible portion of the SSD system consist of the five riser vents that can be observed above the roof top of the building with each terminated with a wind operated turbine with guy wires. No levels of organic vapors were detected at each of the five SSD system risers utilizing a Photoionization detector (PID).

Organic vapors measurements at the SSD system riser

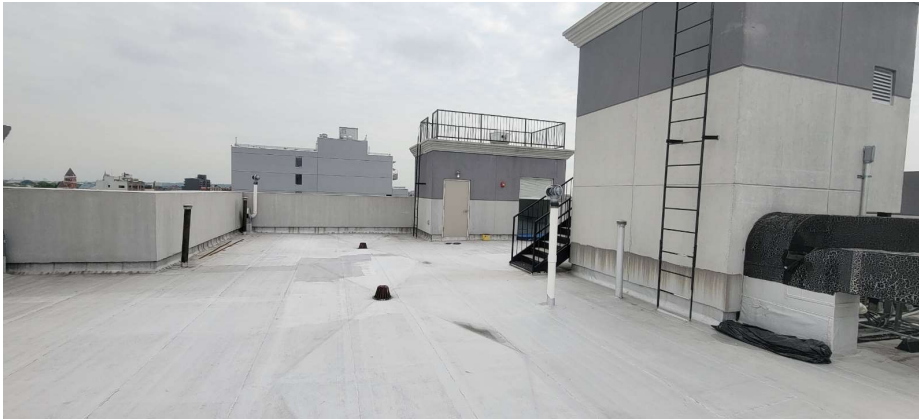
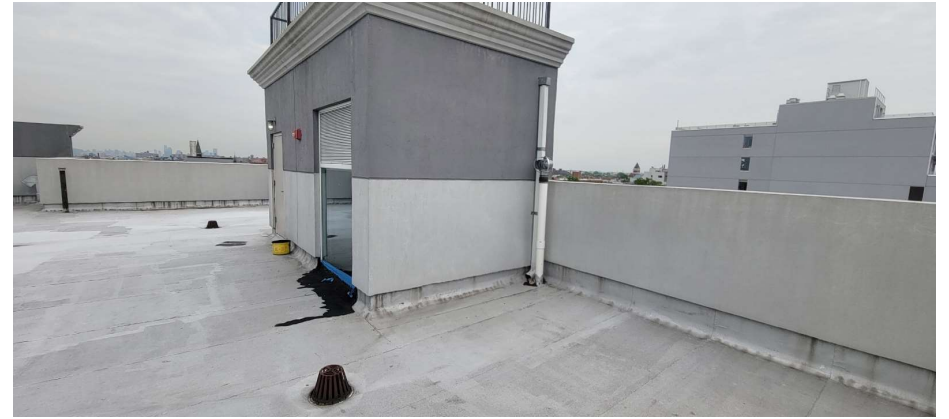
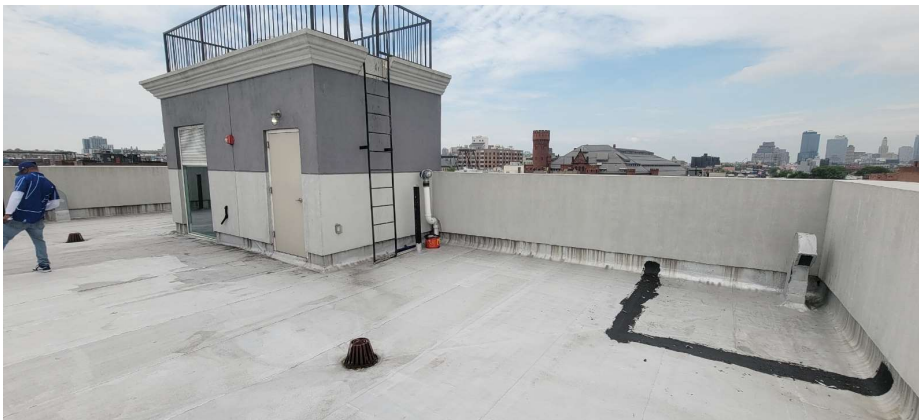
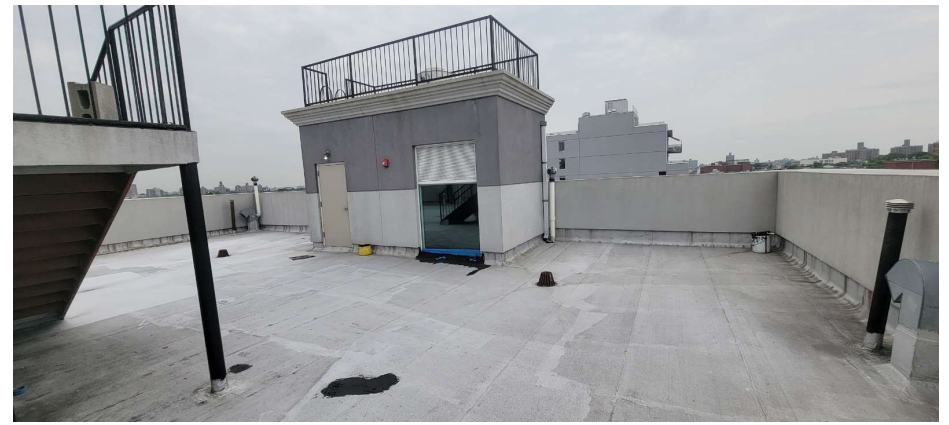
View of SSD system risers above rooftop
