Project Name: 801 Bedford Avenue, Brooklyn, NY
Project Number: 17CVCP076K, 14EHAZ289K
Site Management Reporting Period: 2021-2022
Inspection Date: July 19th, 2022 and August 18, 2022
Inspector and Certifier: Patrick Recio and Thomas Gallo
Report Submittal Date: October 19, 2022
Report Preparer: Brussee Environmental Corp on behalf of Stone Edge Management

Site Inspection and Certification Letter Report

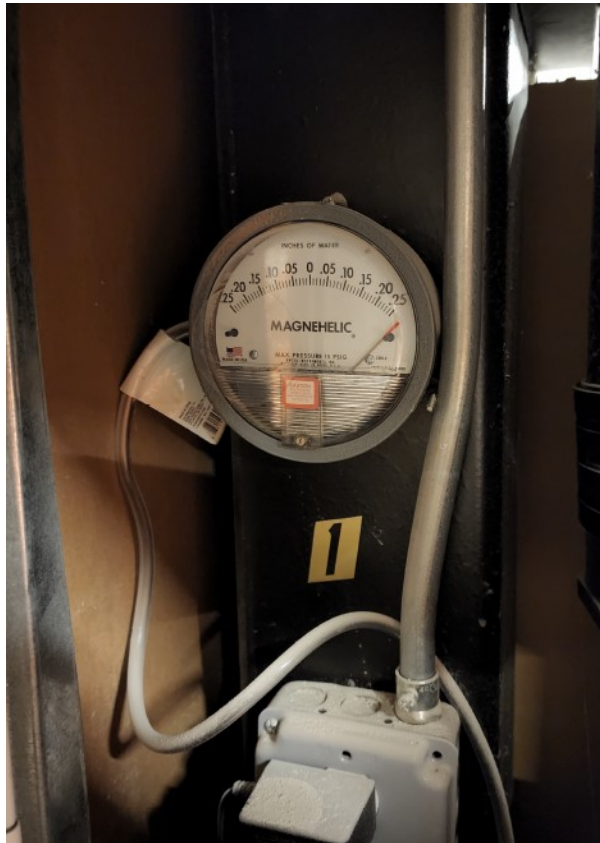
Photo 1: View of Riser 1 alarm and gauge cabinet at 801 Bedford Avenue, Brooklyn, NY.

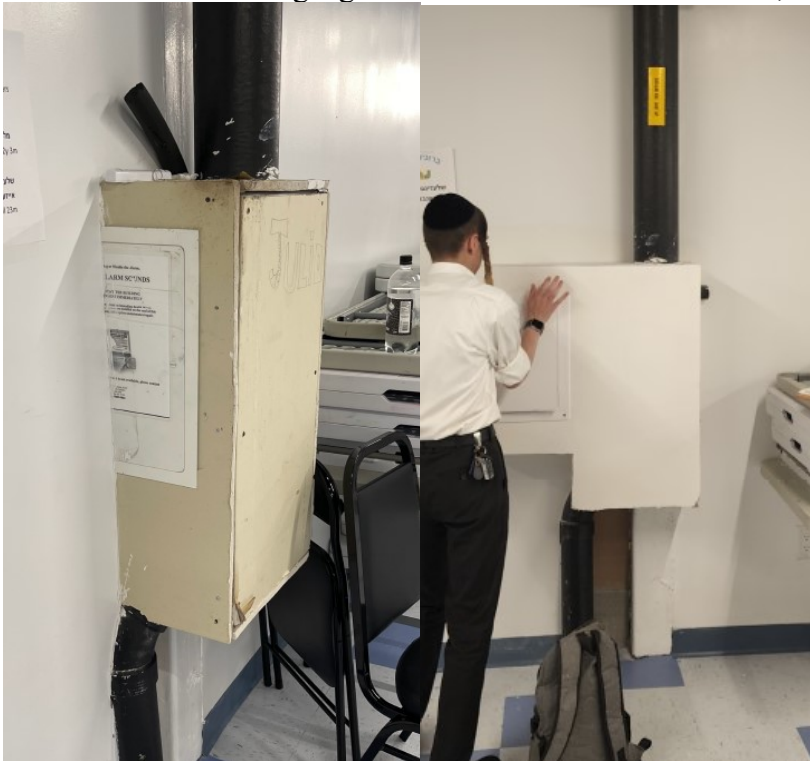
Three of the four blowers and alarms for the active SSD system were inspected on July 19, 2022. The access panel for riser #1 was found to have sheetrock covering half of the panel opening, which did not allow for the riser to be accessed. A new access panel was installed and replaced by August 8, 2022. All alarms and all blowers were found to be operating without issue. The vacuum gauge for Riser 1 installed within the protective cabinet located against the support column in the open space of the cellar recorded a vacuum reading of approximately 1.10" of water. The vacuum gauges for Riser 2, Riser 3 and Riser 4 are located within the wall of the compactor room and record a vacuum reading of approximately 1.00" of water, 1.00" of water and 1.20" of water respectively. The alarms were not sounding and the alarm lights were green. A photo of the vacuum gauge and amended access panel for Riser #1 are attached.

Photo 2 & 3: View of Riser 1 access on July 19th (left) and View of Riser 1 after adjustments on August 8th (right).

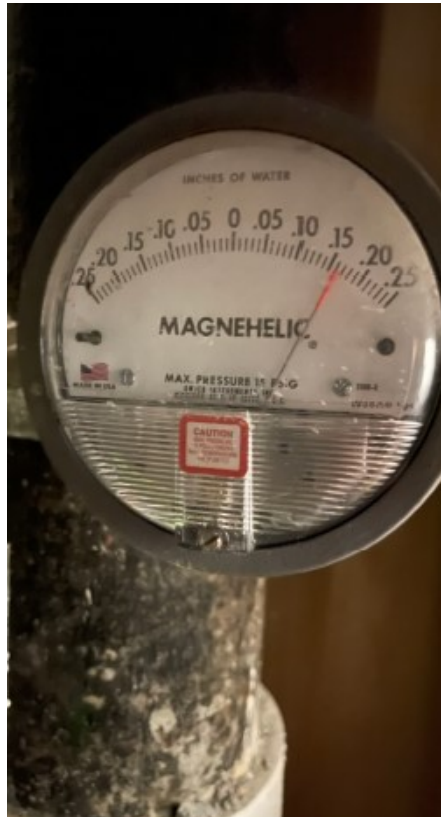
Photo 3 - View of Riser 4 gauge.

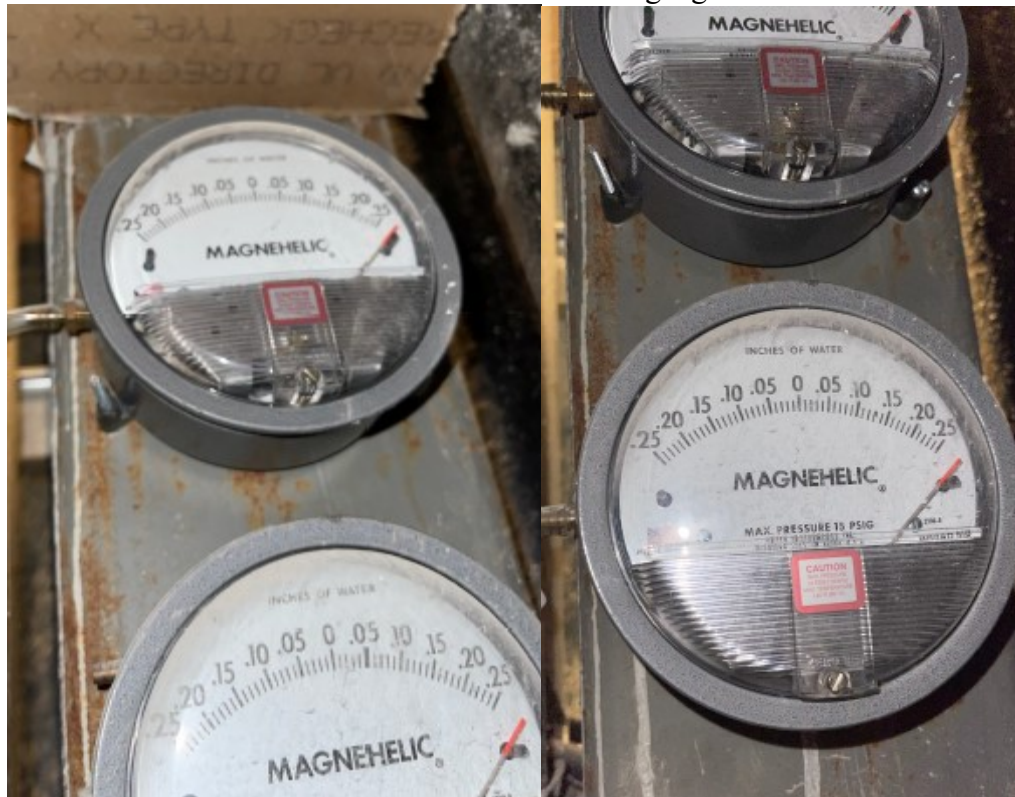
Photo 4 & 5 - View of Riser 2 and 3 gauges.

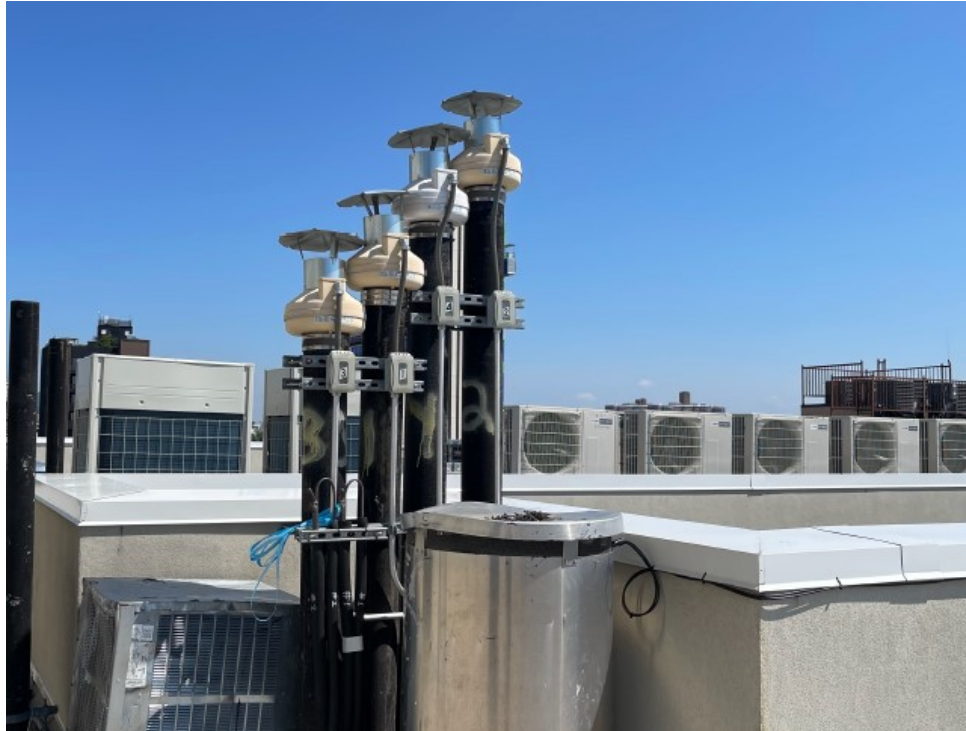
Photo 6 - View of riser exhausts on roof.
