Re: Annual SSDS Inspections and Certifications
at 217-21 Merrick Blvd, Queens, New York
NYCOER Project Number: 11EH-N075Q
E-Designation Project Number: E-219

Project Name 217-21 Merrick Blvd, Queens, New York

Site Inspection and Certification Letter Report

217-21 Merrick Blvd, Queens
Sub-Slab Depressurization System (SSDS) Annual Inspections
December 14, 2024

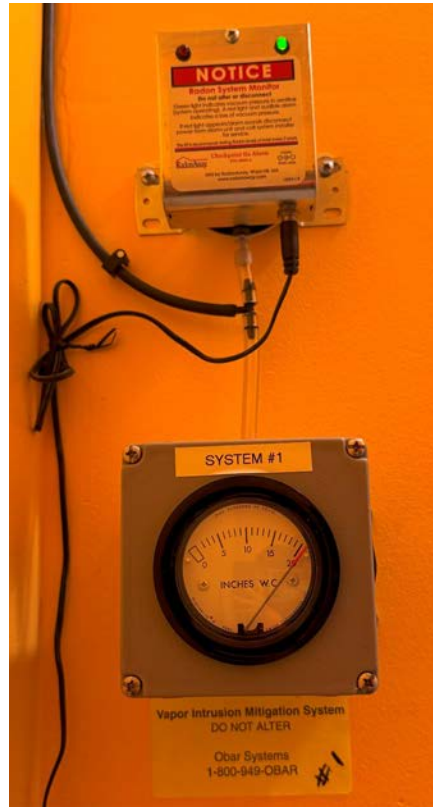
System 1 Reading – 20 inches W.C.

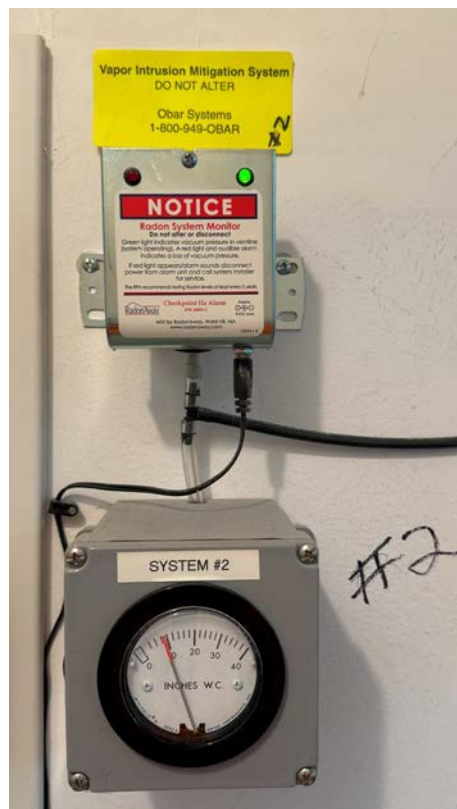
System 2 Reading – 10 inches W.C.

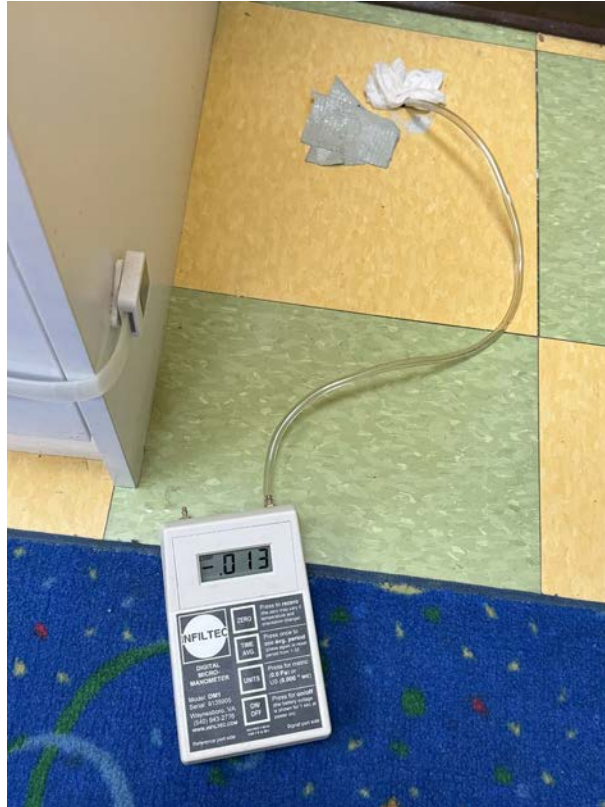
Test Point Location Reading TP-1 (-0.013)

- JRH recommends installing new sub-slab test points due to the possibility of moisture being drawn underneath the slab causing a blockage in airflow. Consequently, we believe this recommendation will result in an improvement in the readings of the sub-slab vacuum.

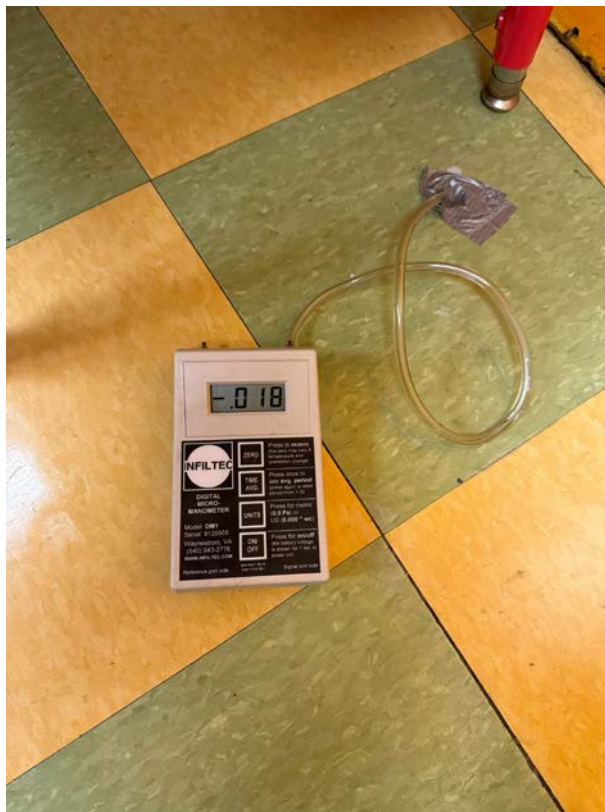
Test Point Location Reading TP-2 (-0.018)

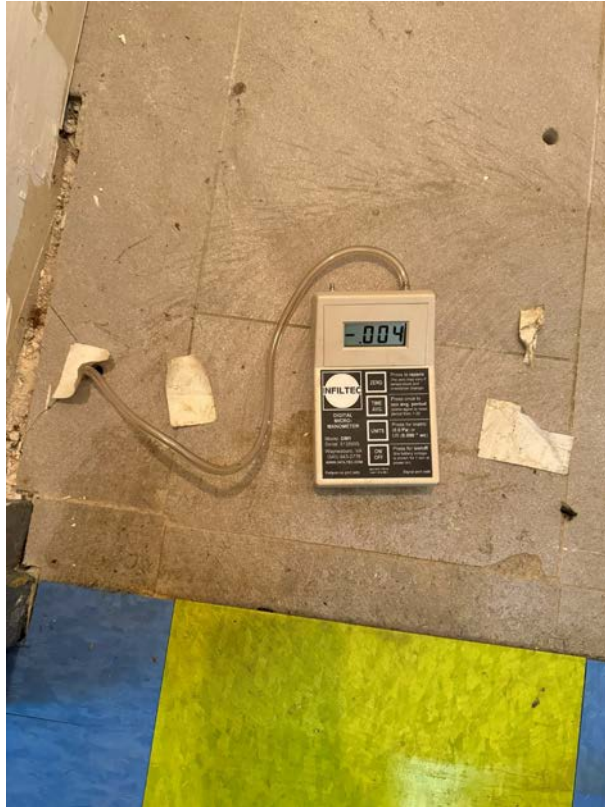
Test Point Location Reading TP-3 (-0.004)

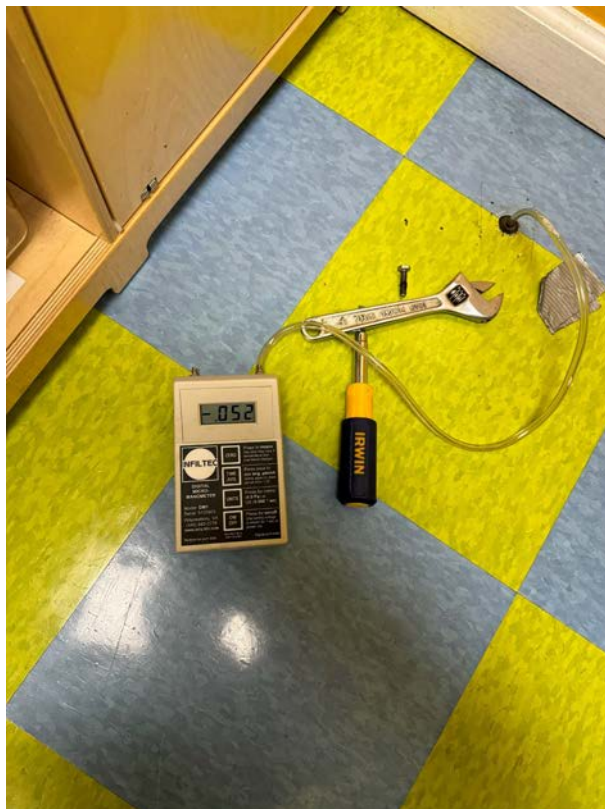
Test Point Location Reading TP-4 (-0.052)

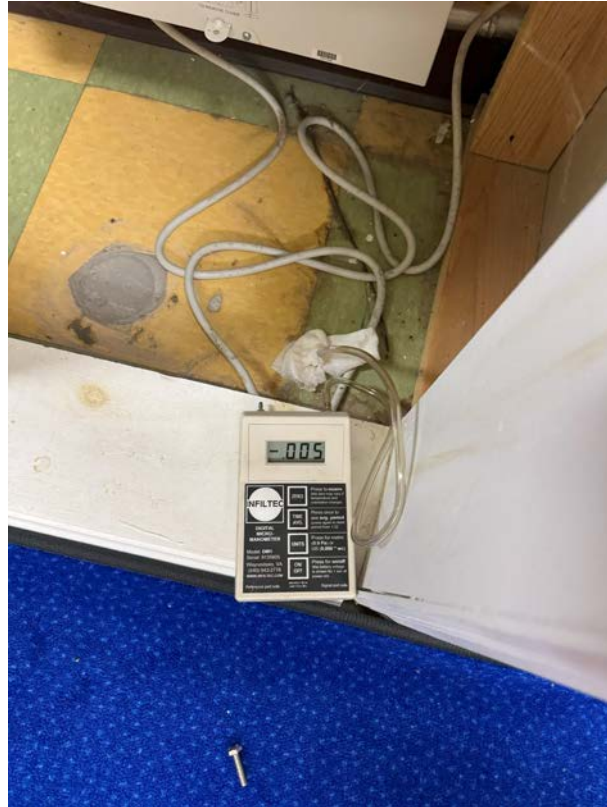
Test Point Location Reading TP-5 (-0.005)

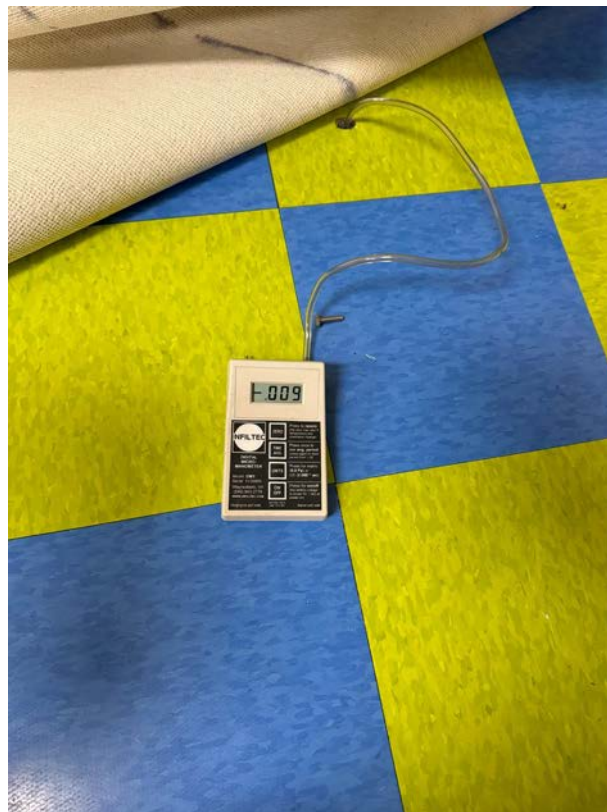
Test Point Location Reading TP-6 (-0.009)

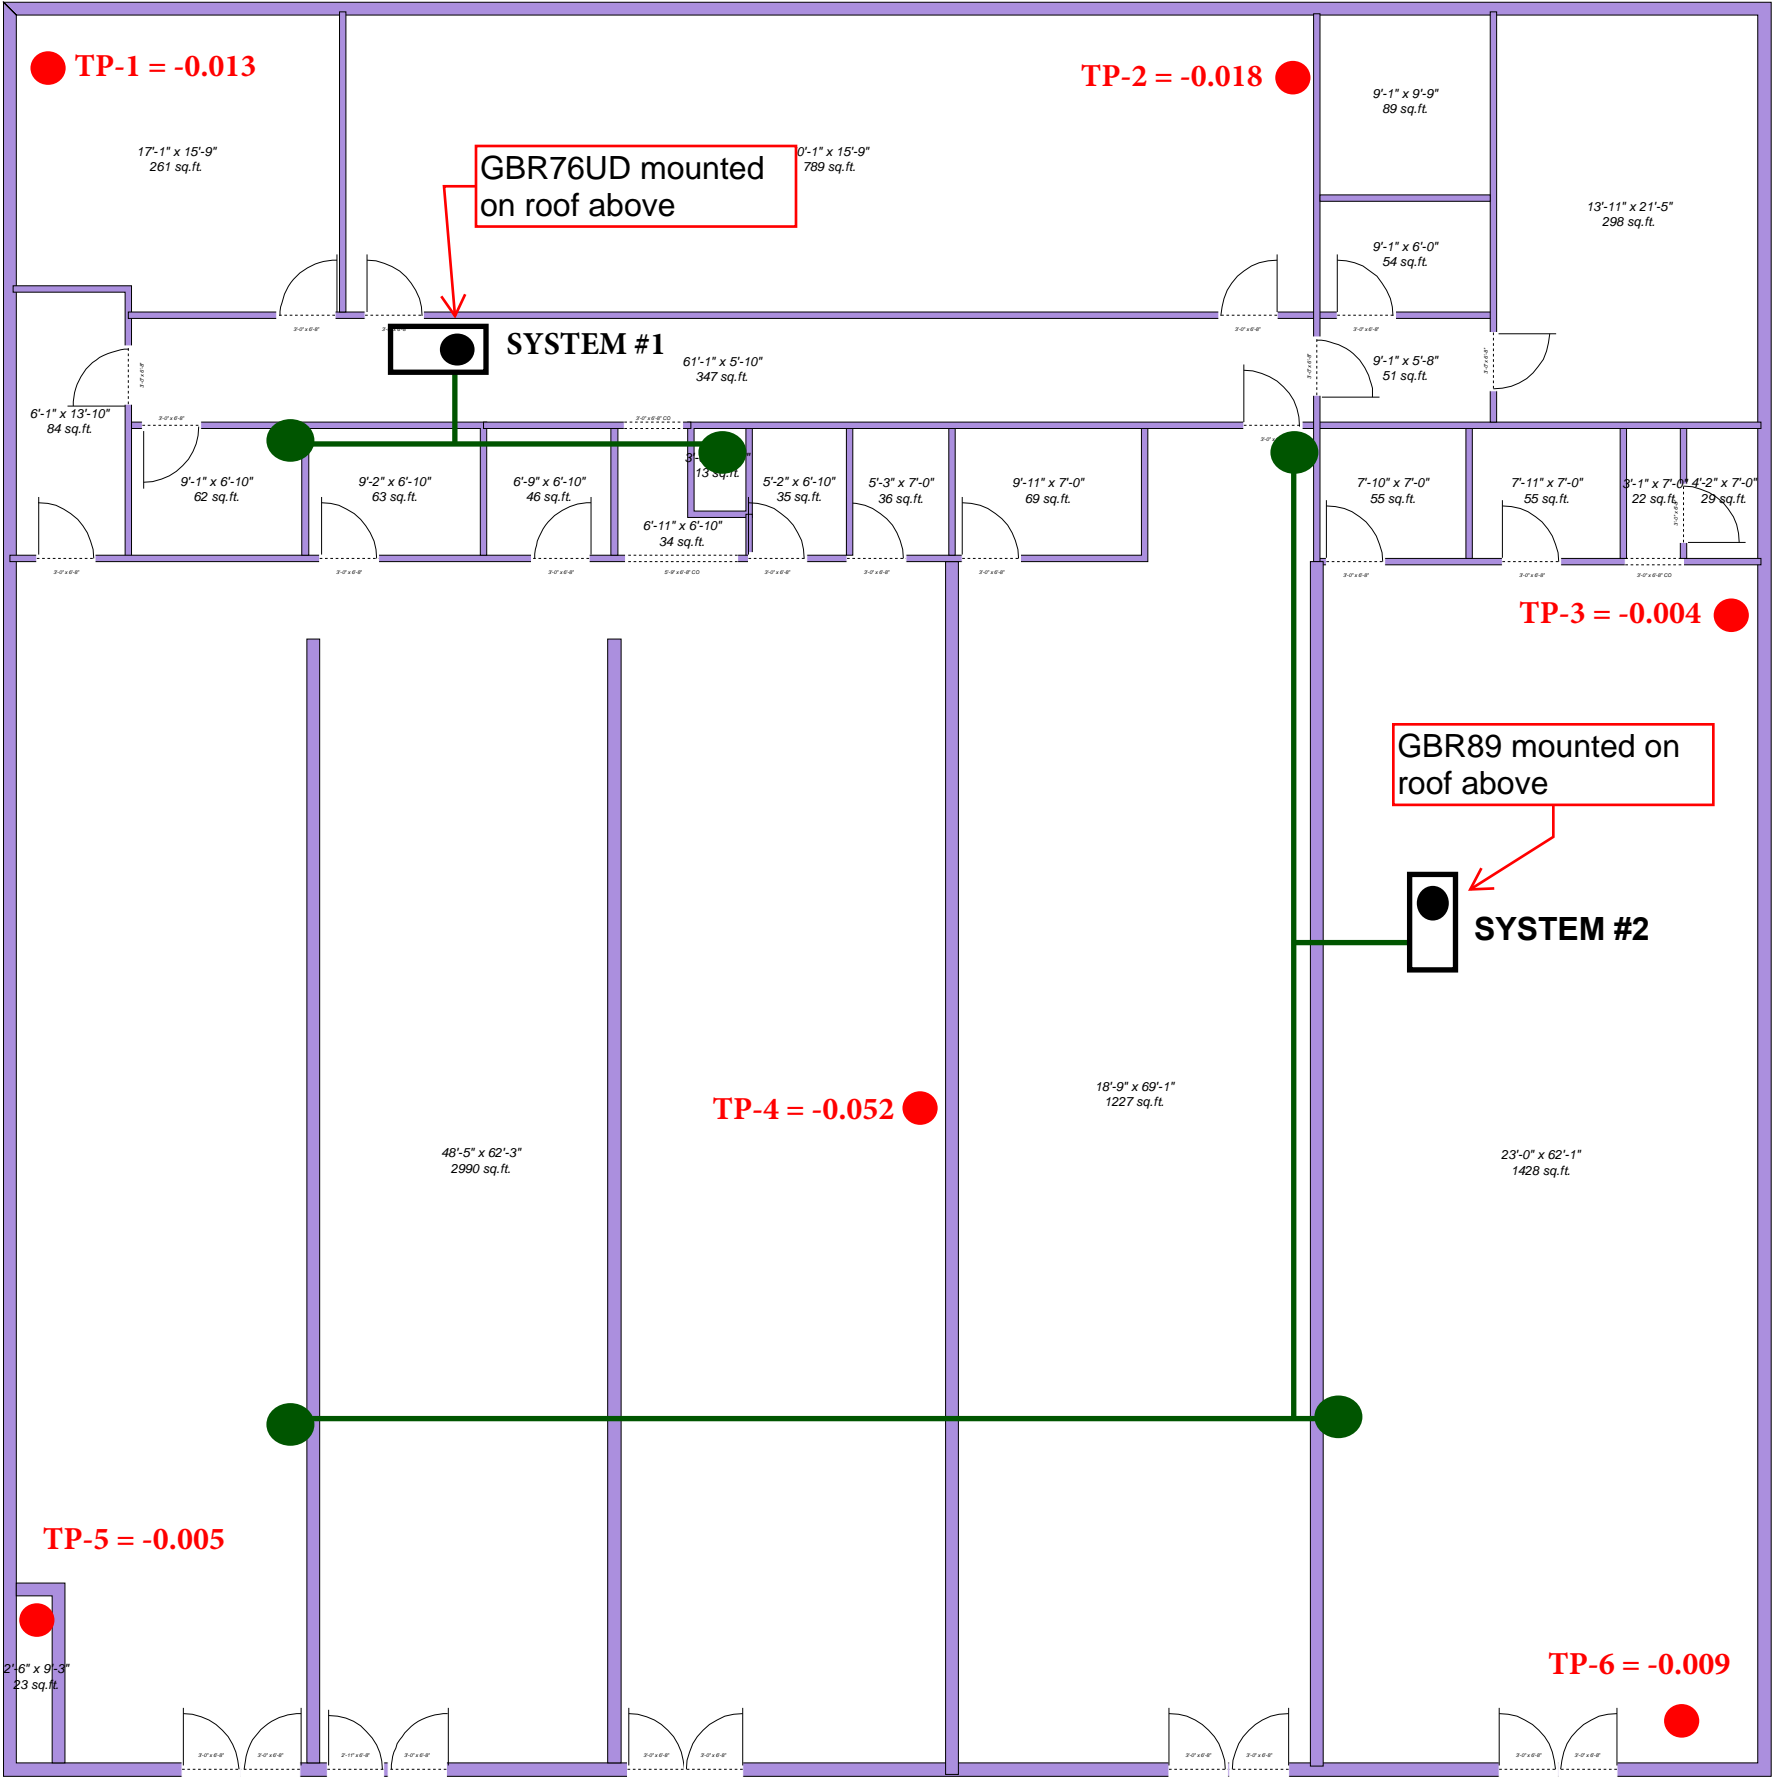
SHEET NAME: Vapor Intrusion Mitigation System Design		DRAWING NO: 2 of 3	
OBAR Systems Inc. 2696 Rt. 23 South Newfoundland, NJ 07435

SYSTEM #1 = 20" W.C.
SYSTEM #2 = 10" W.C.
