Project Name: 137-139 Frost Street, Brooklyn, New York (the “Site”)

Project Number: New York City Voluntary Cleanup Program (VCP) Project No. 18CVCP047K;
E-Designation Project No. 18EHAZ178K

Inspection Date: May 27, 2025

Site Management Inspection and Certification Report

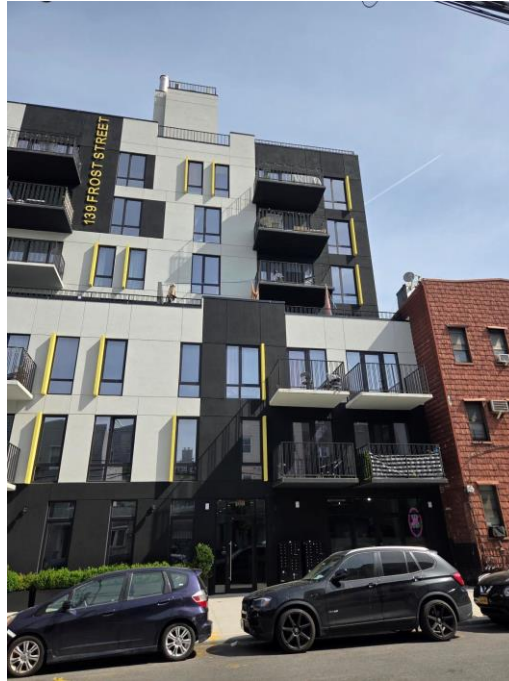
Photo 1: Building exterior, facing north

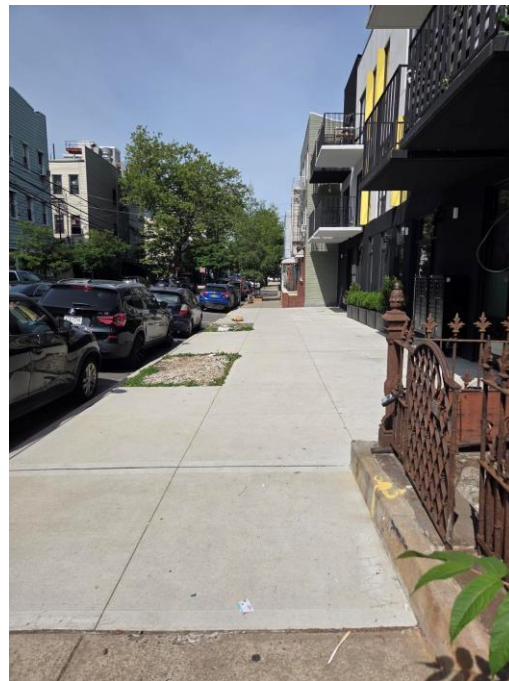
Photo 2: Setback between building (right) and Frost Street (left), facing west

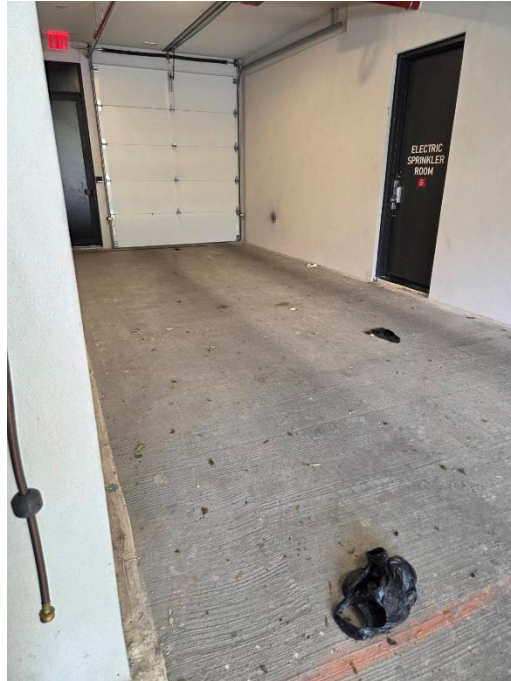
Photo 3: Garage area in western portion of the building

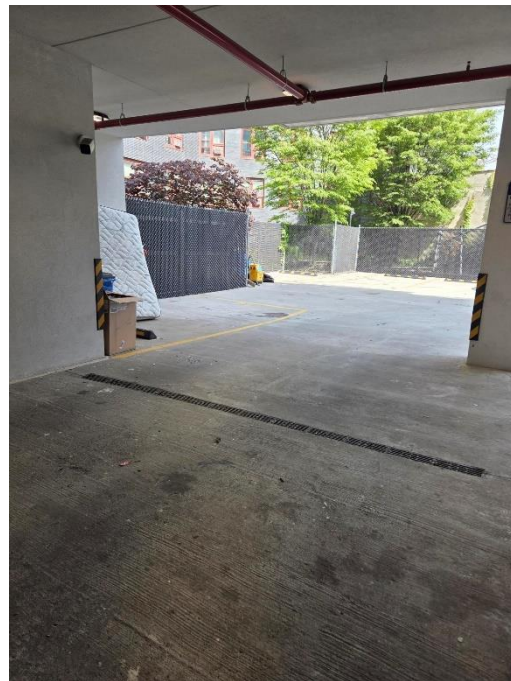
Photo 4: Garage area facing rear yard and parking area, followed by fencing, facing northwest

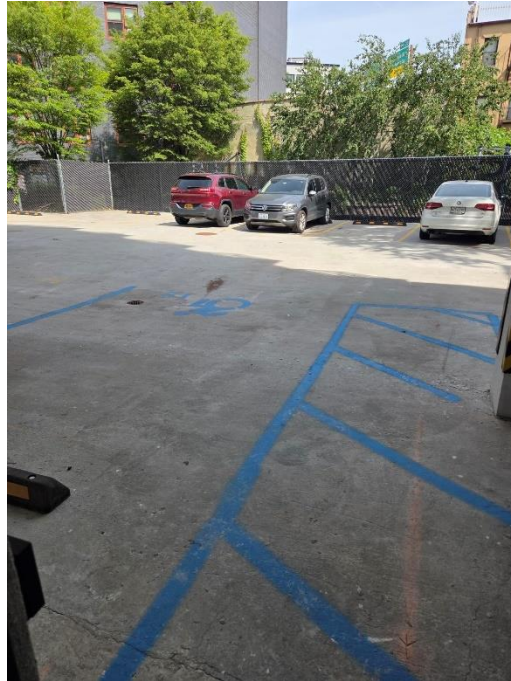
Photo 5: Rear yard and parking area, facing north

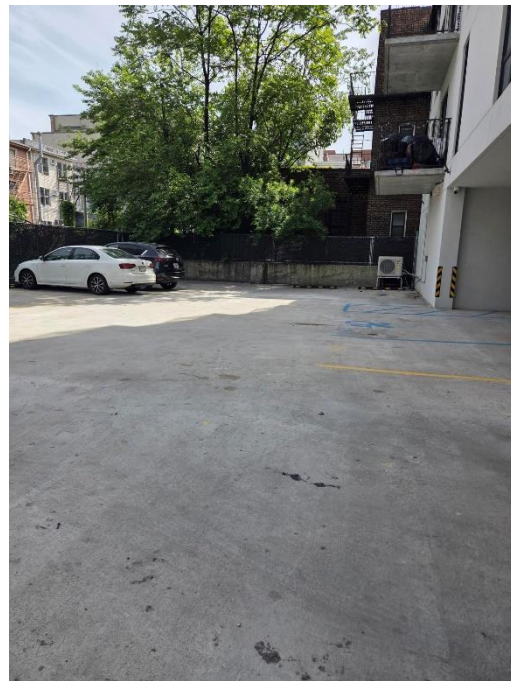
Photo 6: Rear yard and parking area, facing east

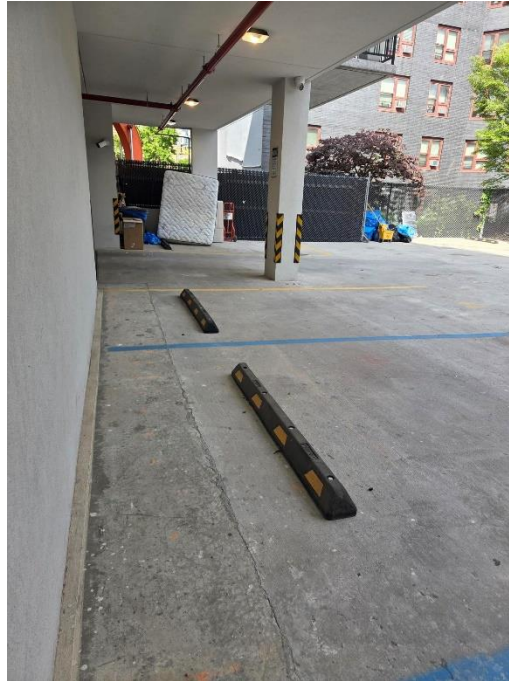
Photo 7: Rear yard and parking area, facing east

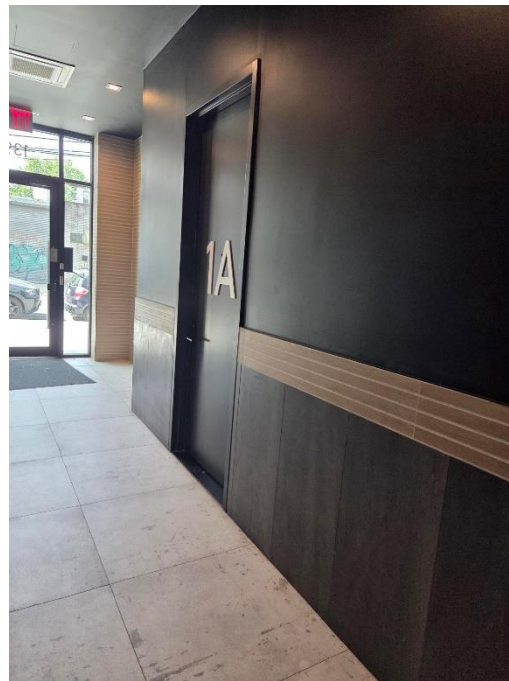
Photo 8: First floor interior hallway, facing south towards entrance and Frost Street

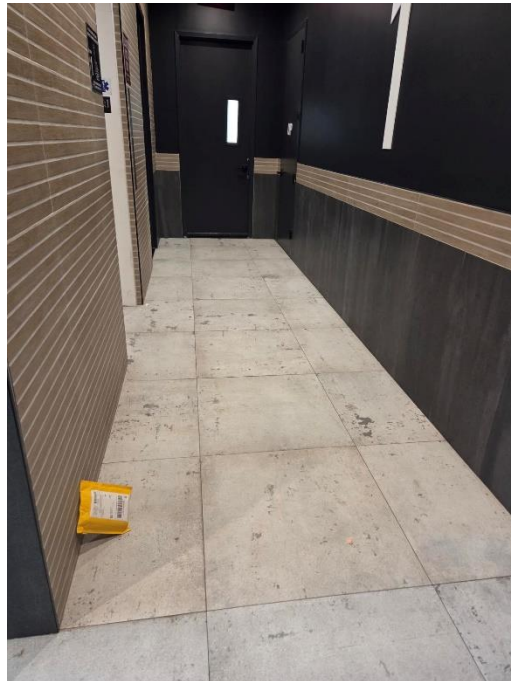
Photo 9: First floor Interior hallway, facing north

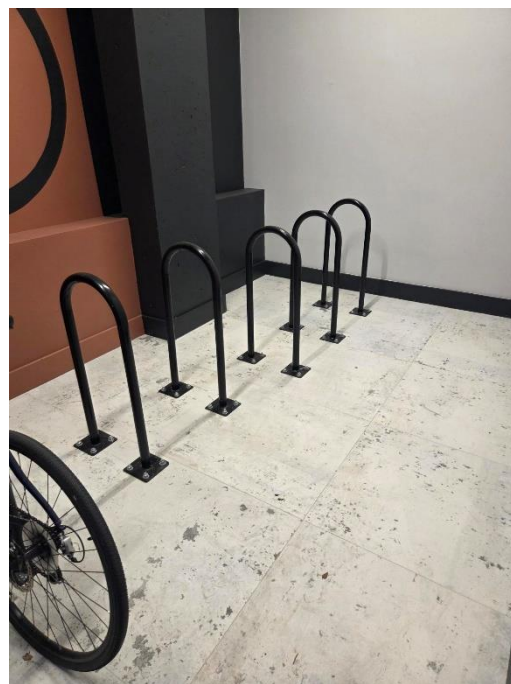
Photo 10: Bicycle room, first floor interior

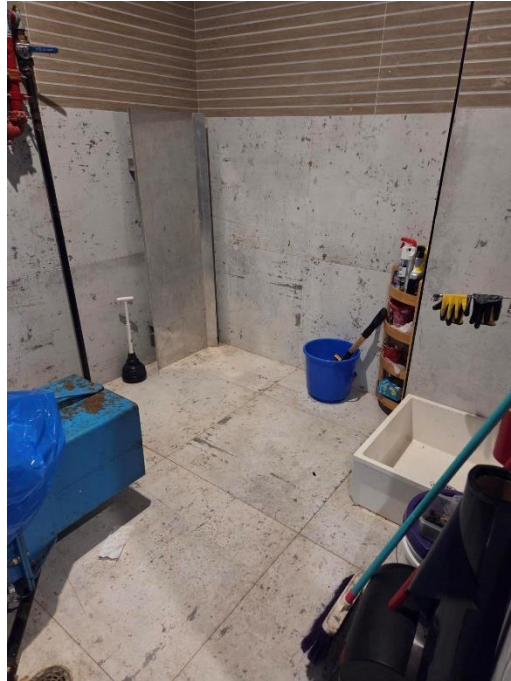
Photo 11: Compressor room, first floor interior

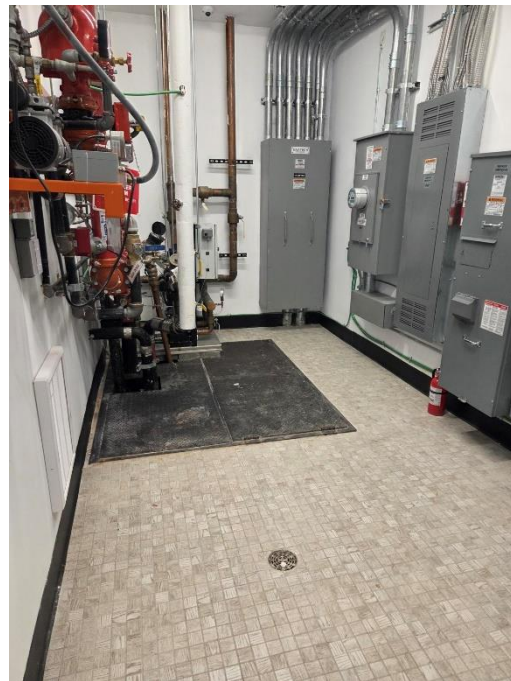
Photo 12: Electrical room, first floor interior

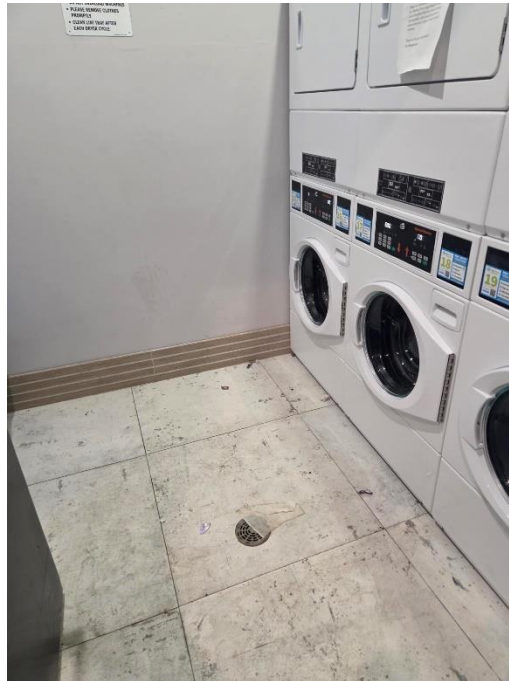
Photo 13: Laundry room, first floor interior

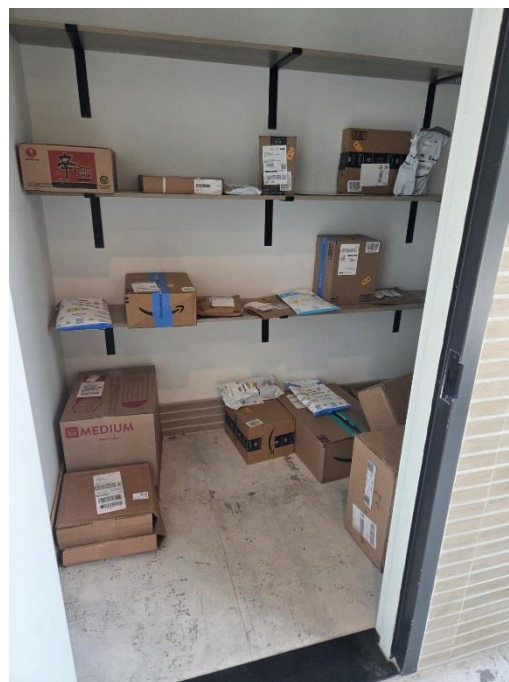
Photo 14: Mail room, first floor interior
