Project Name: 2985 Webster Avenue (Webster III)

Project Number: 13CVCP131X

Inspection Date: March 26, 2025

Site Inspection and Certification Letter Report

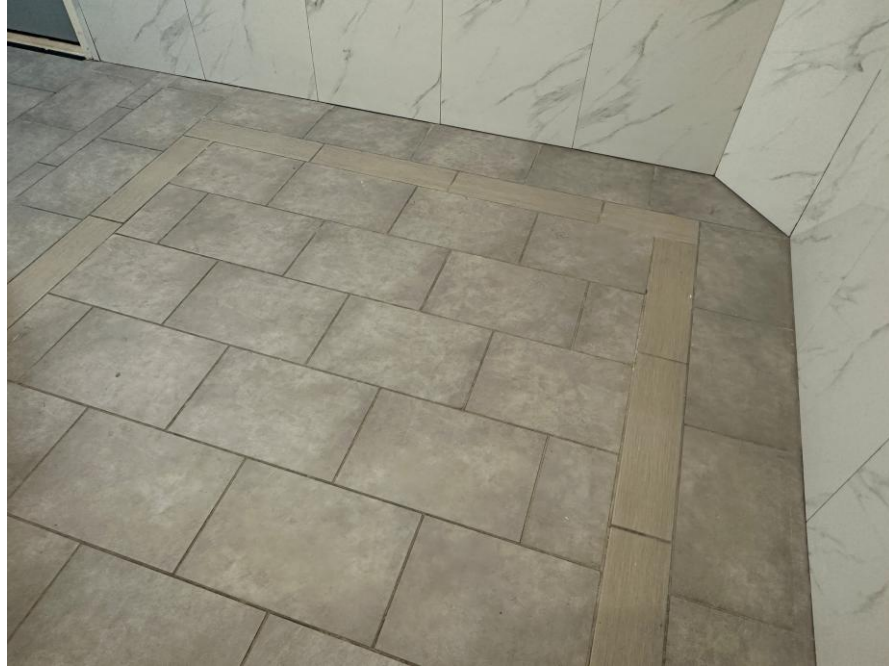
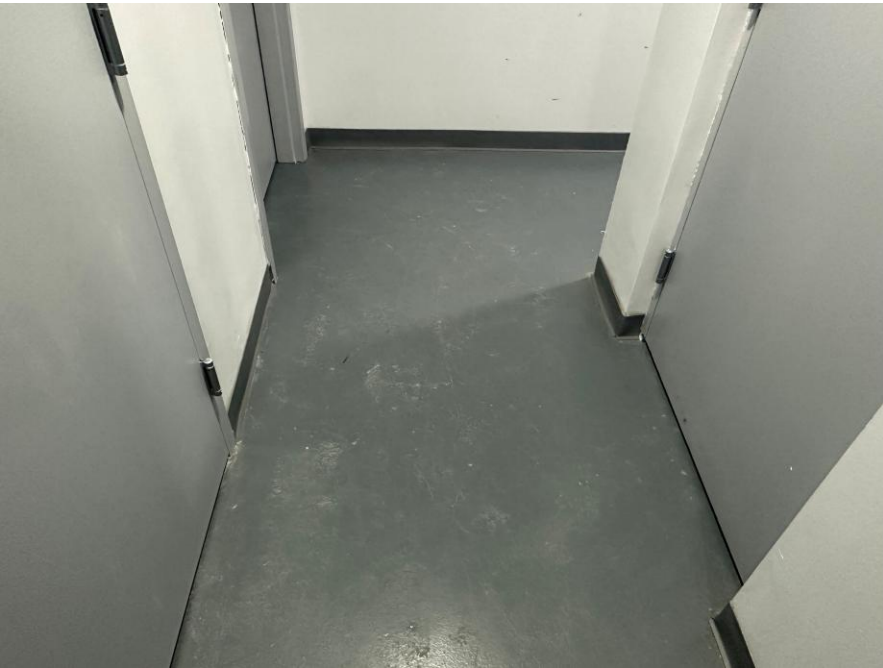
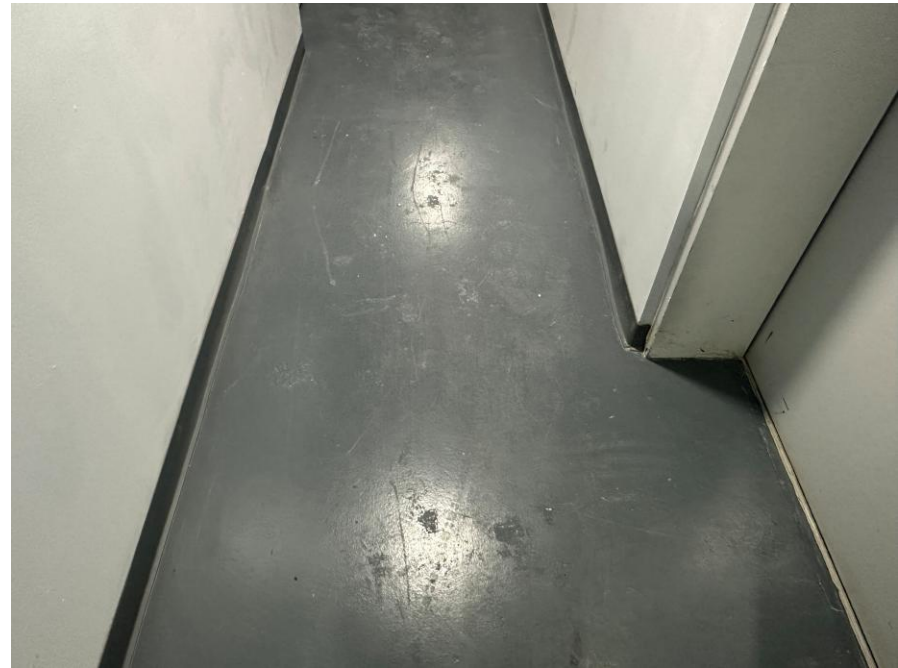
Composite Cover System on 1st Floor

All accessible portions of the composite cover system were visually inspected during the site inspection. The composite cover system at the Site appears to be in sound condition. No major cracks were observed in the concrete slab or foundation walls. Fine cracks were observed in slab and walls, which should not impact the overall protection of the composite system or represent a risk for soil vapor intrusion impact. No exposed vapor barrier was observed. The rear yard appears to be covered with concrete that is maintained in the same condition as observed in the Annual Inspection Report from the last reporting period. Based upon the site inspection, the ECs present appear to be in sound condition and functioning properly. The Site is protective to human health and the environmental.
