SITE INSPECTION AND CERTIFICATION LETTER REPORT

**320 WEST 135TH STREET
NEW YORK, NEW YORK
NYC VCP Project Number 17CVCP078M
E-Designation Project Number 16ENOS062M**

**July 31, 2023
170186401**

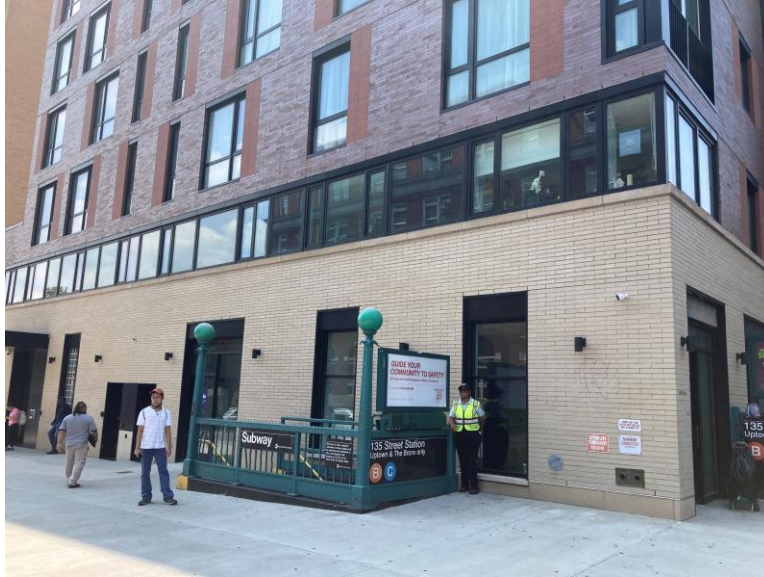
Photo 1: View of the 320 West 135th Street building exterior (facing southeast). Taken 7/25/2023.

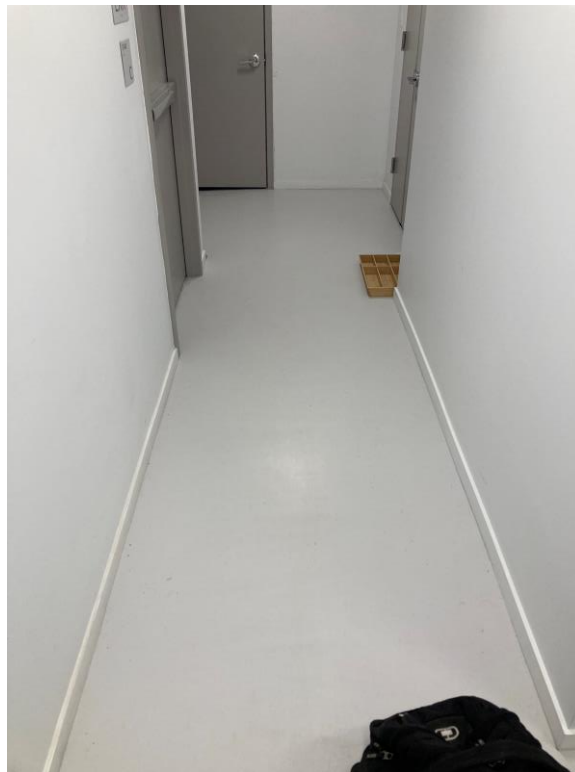
The composite cover system was inspected and was intact with no visible cracks, penetrations, or signs of construction activity that would breach the composite cover system since the last inspection. There is no exposed residual soil or landscaping on-site.

Photo 2: View of the finished cellar slab (facing southwest). Taken 7/25/2023.

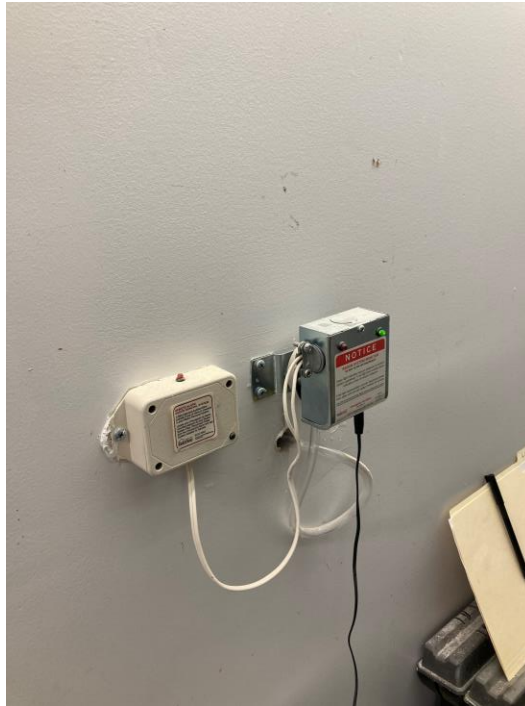
Photo 3: View of the active alarm system (facing northeast). Taken 7/25/2023.

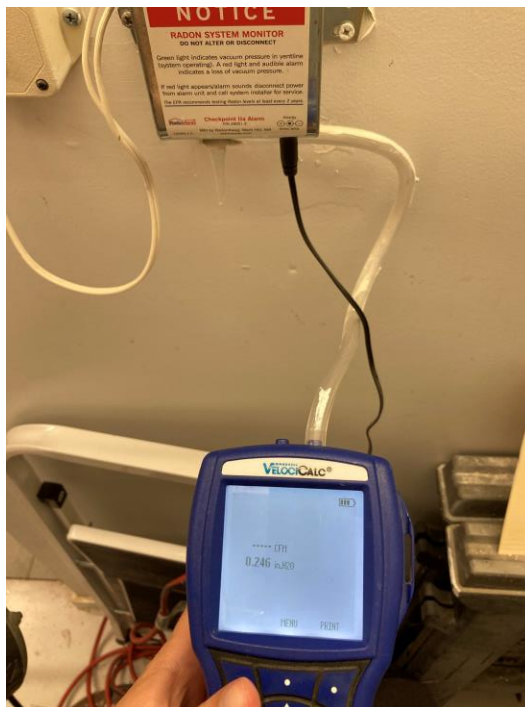
Photo 4: View of a vacuum reading collected from the riser pipe extending from the sub-membrane depressurization (SMD) system, and triggered alarm (facing north).
Taken 7/25/2023.

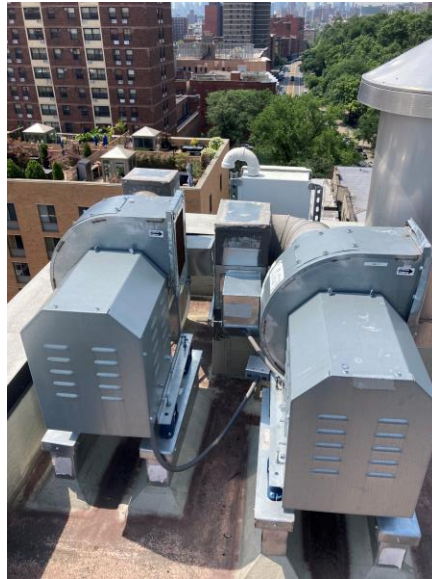
The SMD system blower is located on the roof of the building. The blower was operational at the time of the inspection. The exhaust piping from the blower is composed of 2-inch PVC piping, and terminates above the blower housing. The vent is located a minimum of 10 feet from any operable window or air intake for the building. The system is equipped with a vacuum gauge connected to riser penetration on the roof, and an alarm located in the building trash compactor, which is triggered if the blower stops running. The blower was briefly turned off during the inspection to test the alarm, which was confirmed to be operating correctly.

Photo 5: View of the SMD fan and exhaust on the highest roof of the 320 West 135th Street building (facing south). Taken 7/25/2023.

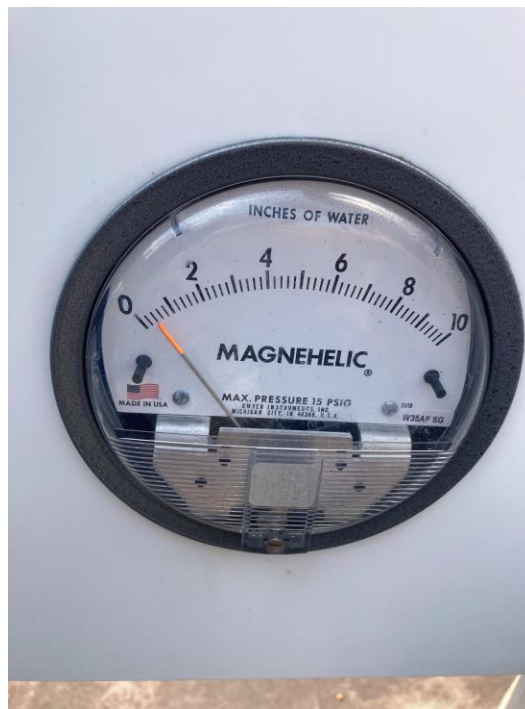
Photo 6: View of the magnehelic gauge on the SMD roof exhaust system (facing south). Taken 7/25/2023.
