March 21, 2024

Ref: 21774.00

Re: 2023 Site Management Inspection and Certification Report
963 Atlantic Avenue, Brooklyn, NY
NYC VCP Number 15CVCP089K | E-Designation Site Number 15EH-N012K
Inspection Date: September 11, 2023
Inspector and Certifier: George Lester, PE
Report Submittal Date: March 21, 2024

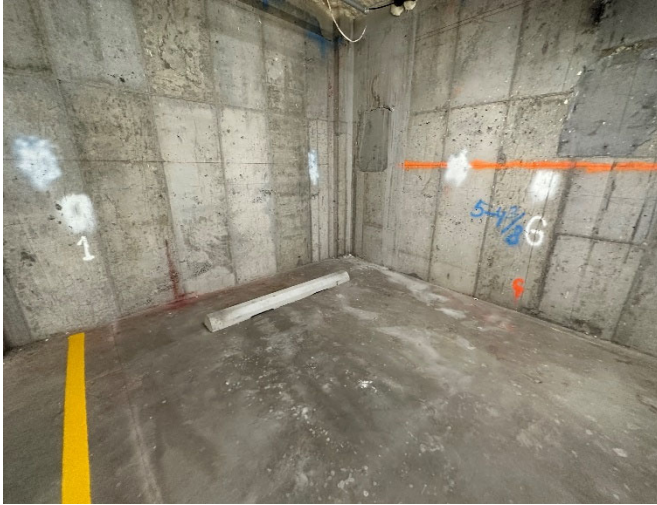
NO. 1 / 9.11.2023 10:57 AM

View of the southeast corner of the parking garage.

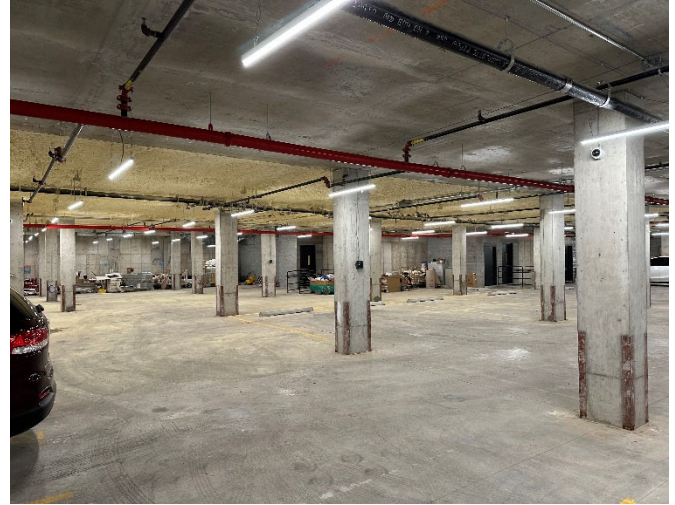
NO. 2 / 9.11.2023 11:01 AM

View of the parking garage, facing northeast.

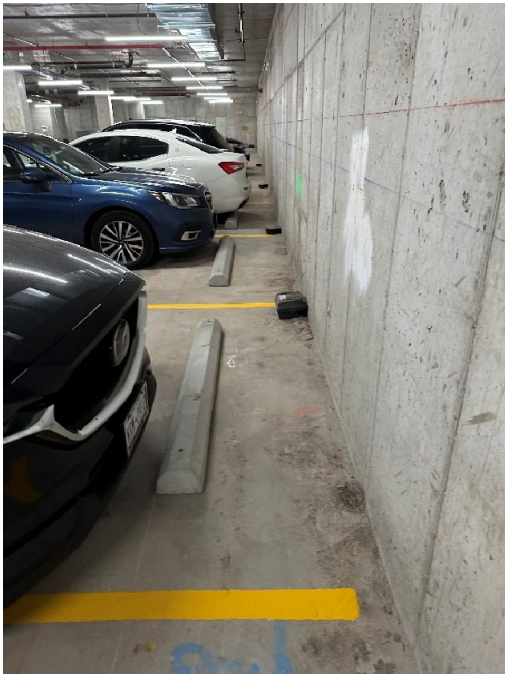
NO. 3 / 9.11.2023 11:03 AM

View of the eastern wall of the parking garage.

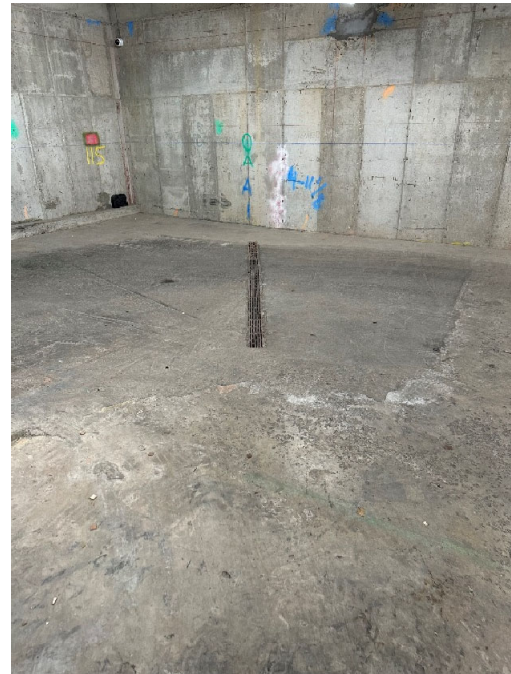
NO. 4 / 9.11.2023 11:06 AM

View of a floor drain at the bottom of the parking garage ramp at the northwest corner of the parking garage.

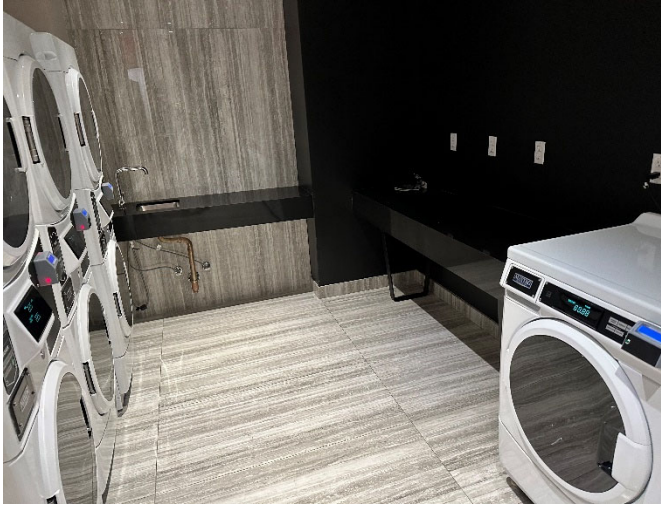
NO. 5 / 9.11.2023 11:10 AM

View of tenant amenity space.

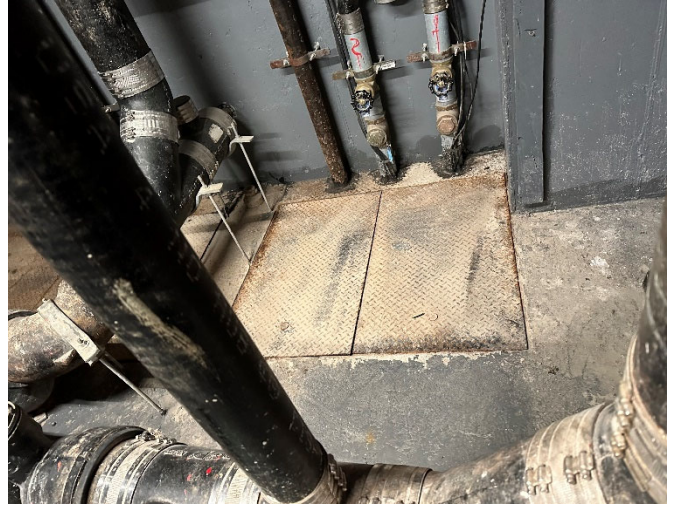
NO. 6 / 9.11.2023 11:15 AM

View of the building sump pit.

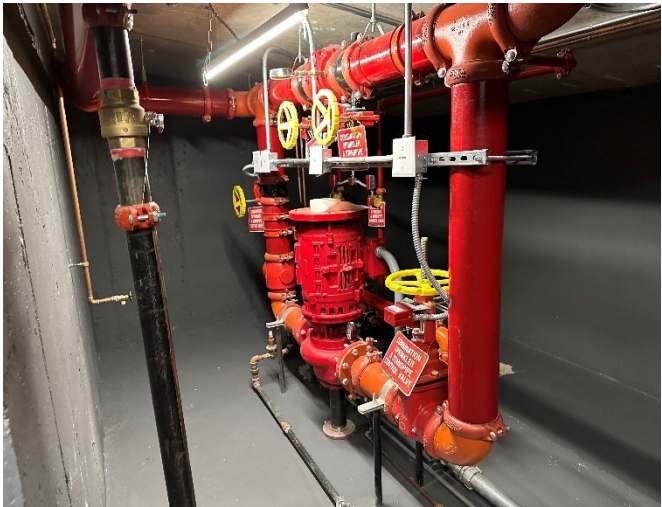
NO. 7 / 9.11.2023 11:16 AM

View of the fire pump area.

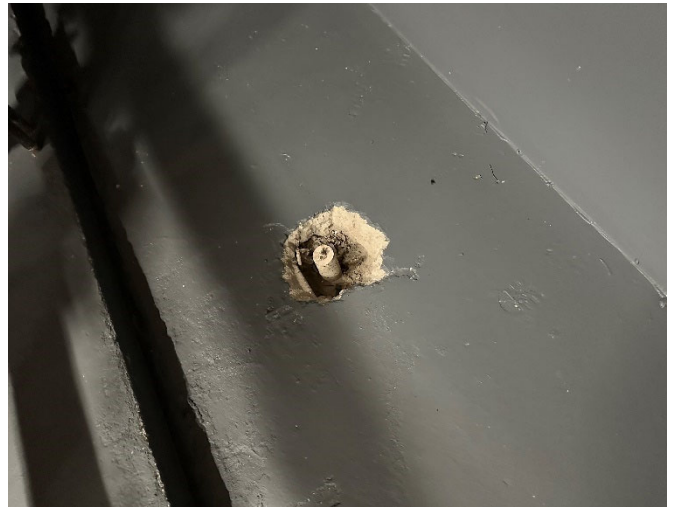
NO. 8 / 9.11.2023 11:16 AM

The Composite Cover System was inspected, and components were observed to be in good condition. Evidence of a small area of concrete (approximately one-foot square) was partially removed from the surrounding structural support for fire pump installation. The vapor barrier was not exposed. The area was repaired on October 17 2023. At the time of Site inspection, no other evidence of a breach or cracks in the system were observed. Additionally, no construction activities were occurring at the time of the Site inspection. Photographs of the Composite Cover System are provided in **Attachment B**.

View of concrete partially removed from the cellar floor in support of fire pump installation. Area to be repaired by building superintendent.

Following the site visit, Plaza Management made repairs to the area of partially removed concrete in the fire pump room using a dry concrete mix on October 17, 2023. During the repair process, the area was monitored, and more concrete was added as needed. Photographs of the concrete repair are provided in **Attachment C**.

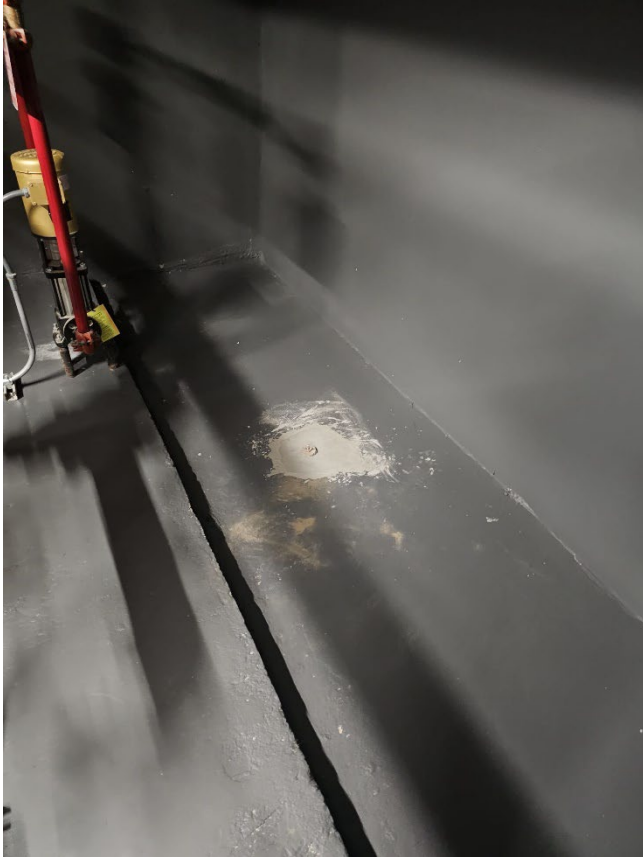
NO. 1 / 10.17.2023

View of the repaired concrete in the fire pump room.

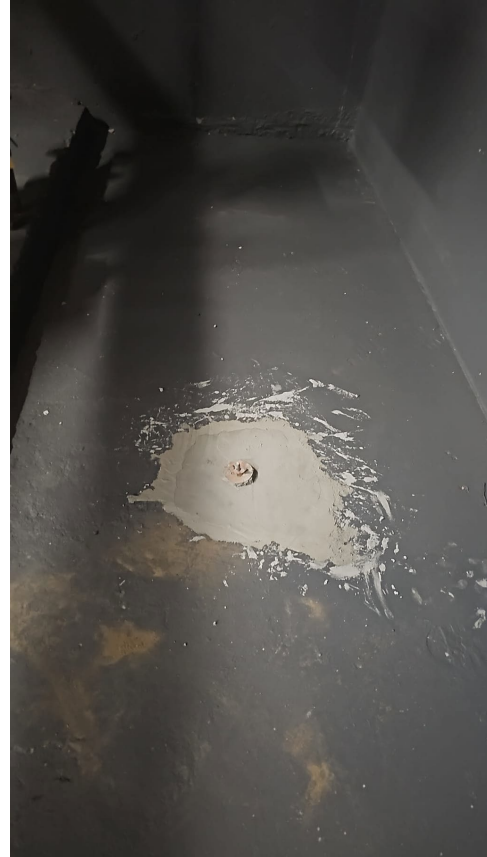
NO. 2 / 10.17.2023

Zoomed-in view of the repaired concrete in the fire pump room.
