**Project Name: Cherry Valley Marketplace**

**801-849 & 881-885 East Gun Hill Road, Bronx, NY**

**Project Number: 12EHAN523X**

**Site Inspection and Certification Letter Report**

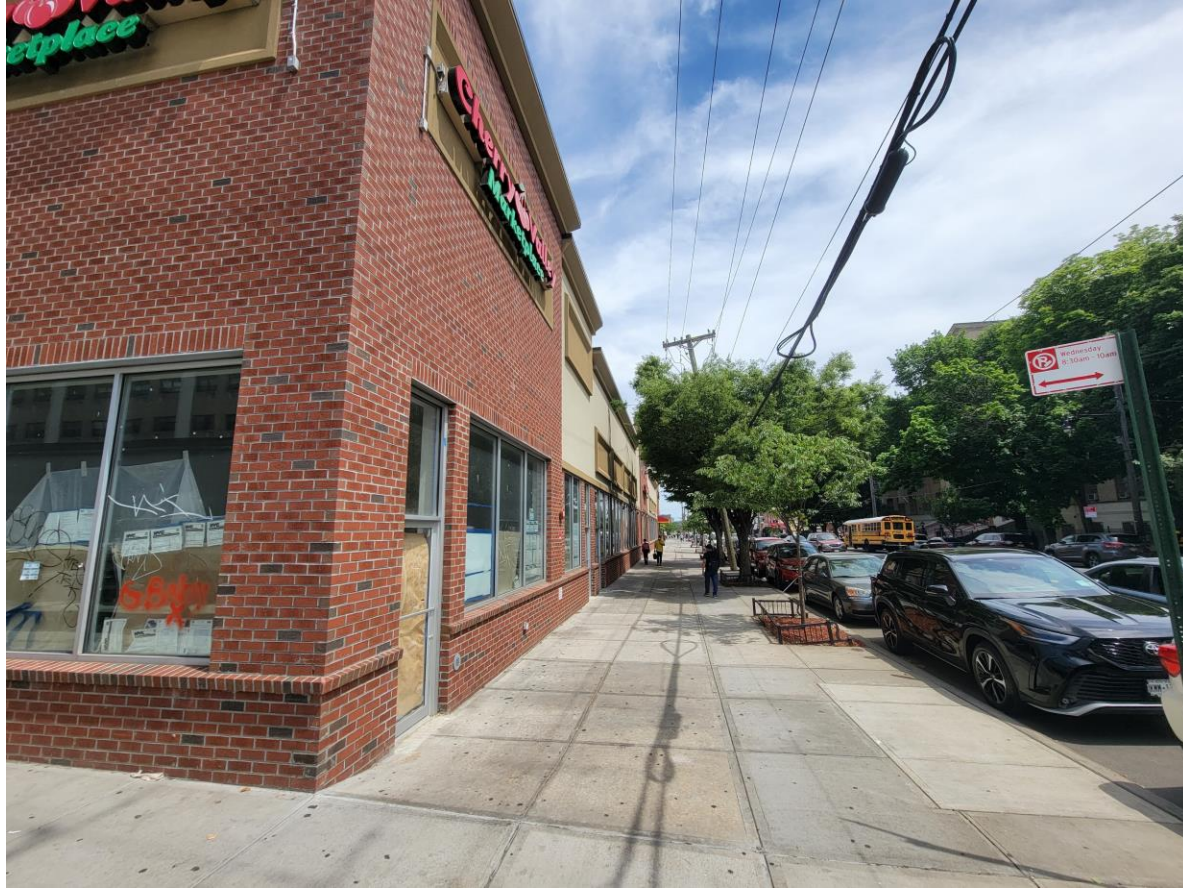
View of Subject Property

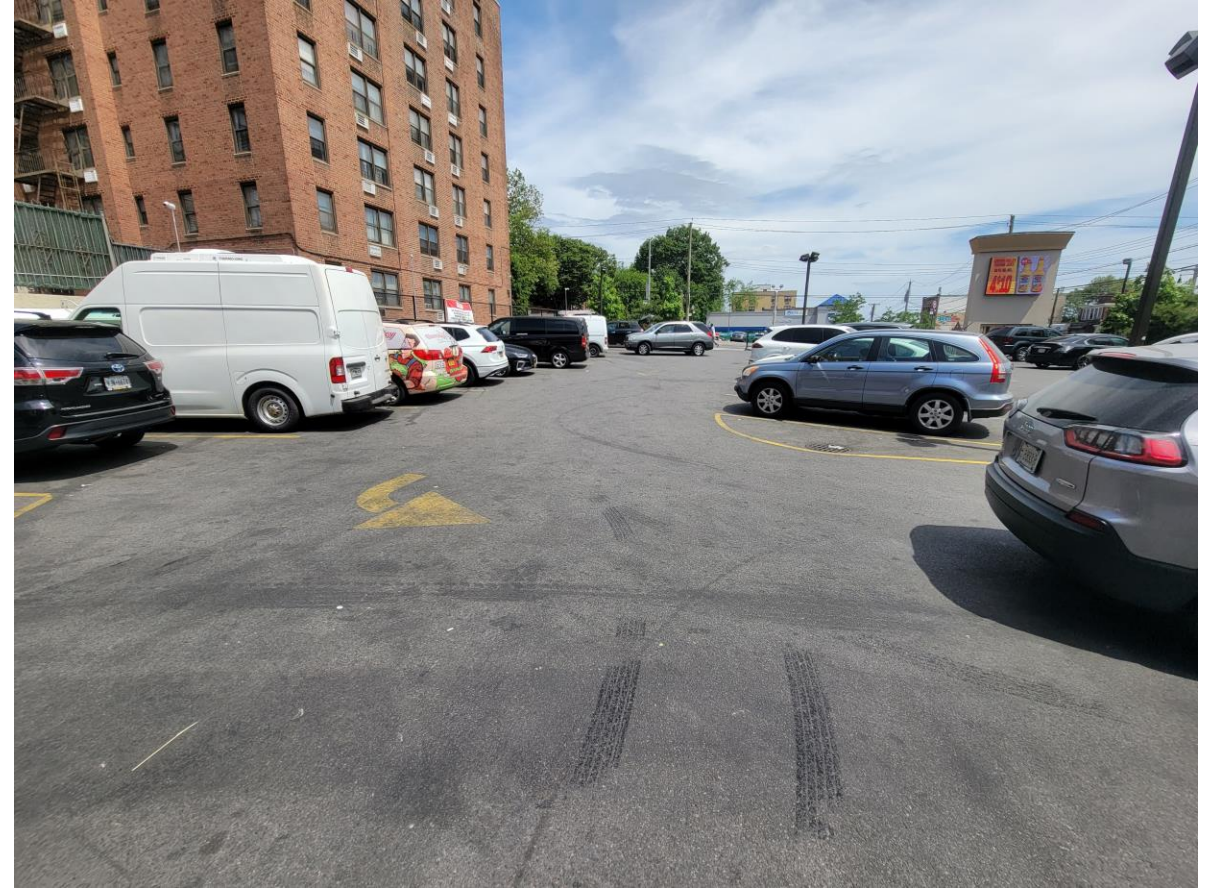
View of Parking Lot

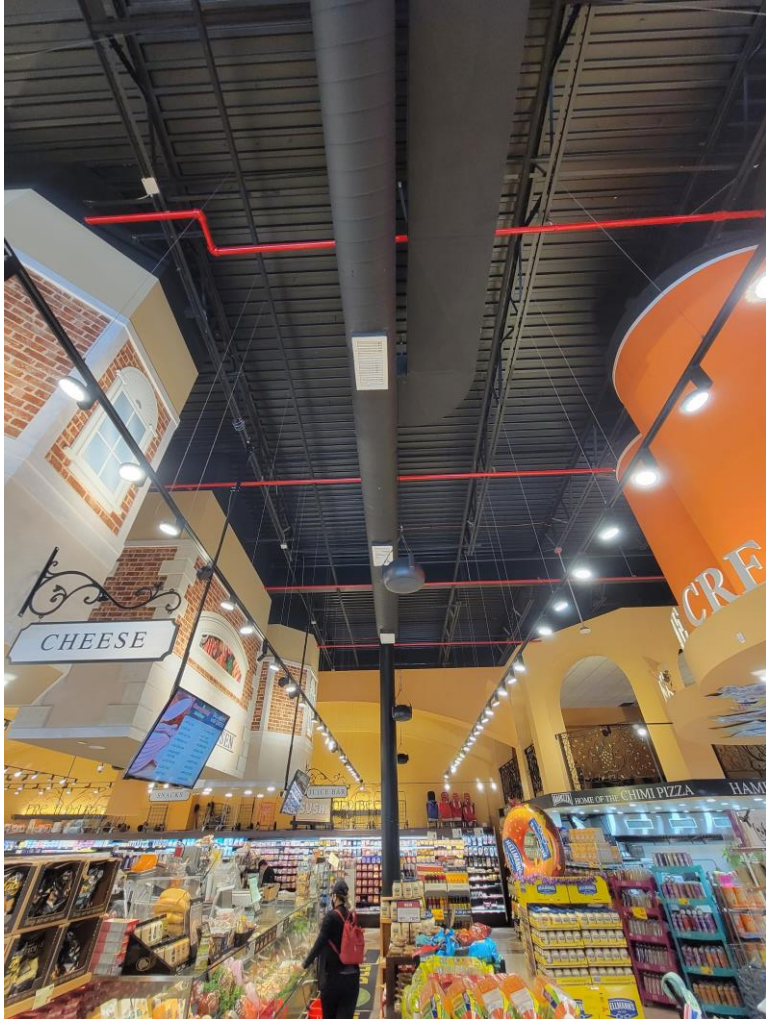
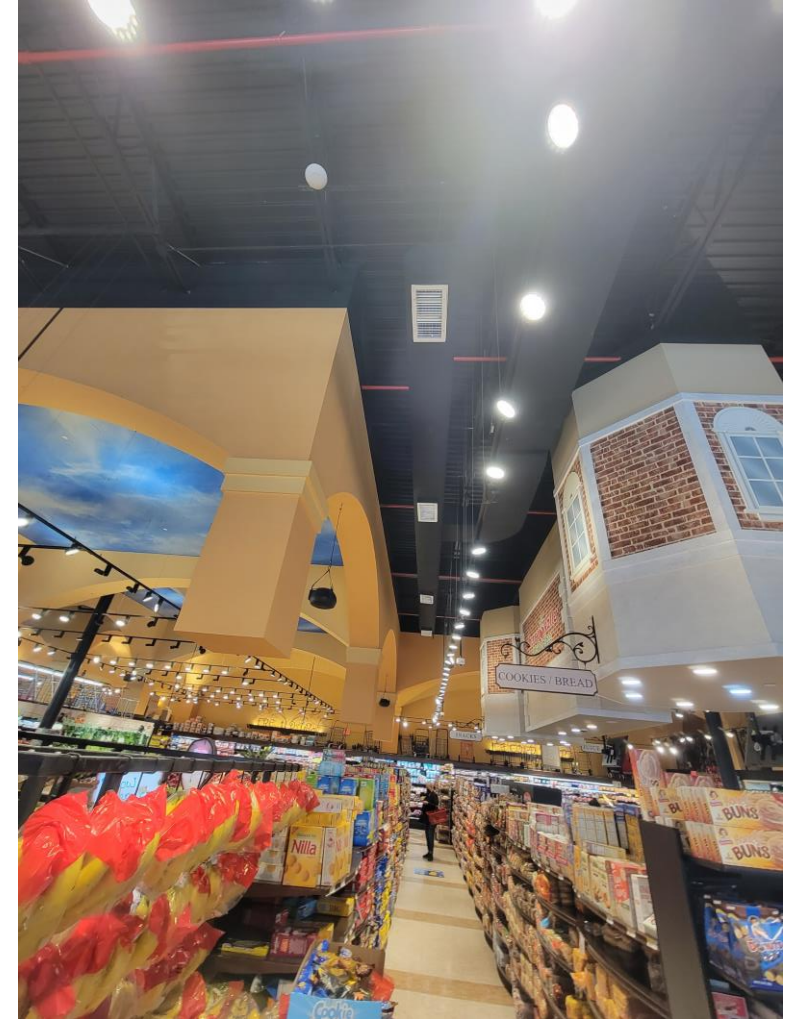
On the day of inspection, all exposed portions of the composite cover system were visually inspected. The composite cover consists of a reinforced concrete slab in the basement and an asphalt pavement in parking lot. The composite cover system appears to be in sound condition. No alterations were identified in the composite cover system. Fine horizontal cracks of around 6 to 10 feet in length continue to be observed in many sections of the concrete slab in the basement, which is utilized for the storage of supermarket supplies. These fine cracks are unlikely to represent a risk for soil vapor intrusion impact since migration of vapor is prevented by a vapor barrier installed under the slab. In addition, any potential impact associated with potential soil vapor vapors intrusion into the building is mitigated by the positive pressure system.

View of Composite Cover
