Project Name: 200 Water Street

Project Number: 14TMP0357K

Inspection Date: July 9, 2020

Site Inspection and Certification Letter Report

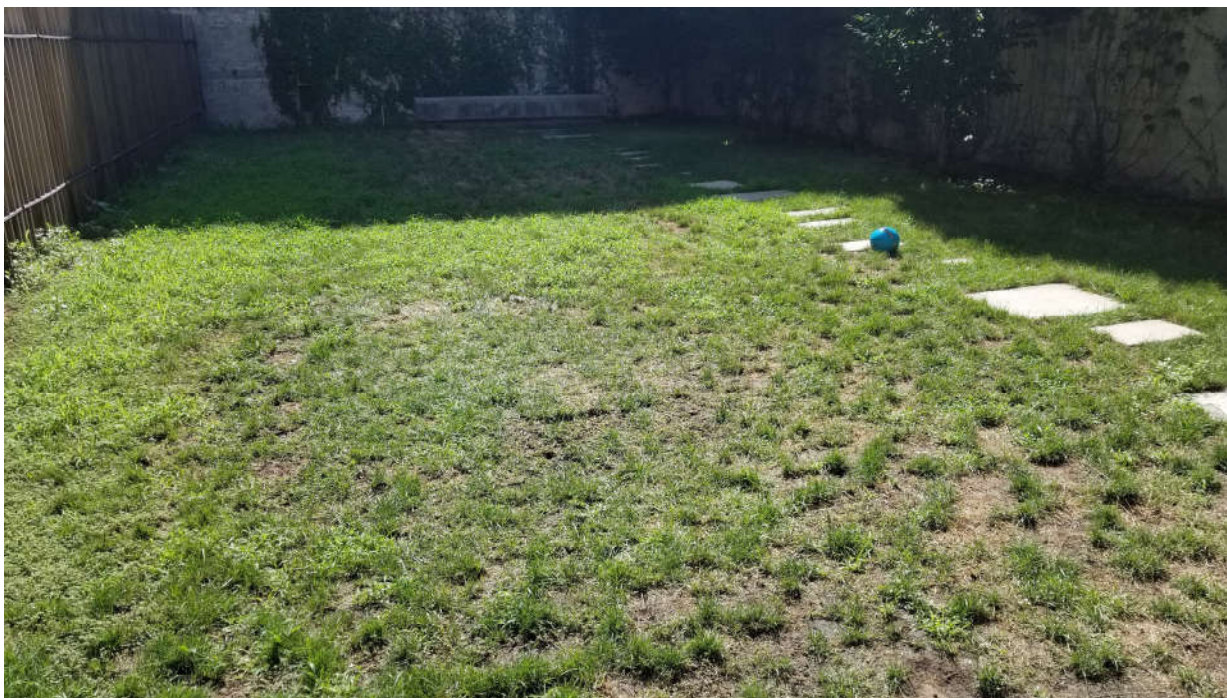
During the site inspection, Ms. Cosenza was escorted by Foad Choudhury, Building Superintendent. ATC inspected the clean-fill cover in the rear courtyard of the Site building, which was found to be undisturbed with no evidence of prior excavation (Photos 1 & 2). In addition, the composite cover system consisting of the concrete basement slab and foundation walls, and vapor barrier, was inspected. The system was found to be intact with no evidence of physical damage or cracks equal to or greater than 1/8-inch in diameter (Photos 3 through 9). ATC visually inspected the crawl space (Photo 10) and verified that the ventilation blower was operating properly with no unusual or excessive noise.

Photo 1: View of Clean-Fill Cover in rear courtyard looking east.

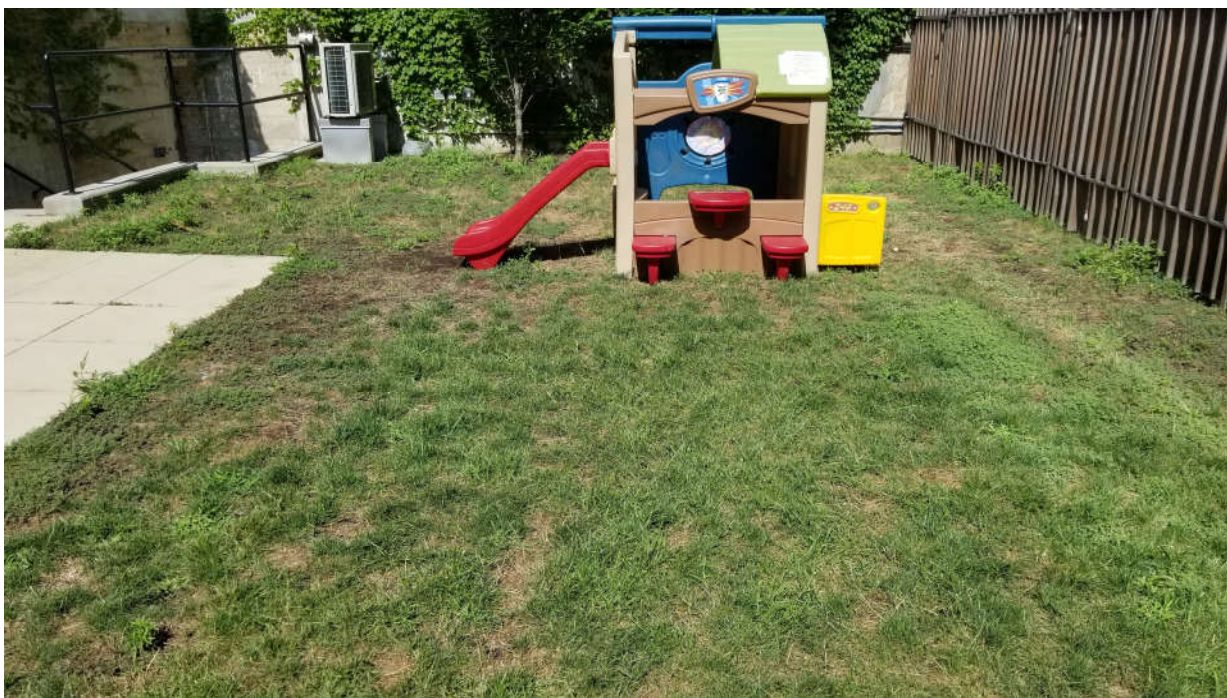
Photo 2: View of Clean-Fill Cover in rear courtyard looking west.

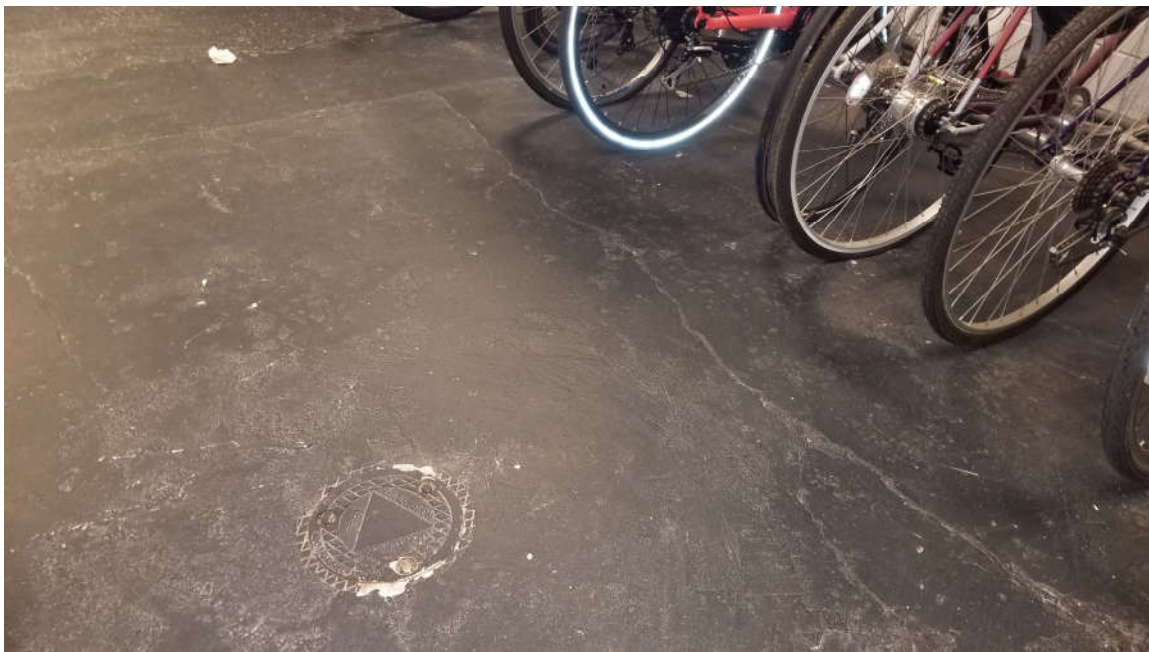
Photo 3: View of concrete floor in cellar Bicycle Storage Room.

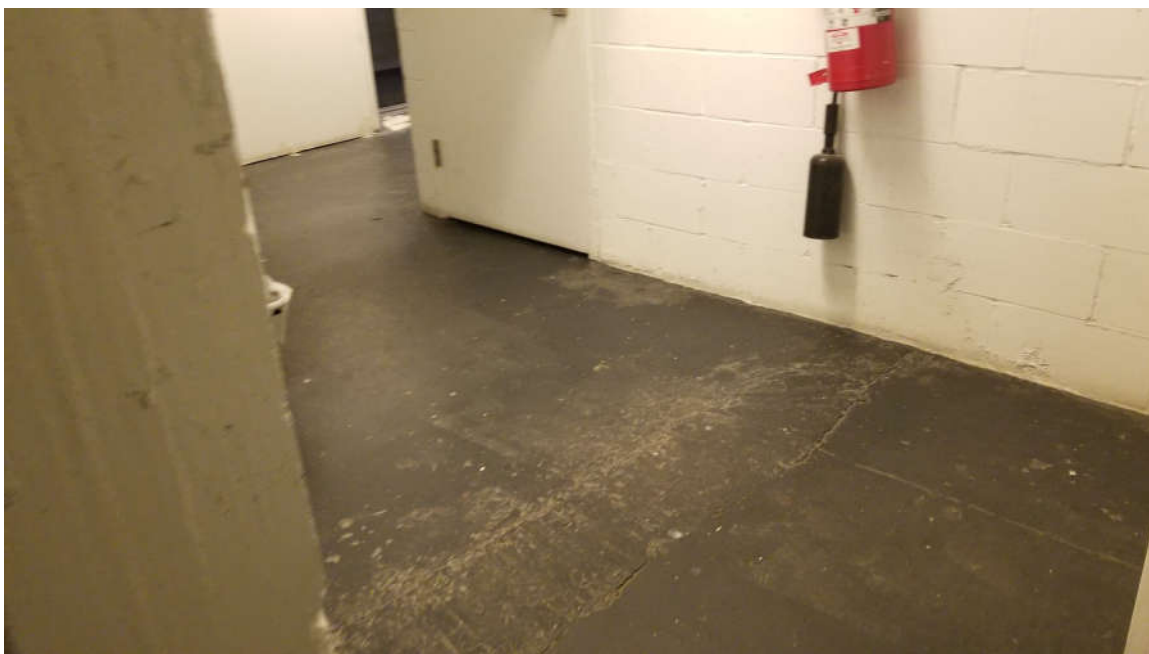
Photo 4: View of concrete floor in cellar Compactor/Recycling Room.

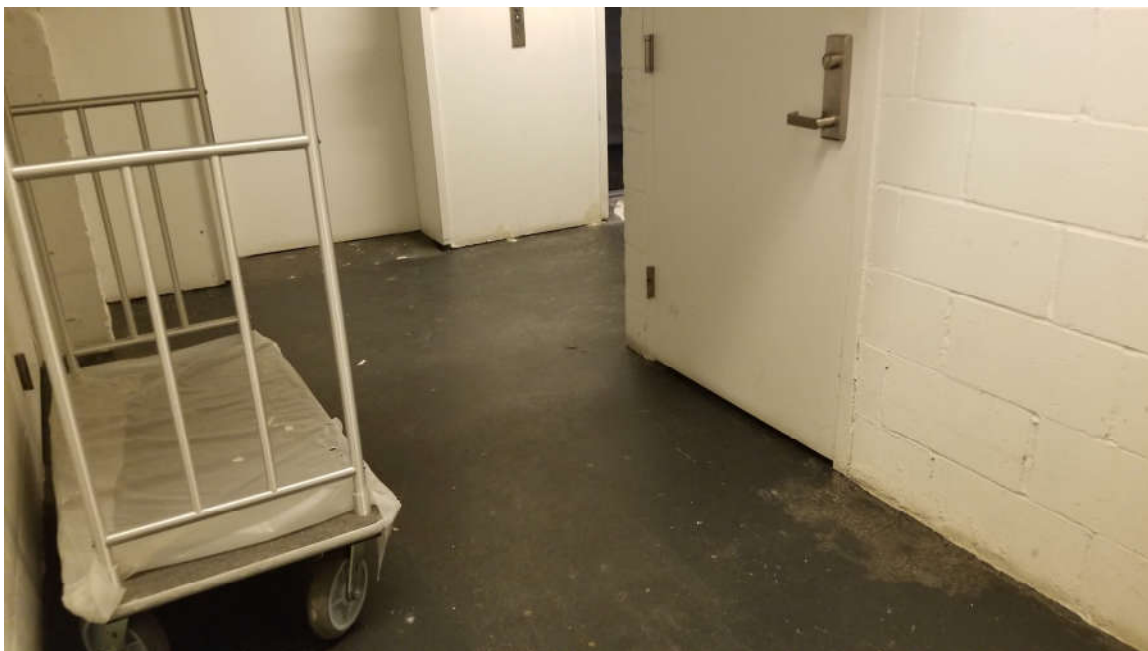
Photo 5: Center Public Corridor within cellar.

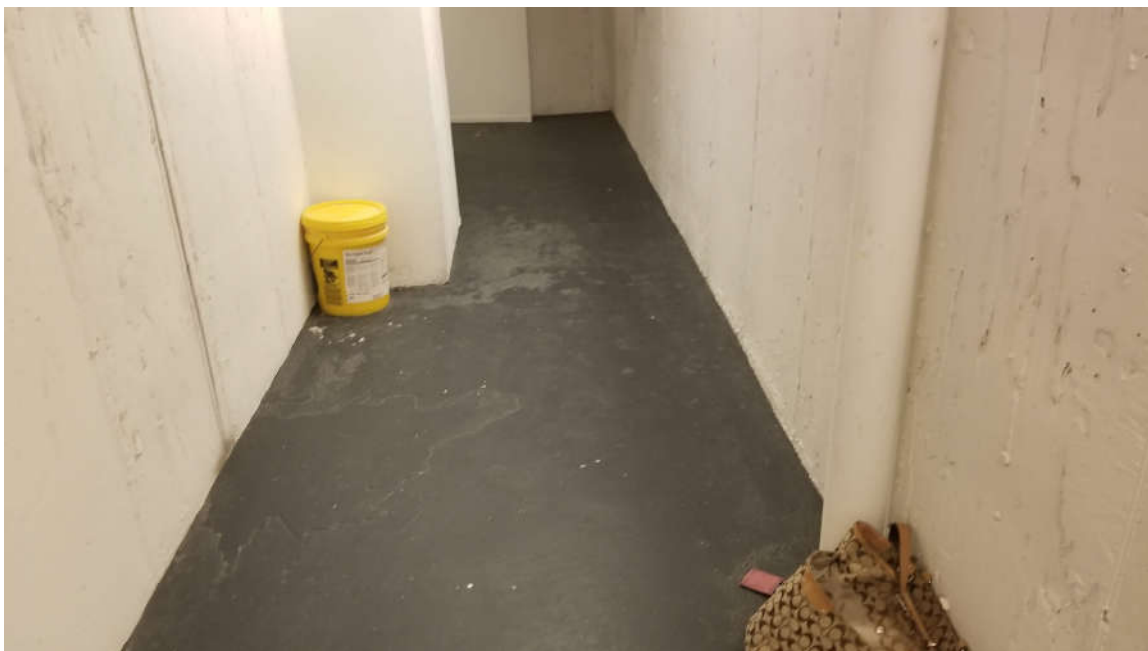
Photo 6: Public Corridor near Stairwell A within cellar.

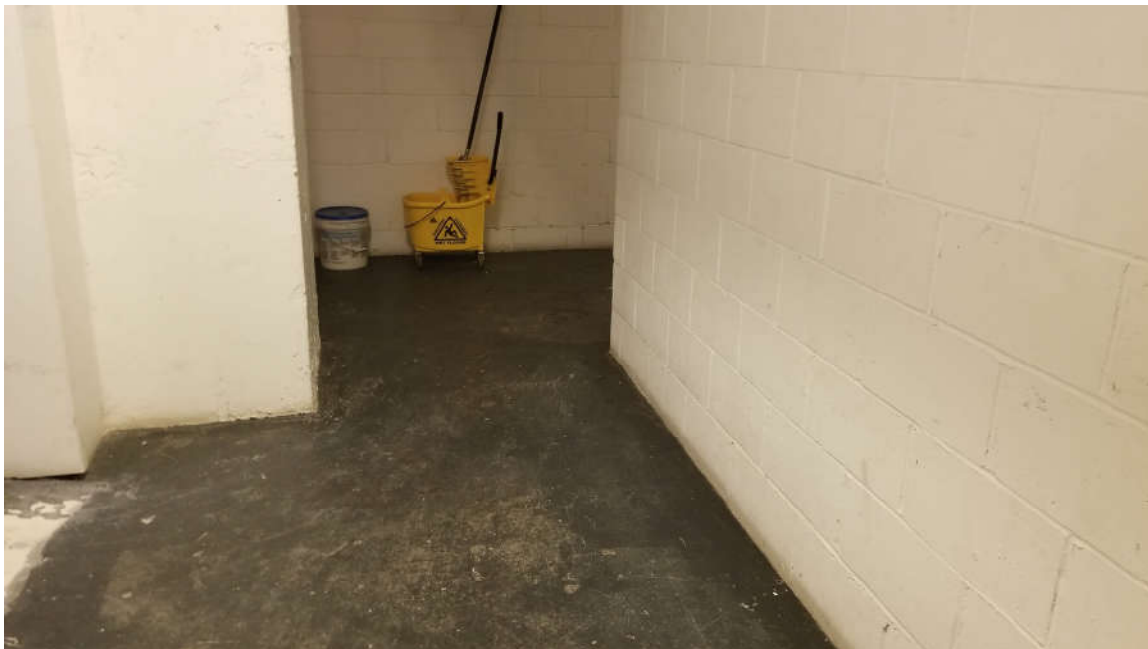
Photo 7: Corridor at south side of the cellar.

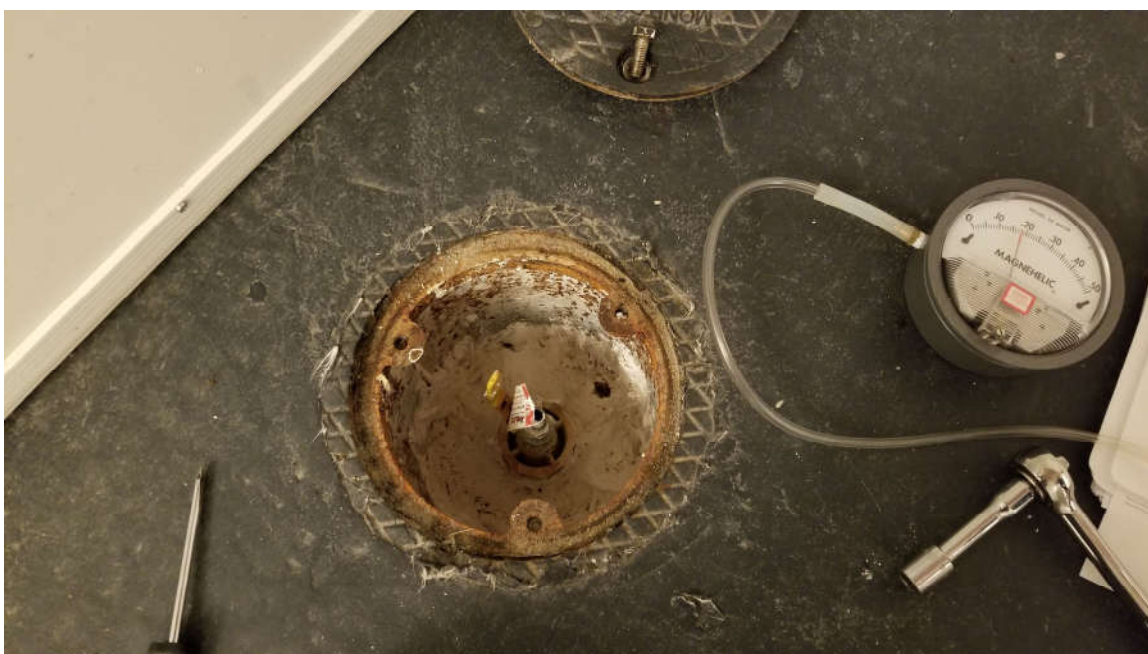
Photo 8: Soil Vapor Monitoring Point V-9.

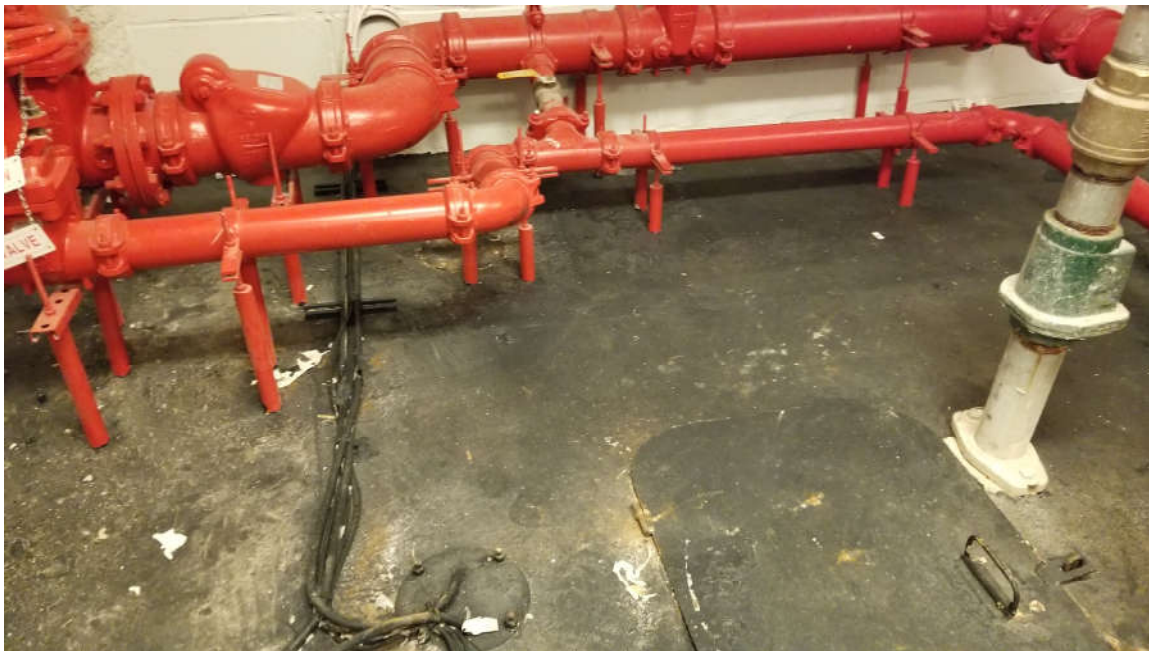
Photo 9: View of Water Meter/Fire Pump Room within cellar.

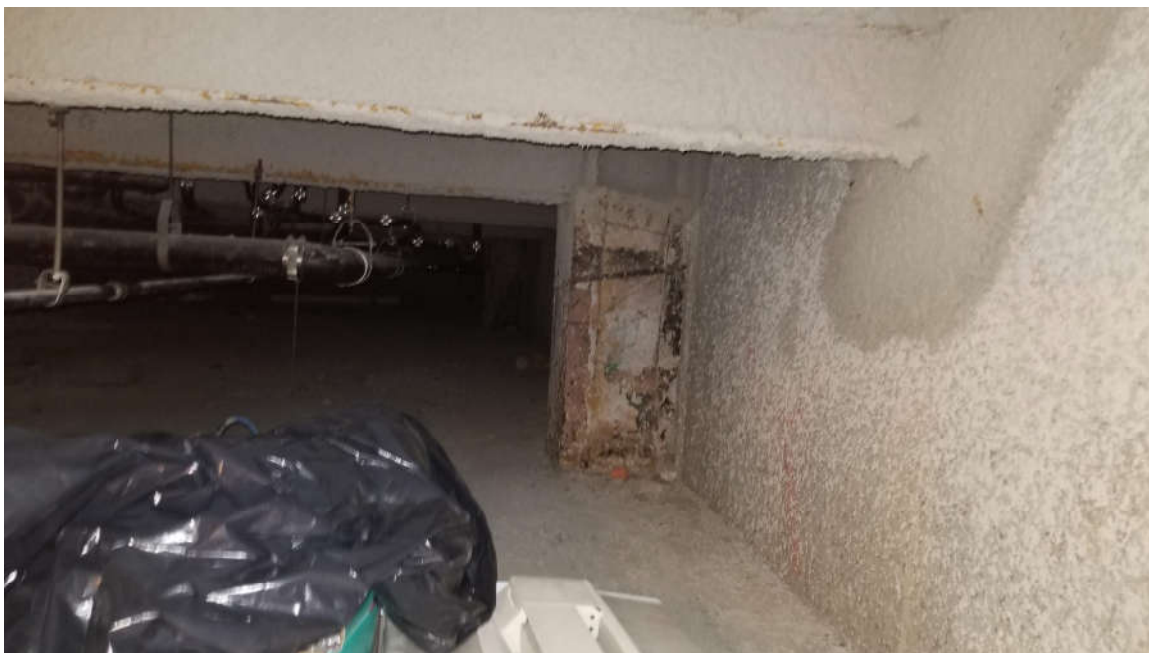
Photo 10: View of Crawl Space.

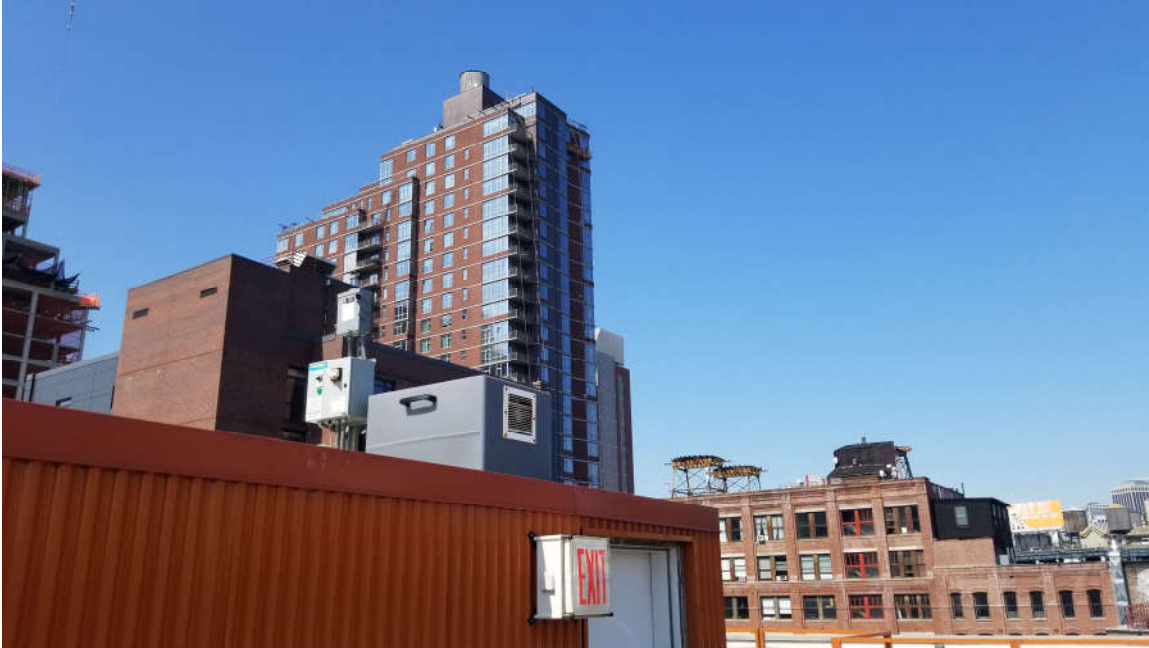
ATC inspected the operation of the sub-slab depressurization system (SSDS). The SSDS blower was observed to be operating properly with no unusual or excessive noise (Photo 11). No air leaks were observed in accessible air conveyance piping and fittings (Photos 12 through 14). Proper operation of the blower alarm was verified. However, the sign on the blower alarm still needs to be replaced (Photo 15). It currently reads "Alarm if Blower Malfunction is Lit Service Blower Immediately". The sign will be replaced to read "Blower Malfunction if Not Lit - Service Blower Immediately". Vacuum gauges on the blower and at each zone (Photo 14) were within proper operational range (Table 1, Appendix B). In addition, communication beneath the cellar floor was demonstrated by measured differential pressures greater than the design goal of 0.016 inches water column (W.C.) at the vapor monitoring points V-1 through V-10 (Table 1, Appendix B). However, differential pressure at vapor monitoring point V-8 could not be measured. The lever to operate the ball joint valve was no longer present and the pressure could not be gauged.

Photo 11: SSDS Blower on roof of stairwell bulkhead.

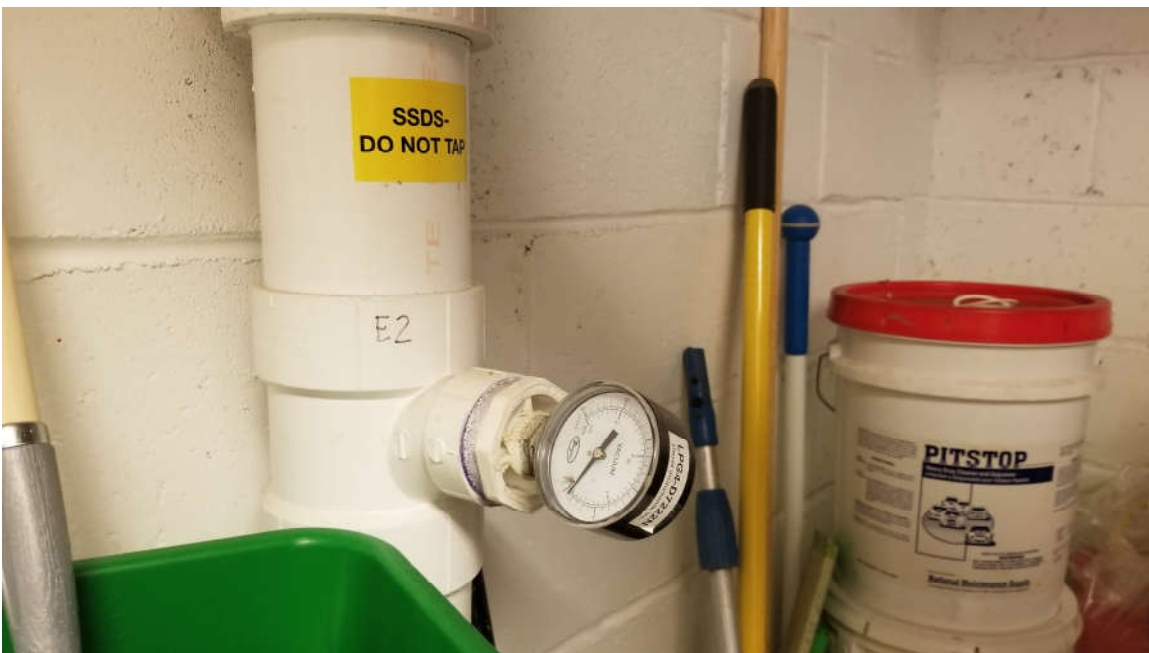
Photo 12: SSDS air conveyance piping and control valve at riser E2.

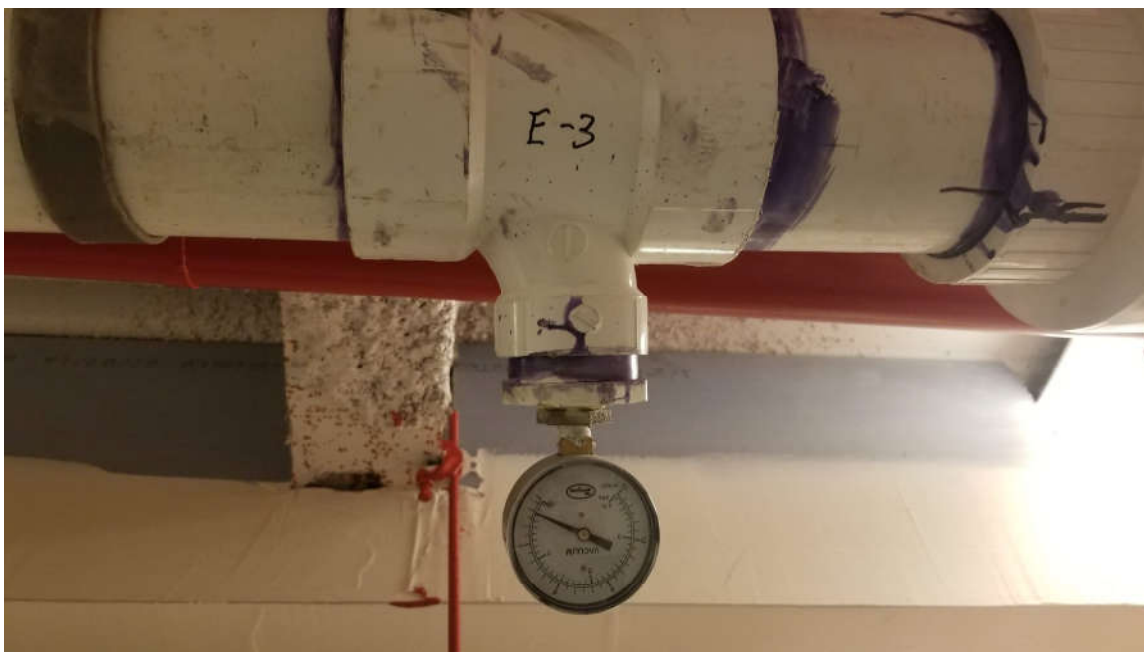
Photo 13: SSDS air conveyance piping and vacuum gauge at riser E3.

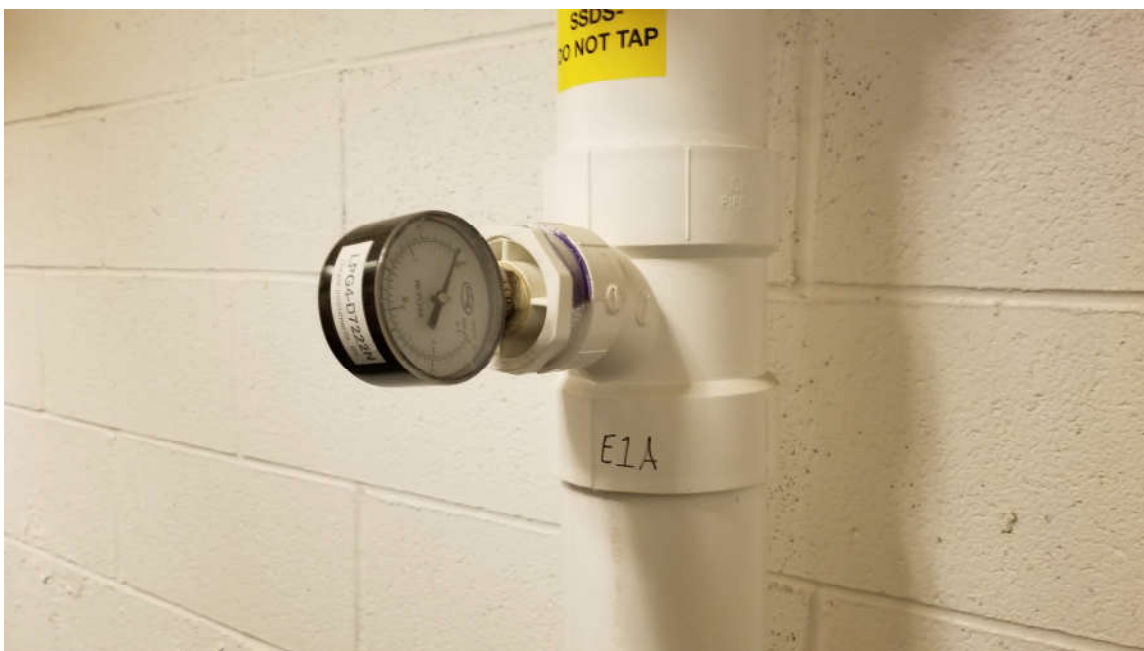
Photo 14: SSDS air conveyance piping and vacuum gauge at riser E1A.

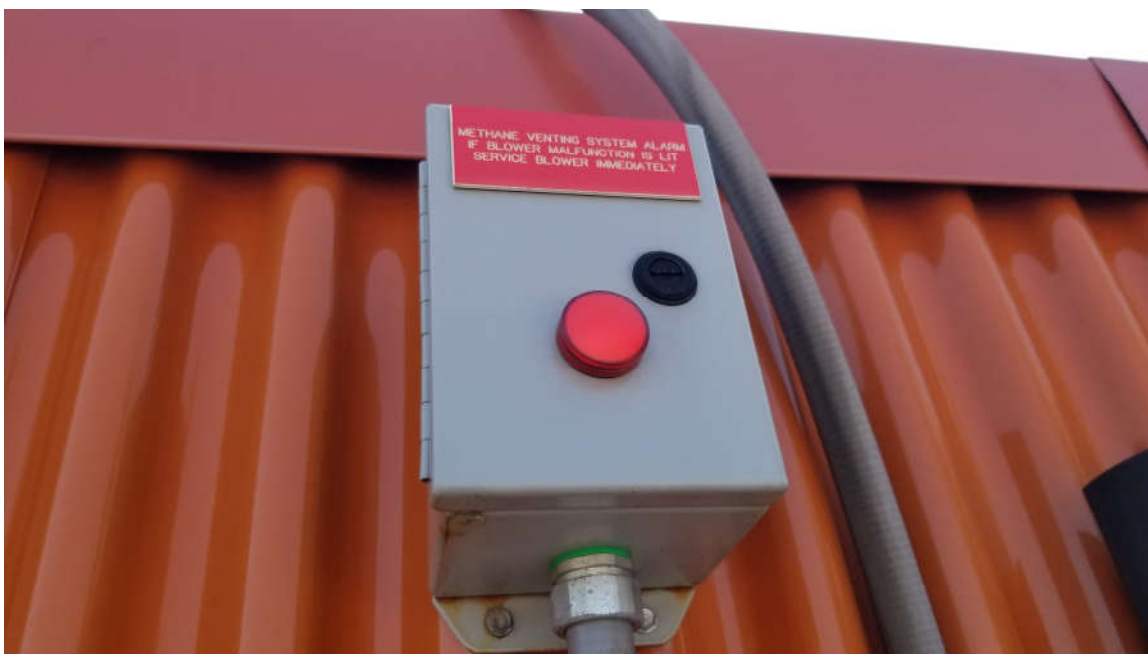
Photo 15: View of SSDS alarm panel.
