Project Name: 509 West 38th Street/ 512 West 39th Street

NYC VCP Project Number: 15CVCP0009M

Inspection Date: 4/2/2024, 6/24/2024, 7/12/2024

Site Inspection and Certification Letter Report

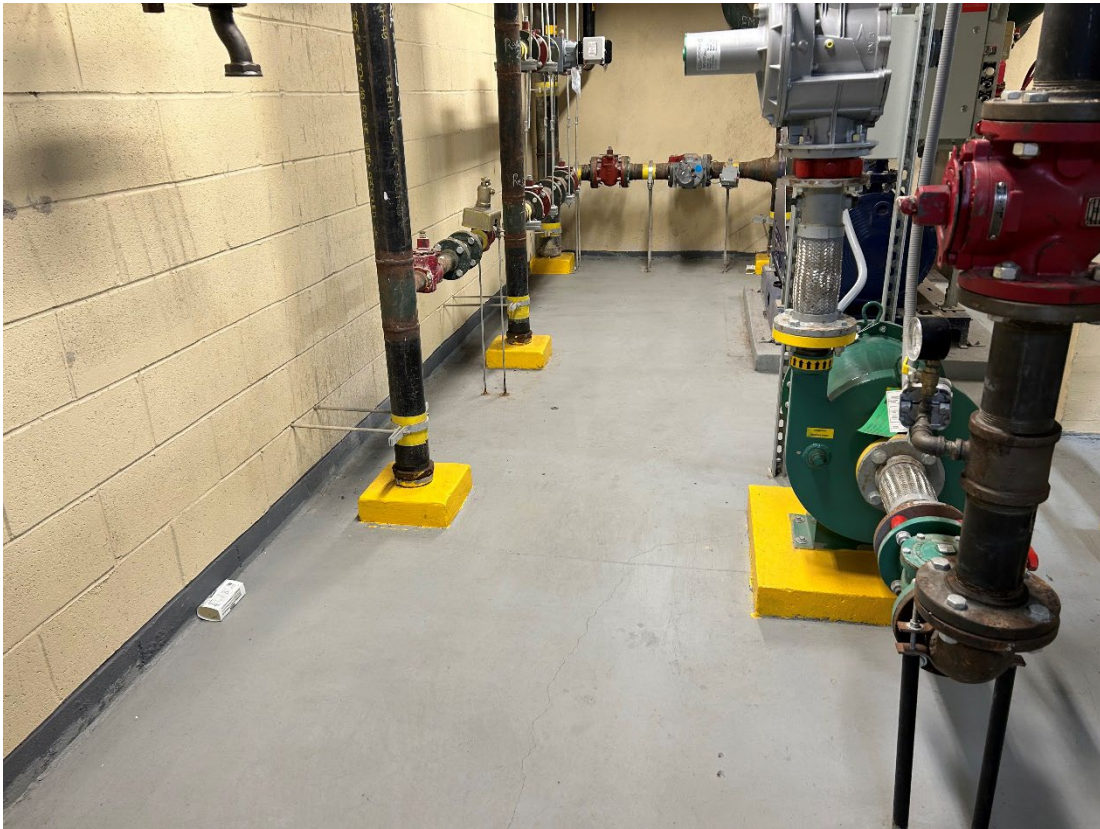
foundation sidewalls and asphalt cover were accessible and did not contain any visible cracks or defects. Therefore, the entire composite cover system is intact.

Photograph 1: View of the basement floor.

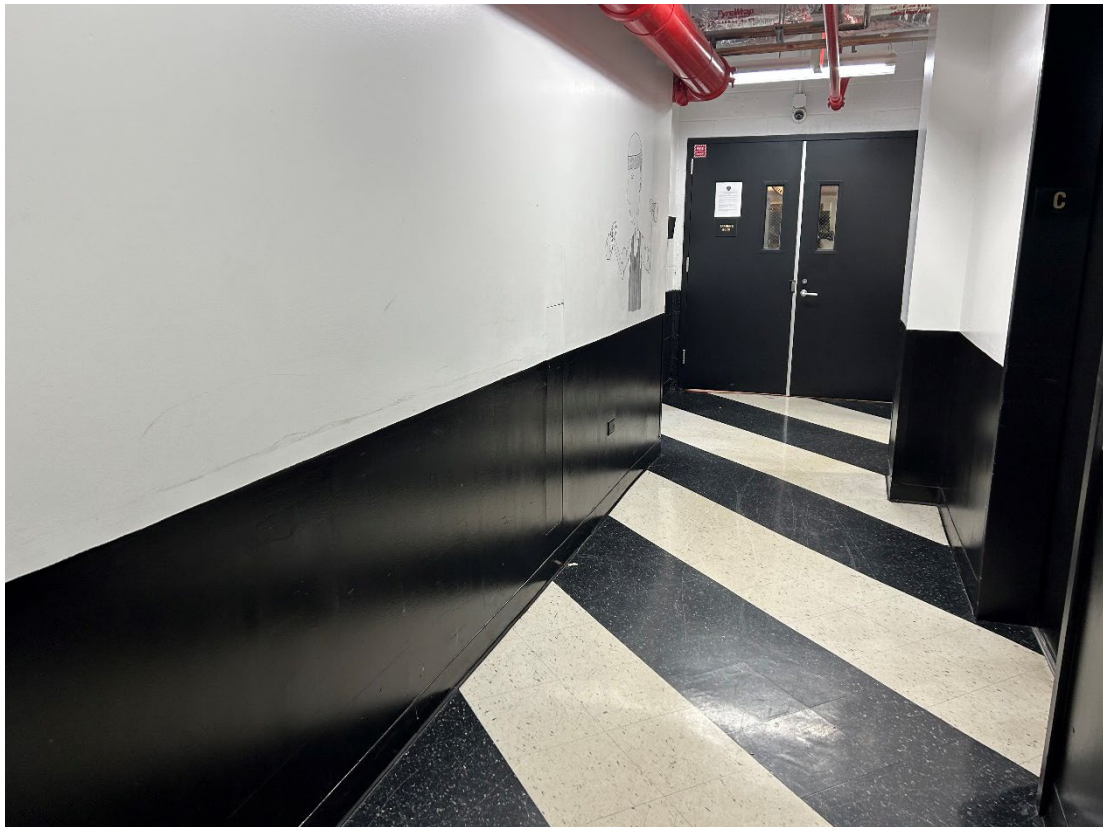
Photograph 2: View of the basement walls and flooring.

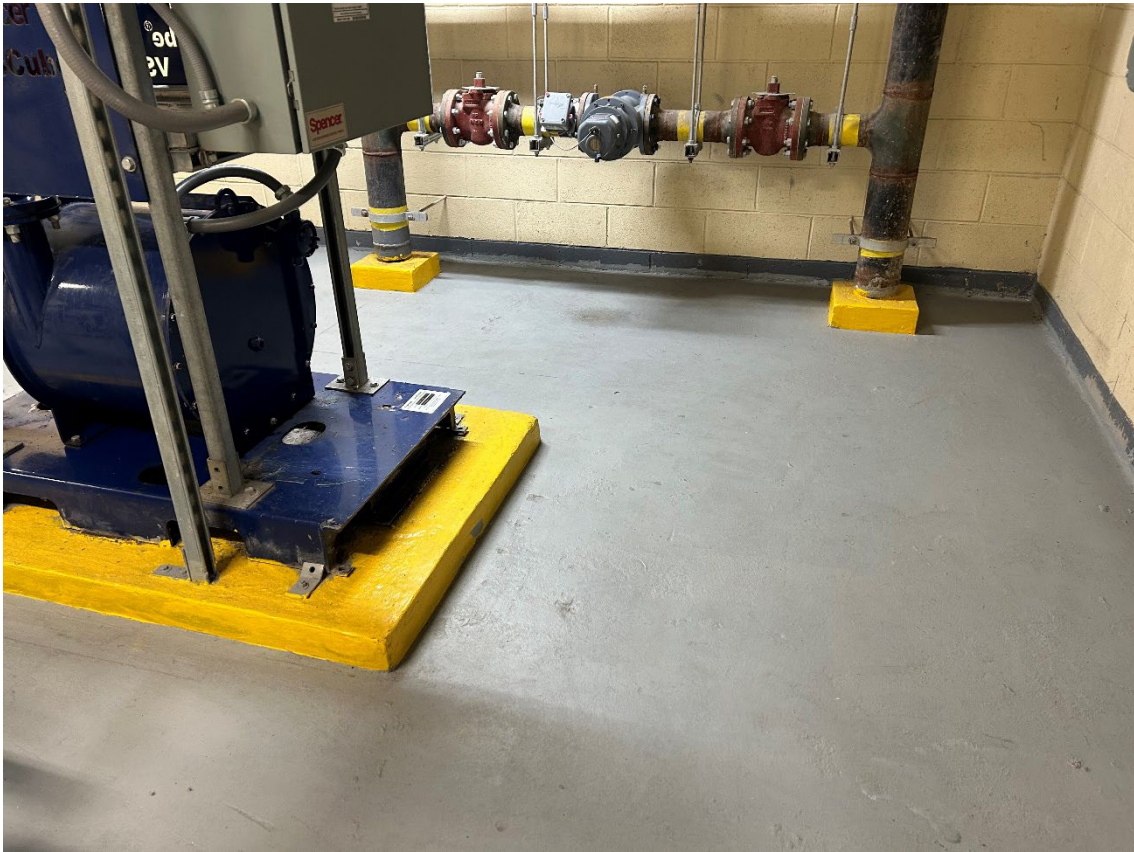
Photograph 3: View of the basement slab.

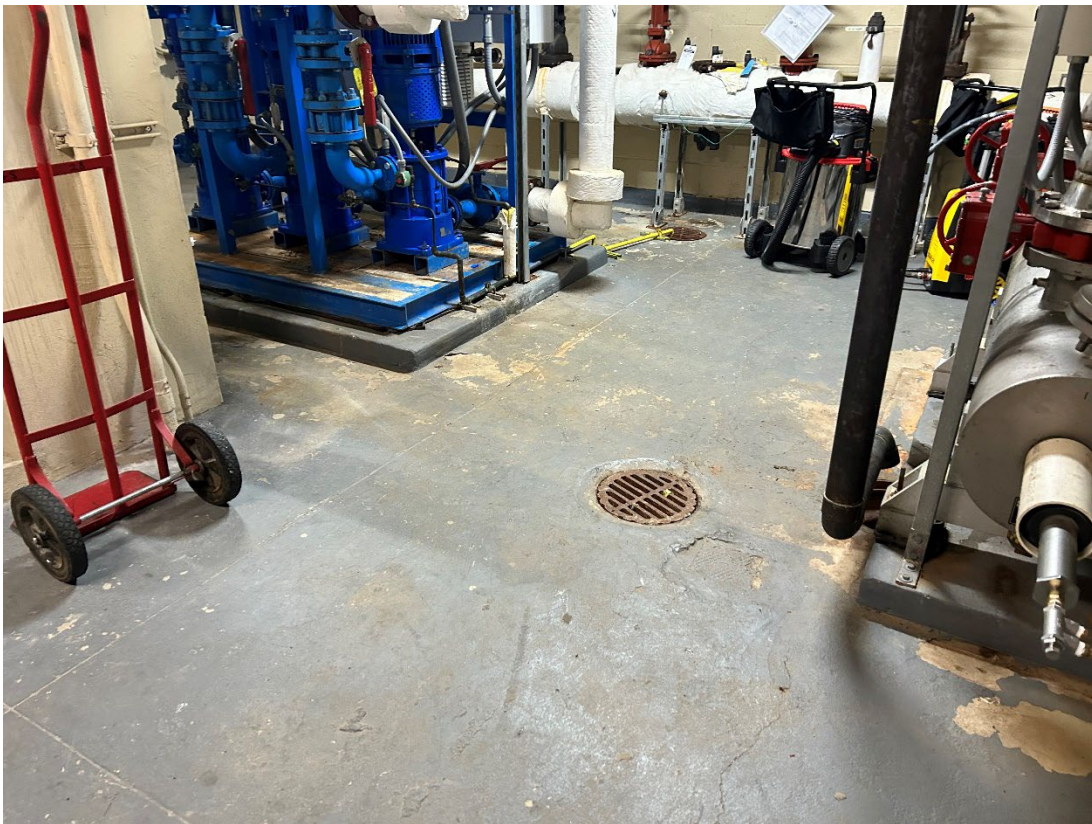
Photograph 4: View of the basement slab in a room with floor drains.

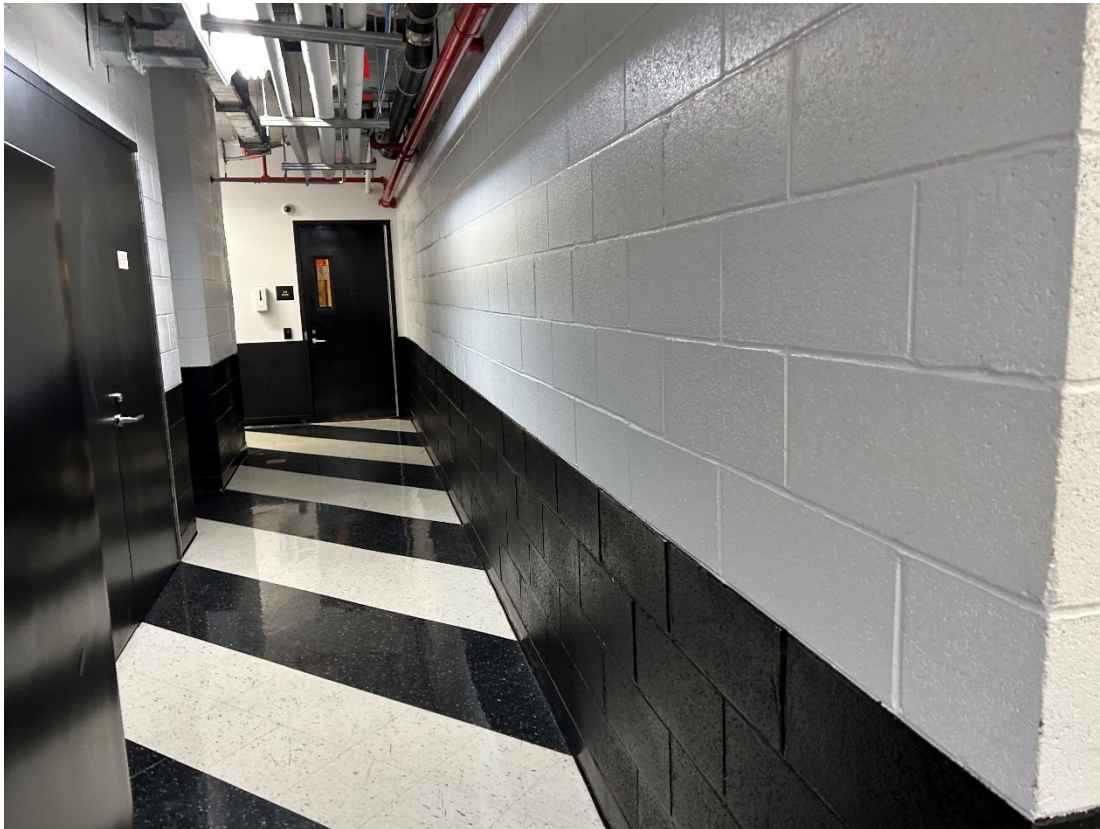
Photograph 5: View of the basement walls and flooring.

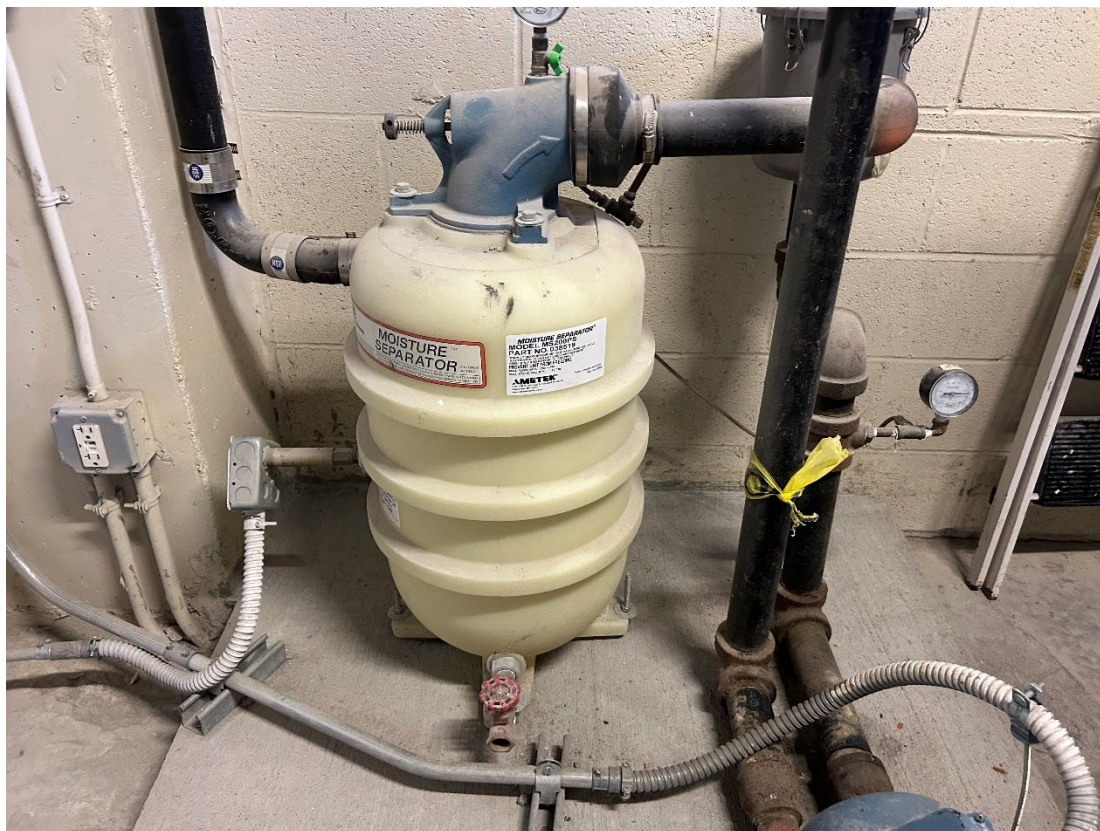
Photograph 6: View of knockout tank for the SSDS.

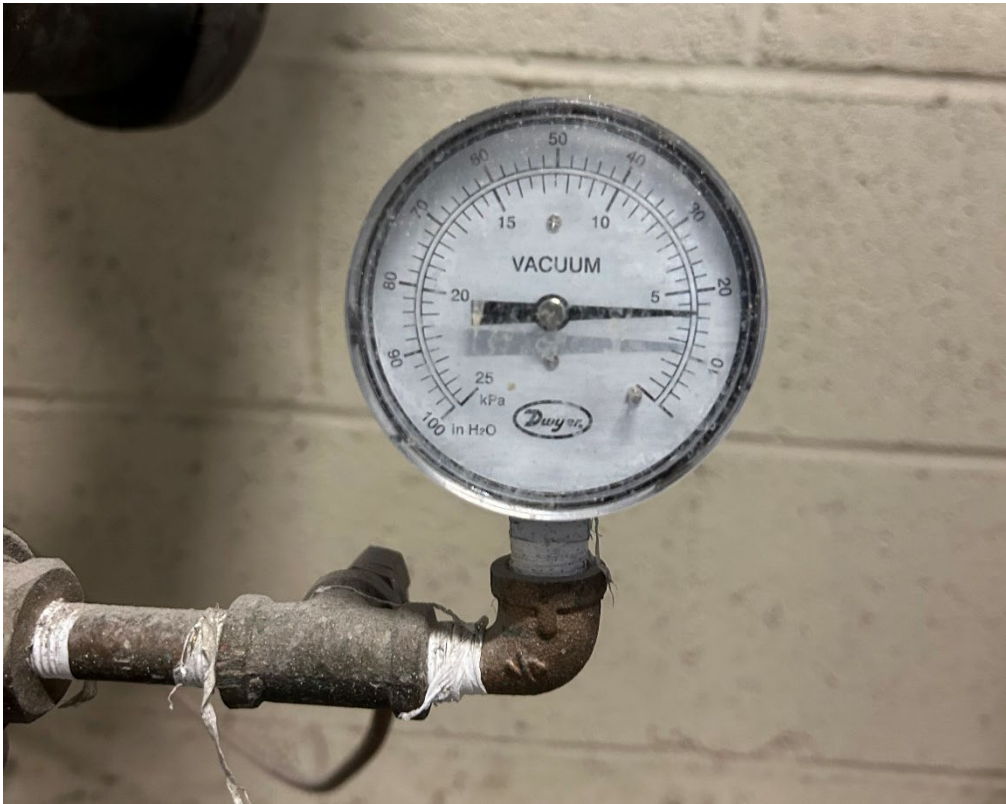
Photograph 7: View of the SSDS gauge.

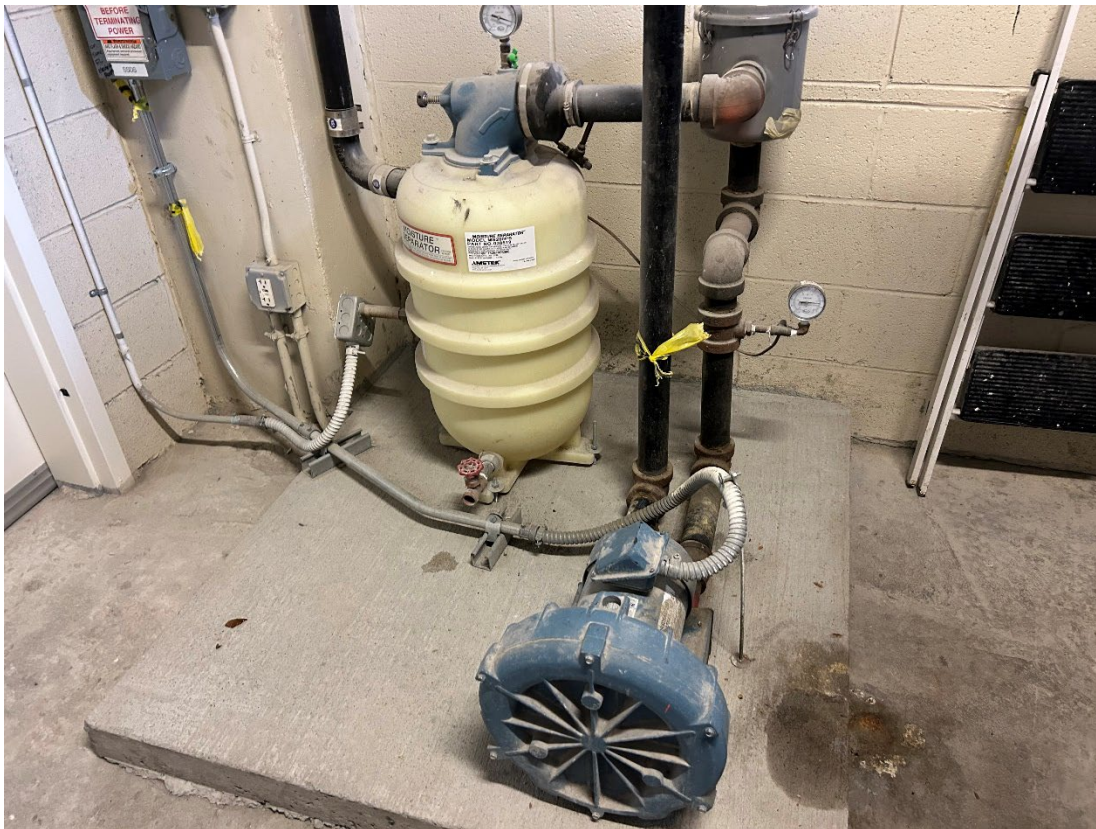
The active SSDS and piping was inspected for any physical wear and damage and other operational problems and no issues were observed. The SSDS piping was also inspected and there were no cracks or breaks in the pipe. The SSDS riser pipe's exhaust terminates at an opening to Lot 42 on the third floor. Ms. Sabatasso inspected the SSDS riser pipe's exhaust termination and found the exterior piping intact and functioning as designed. The piping extending to the blower appeared to be in good condition and no issues or concerns were observed.

Photograph 8: View of SSDS blower.

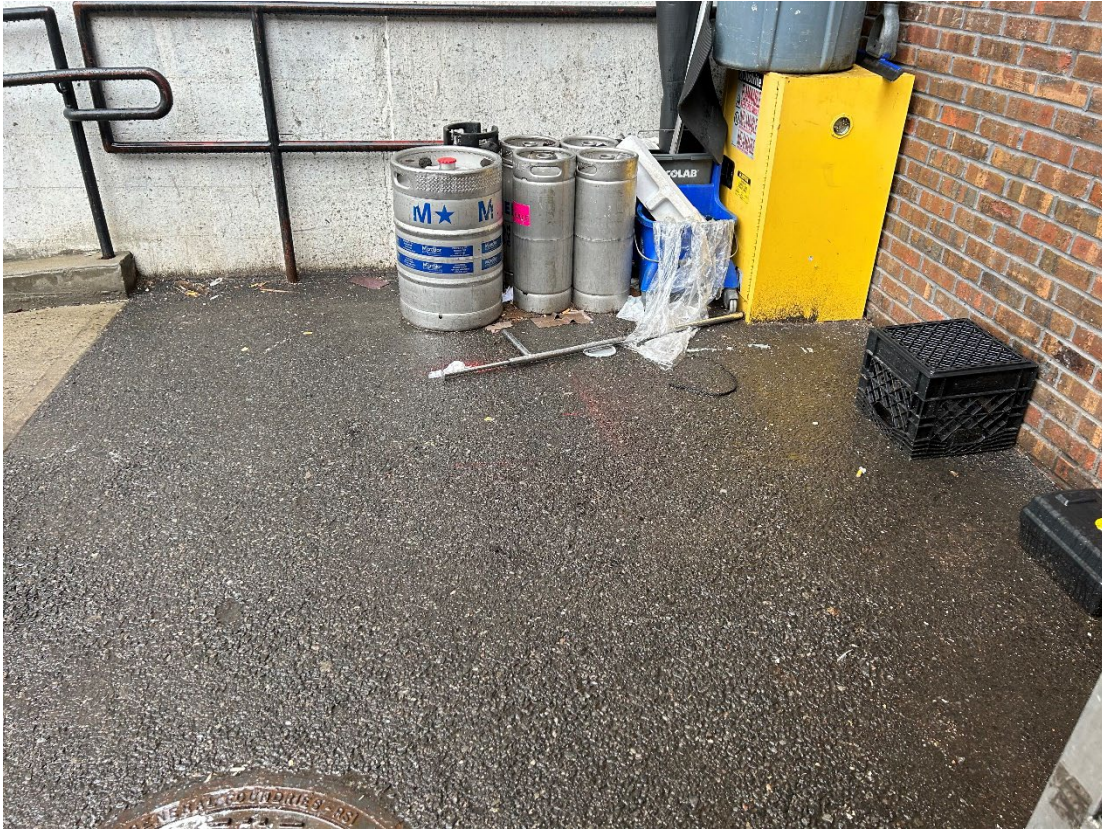
Photograph 9: View of the asphalt cover in Lot 42.

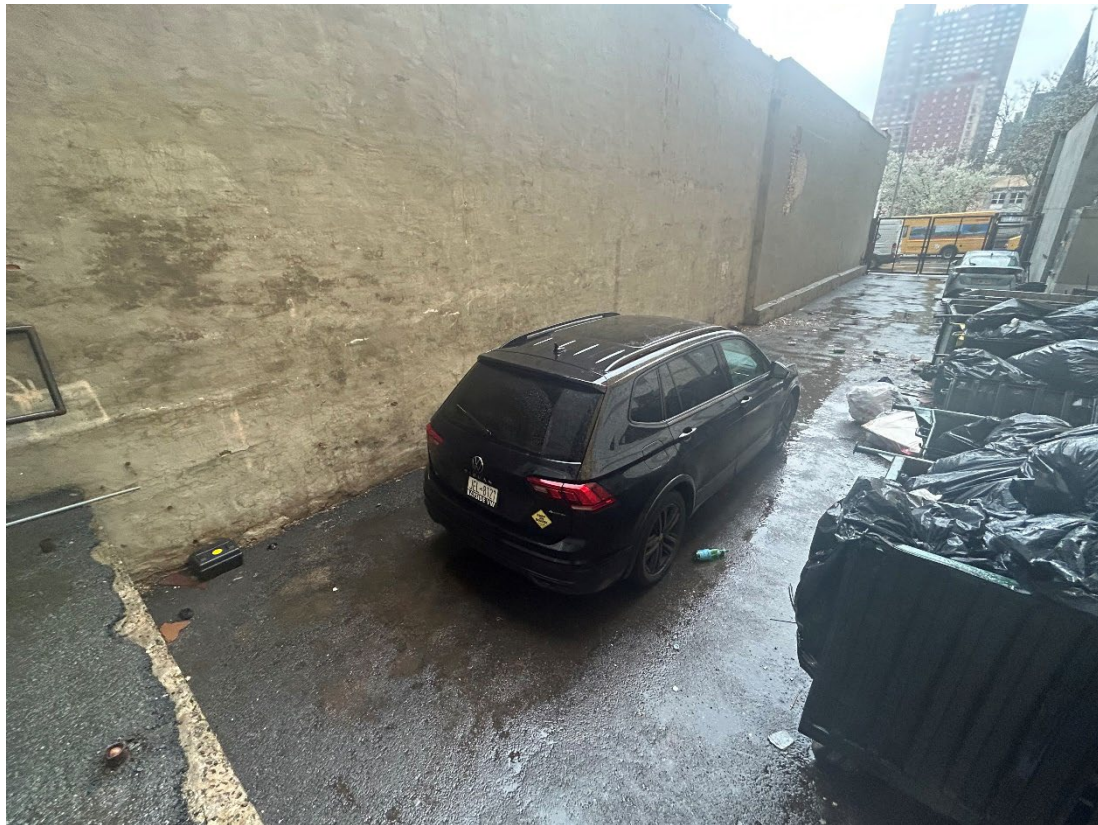
Photograph 10: View of the asphalt cover in Lot 42.

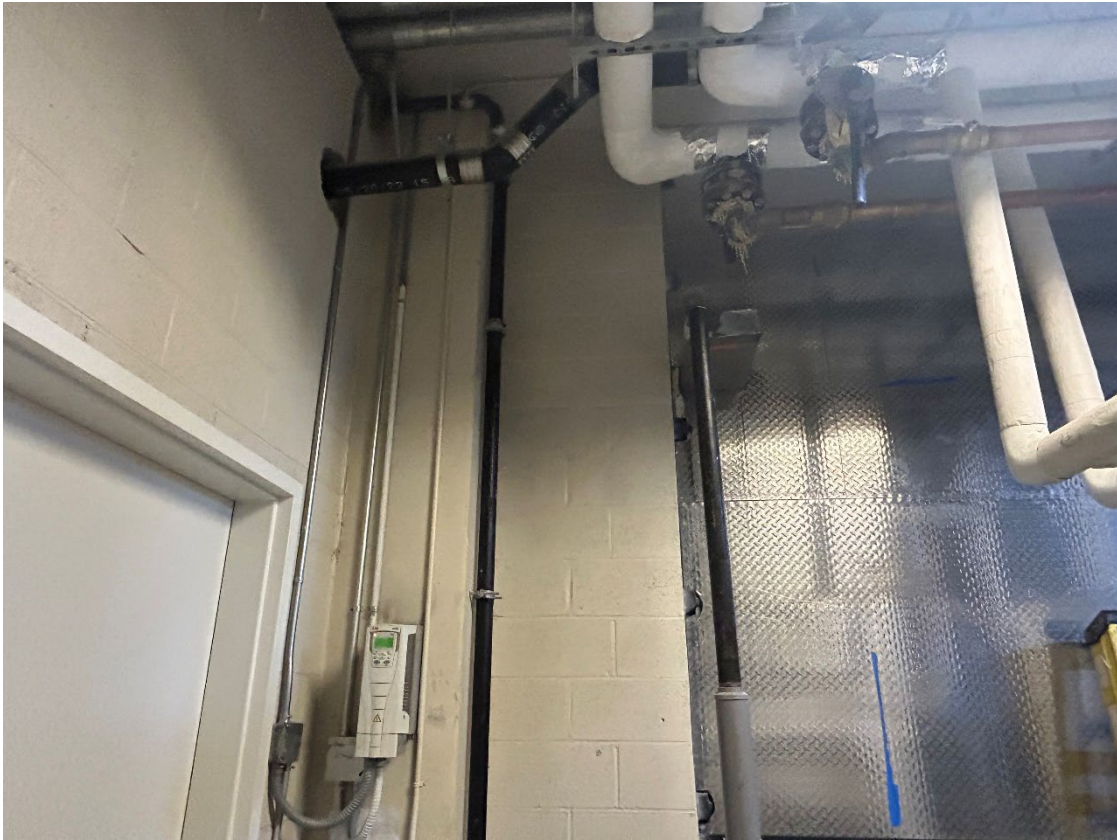
Photograph 11: View of SSDS piping from blower through the wall.

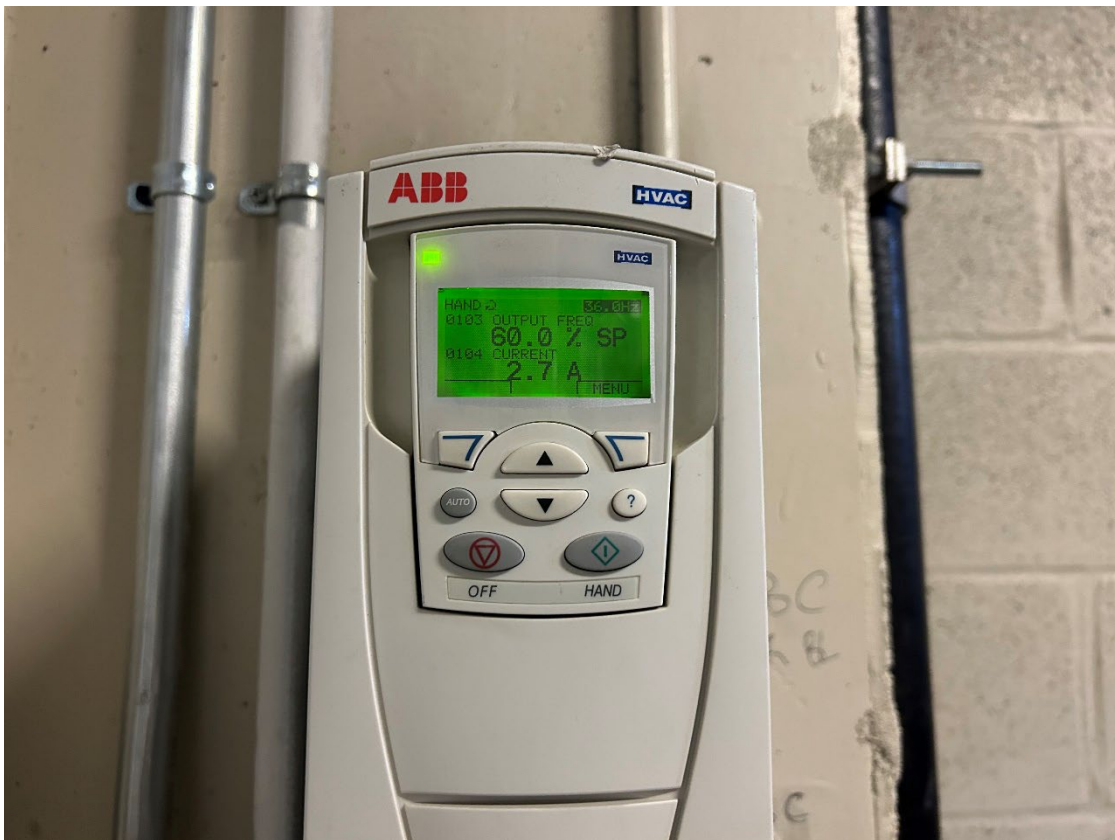
Photograph 12: View of the VFD for the system.

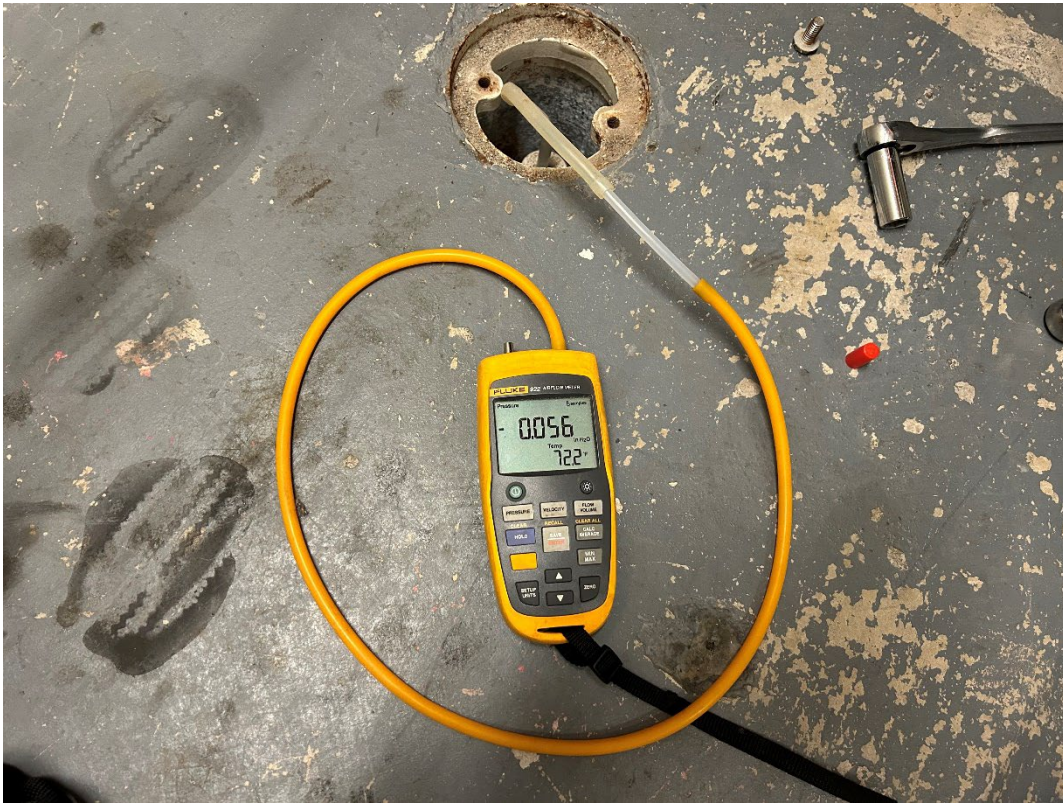
The SSDS has two monitoring points: SV-1 and SV-2. Vacuum readings were collected using a micromanometer. SV-1 and SV-2 had vacuum readings of -0.056 and 0.156, respectively. The positive reading in SV-2 does not appear to be representative of the system function, since the blower is operating the same as the startup and given the negative reading at SV-1. However, a Roux staff went back to the Site on June 24, 2024 to investigate a possible clogging of SV-2. The Roux staff installed a PVC cap to attempt to seal the SV-2 point but was not able to produce a vacuum. We concluded that this point has some type of obstruction given its location (kitchen) and the presence of dirt and grease surrounding the point. Another attempt to install a vapor pin on the southeast corner of the property was unsuccessful due to potential reinforced rebar at that location. On July 12, 2024, the Roux staff went back to the Site a third time to attempt to install a new vapor pin in the kitchen area, near SV-2, however it was again unsuccessful likely due to heavily reinforced concrete. Based on that information, and the fact that SV-1, which is located the furthest from the blower, is measuring strong vacuum, we concluded that the system is operating properly with vacuum influence across the floor slab and SV-1 is sufficient to monitor the system.

Photograph 13: View of the micromanometer measurement at the SSDS monitoring point SV-1.

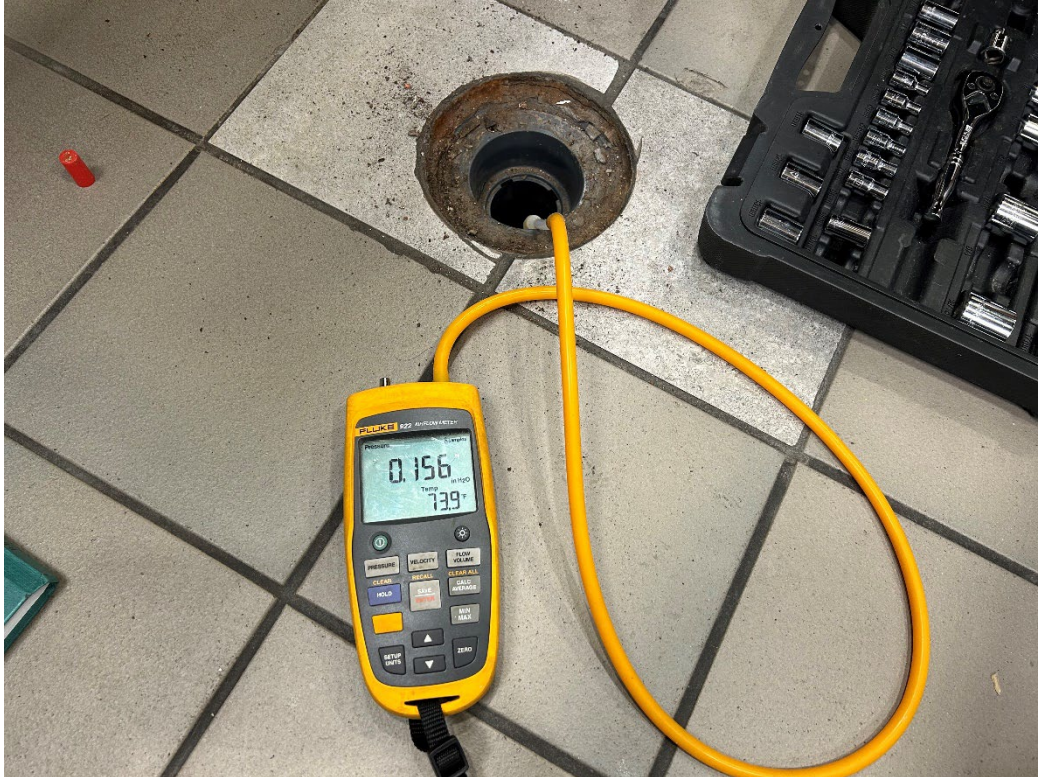
Photograph 14: View of the micromanometer measurement at the SSDS monitoring point SV-2.
