**Project Name:** 29-10 Broadway, Queens, NY  
**Project Number:** 15CVCP094Q, 15EHAZ310Q  
**Site Management Reporting Period:** 2019-2020  
**Inspection Date:** July 22, 2020  
**Inspector and Certifier:** Thomas Gallo  
**Report Submittal Date:** July 28, 2020  
**Report Preparer:** Environmental Business Consultants on behalf of H&L Broadway Holdings LLC and Jetsam Realty LLC

## **Site Inspection and Certification Letter Report**

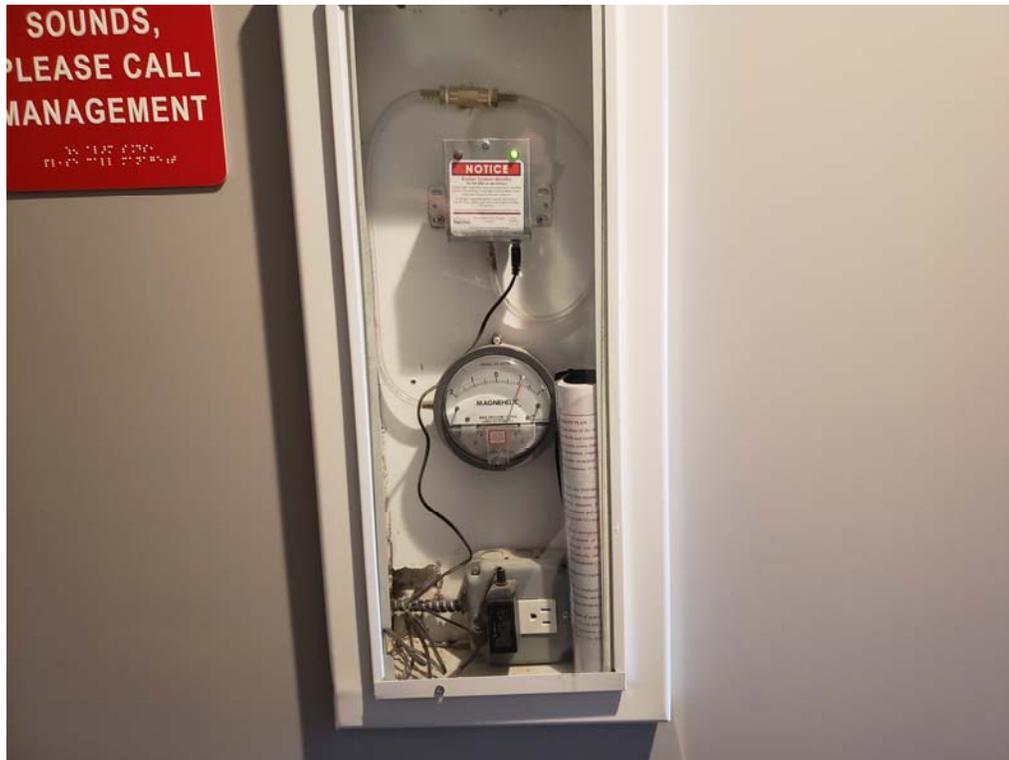
The blower for the active SSD system was inspected on July 22, 2020 and found to be operating. The vacuum gauge installed within the protective cabinet located against the interior wall of the 4<sup>th</sup> floor hallway recorded a vacuum reading of approximately 1.1" of water. The alarm was not sounding and the alarm light was green. A photo of the vacuum gauge and alarm is attached.

Photo 1: View of alarm and gauge in 4<sup>th</sup> floor hallway at 29-10 Broadway, Queens, NY.

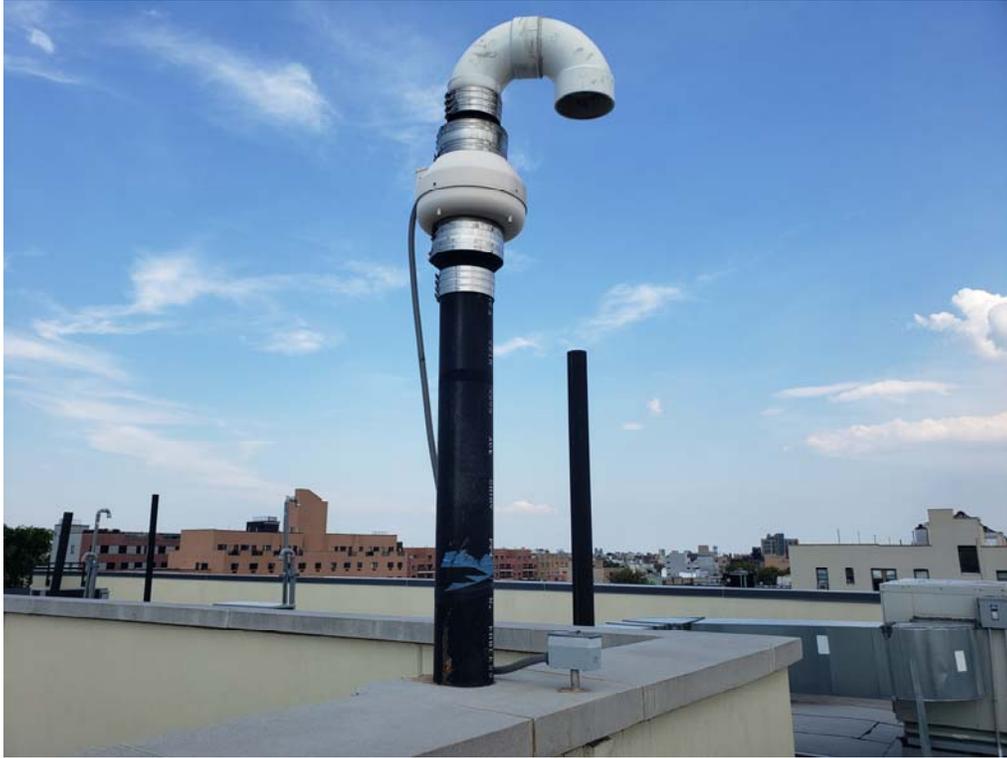
Photo 2: Exhaust location.
