Project Name: 856 East 213th Street, Bronx, NY

Project Number: 12EHA311X

Inspection Date: October 16, 2019

Site Inspection and Certification Letter Report

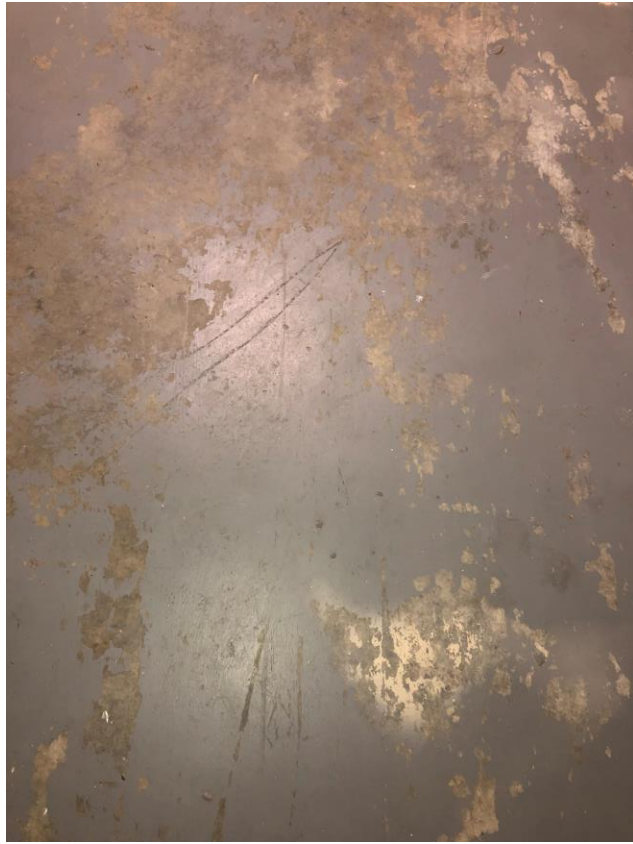
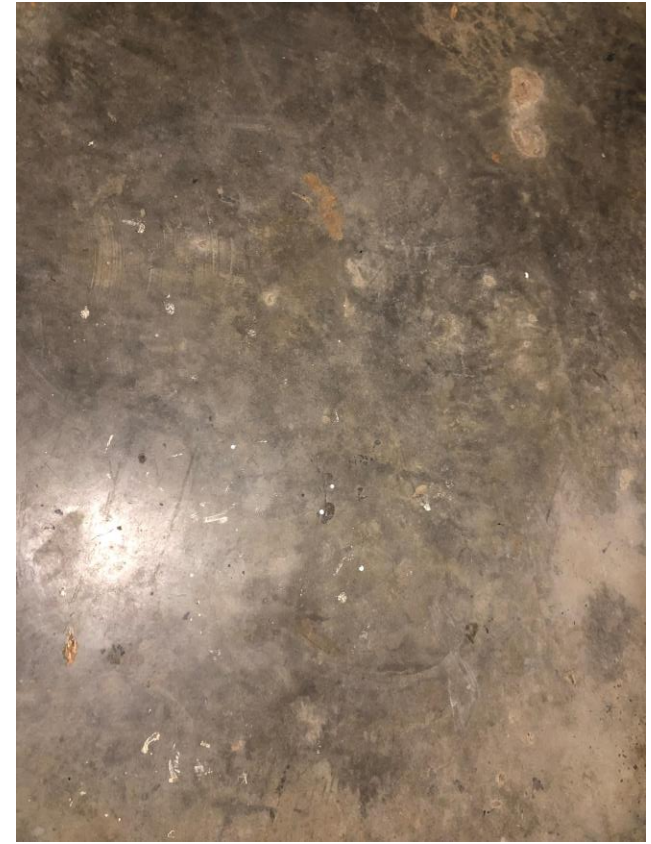
Composite Cover

All accessible portions of the composite cover system were visually inspected during the site inspection. The composite cover system appears to be in sound condition. No cracks were observed in the concrete slab.

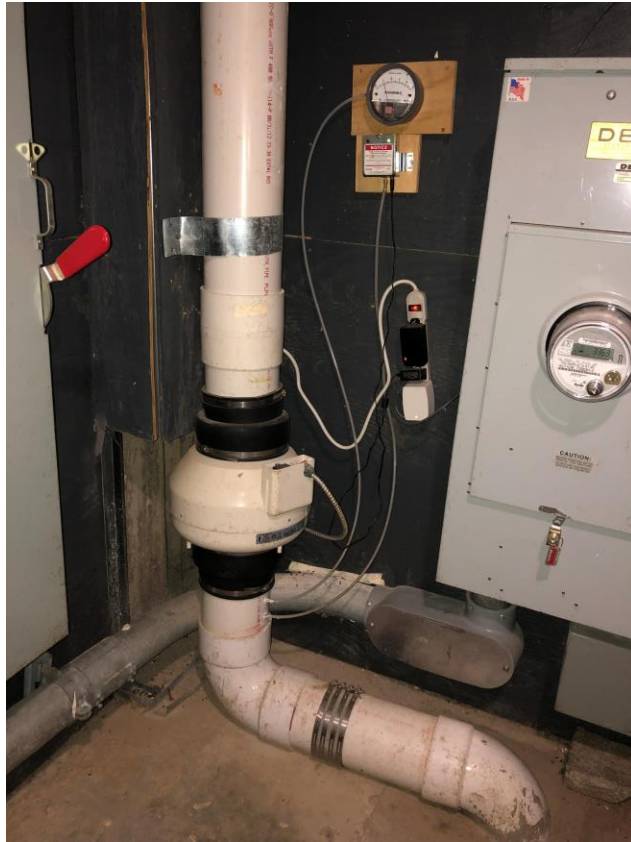
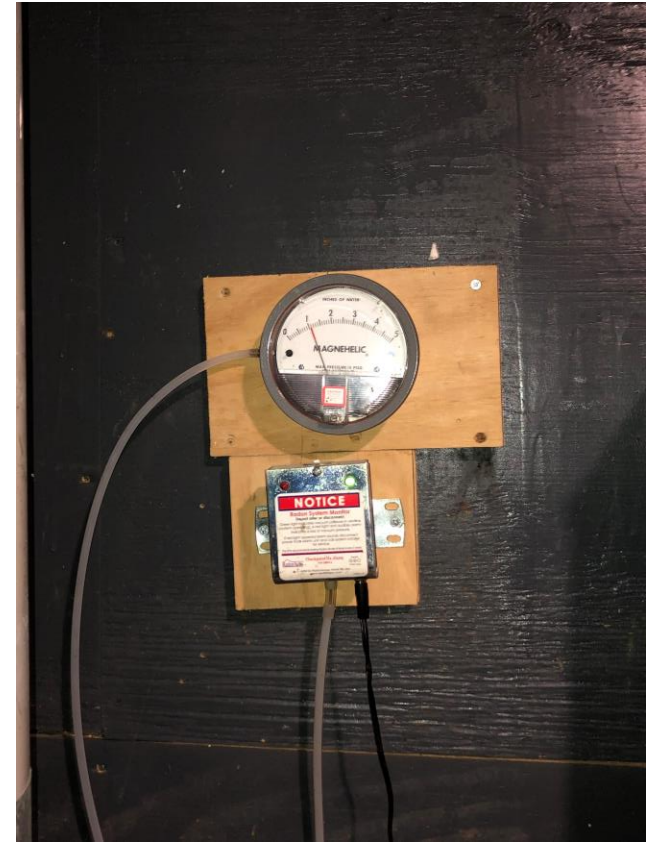
Active SSDS System

Visual inspection of the active SSDS indicates the blower on the roof level is working properly. The alarm was noted to be plugged in and operational upon arrival appeared to be in working condition. The magnehelic gauge was reading pressure of 1-inch H₂O. The results of the initial inspection were communicated to the client and their building management team.
