PHASE I ENVIRONMENTAL SITE ASSESSMENT REPORT

FAIRHAVEN FUNERAL CHAPEL, INC.
1041-1047 Fulton Street
Brooklyn, New York 11238

February 5, 2010
Partner Project No. 09-65096.1

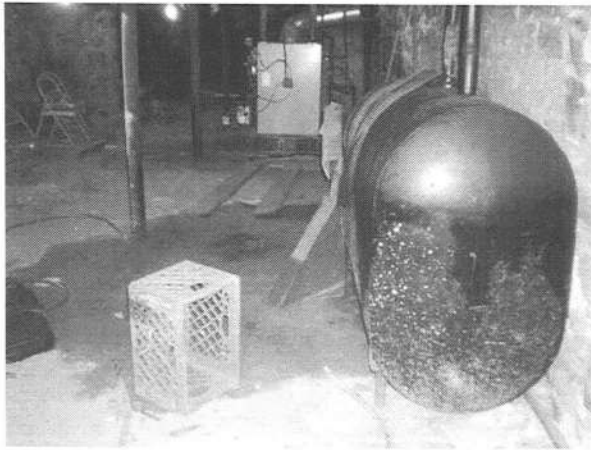
The two subject property basement areas are each equipped with one steel-walled, 275-gallon #2 fuel oil aboveground storage tank (AST). Staining and odor that is indicative of heating oil was noted on the dirt flooring of the basement beneath the western basement area's AST. According to the subject property owner, Mr. Al Sheppard, there was a recent overflow problem that caused a small amount of heating oil (reportedly less than five gallons) to spill onto the basement floor. The subject property was not listed in the regulatory database in association with any on-site oil spills. Although the heating oil release in the basement of the subject property appears to be surficial in nature, the dirt floor beneath the AST serves as a direct conduit to the subsurface and the spill caused by overflow represents an environmental concern.

13. View of fuel oil AST and boiler in the western basement area (note dark staining).

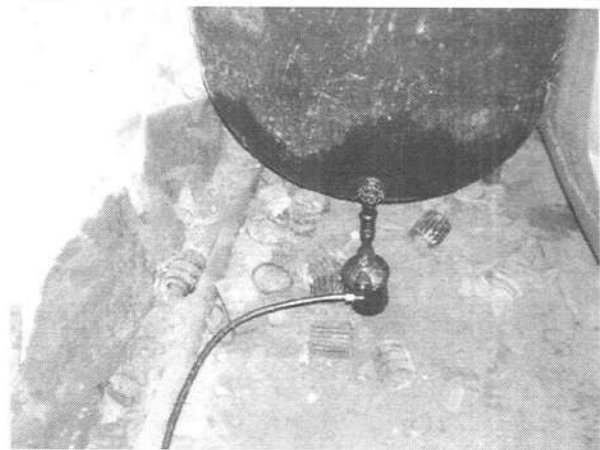
14. View of the dirt floor beneath the AST.

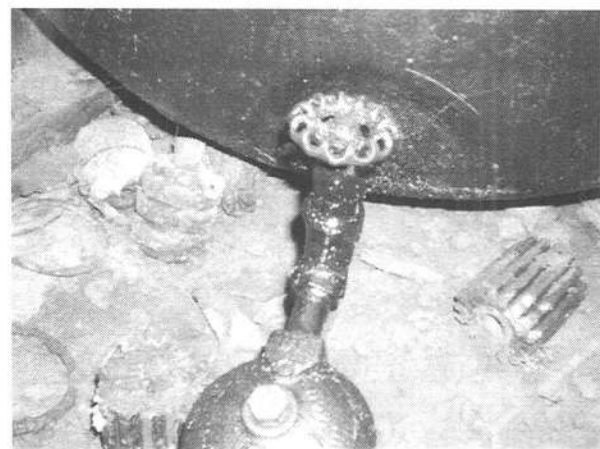
16. Close-up view of product line coming out of the AST base (note oily residue).

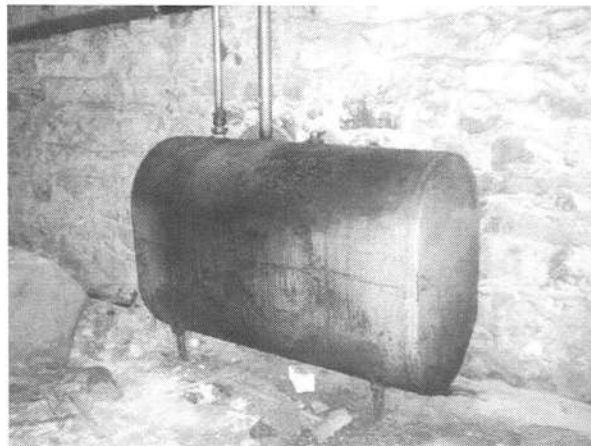
17. View of AST in the eastern basement (no staining noted).

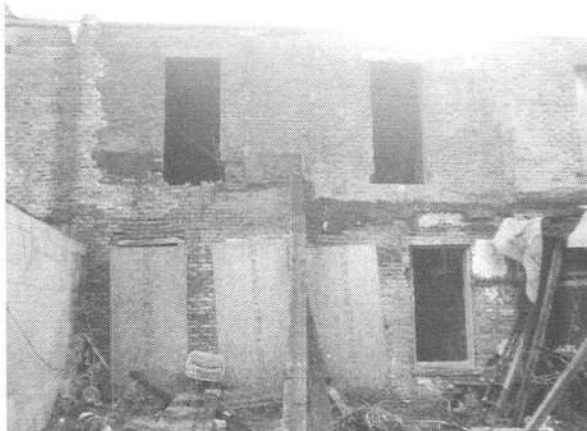
23. View of the fire-damaged portion of the subject property building and vacant building to the west (facing south).
