Project Name: 411 Wales & 408 Concord Avenue, Bronx, NY 10454

Project Number: E-475

Inspection Date: 8/7/2020

Site Inspection and Certification Letter Report

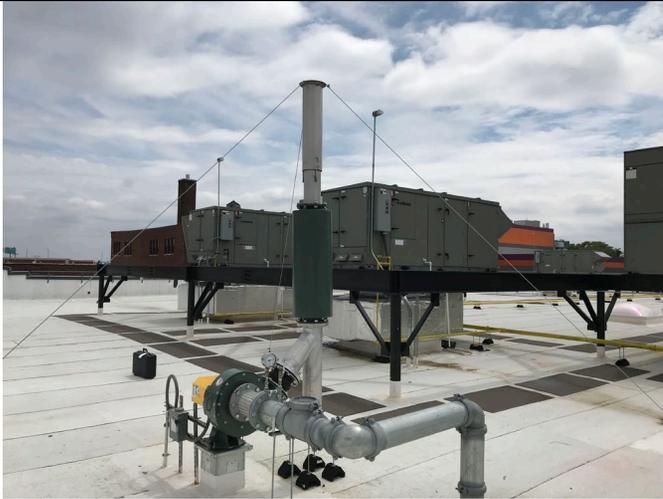
Photo 1: Inspection of SSDS fan, SF-1, and associated rooftop SSDS accessories.

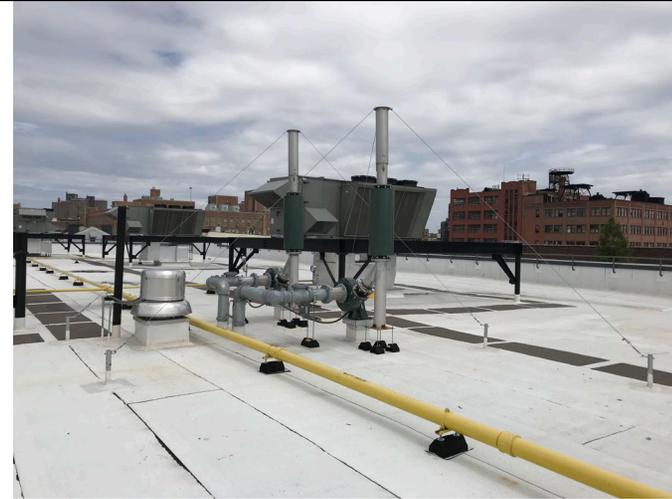
Photo 2: Inspection of SSDS fans, SF-2 and SF-3, and associated rooftop SSDS accessories.

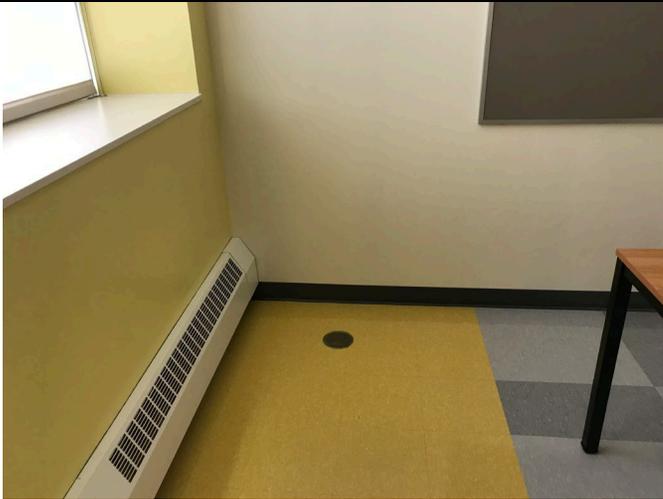
Photo 3: Inspection of SSDS monitoring point, MP-5.

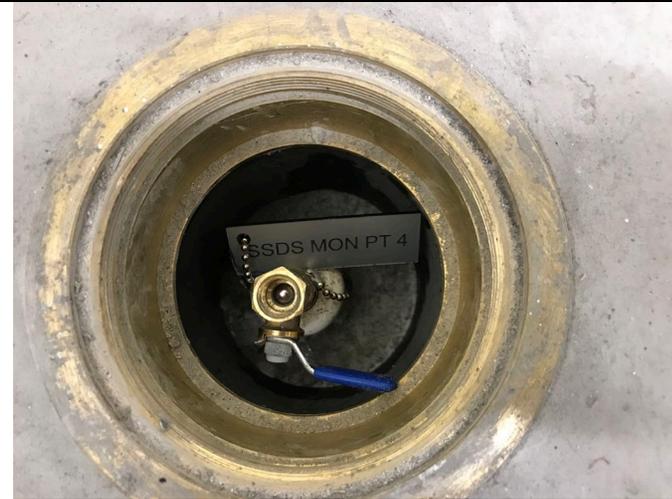
Photo 4: Inspection of interior of SSDS monitoring point, MP-4.

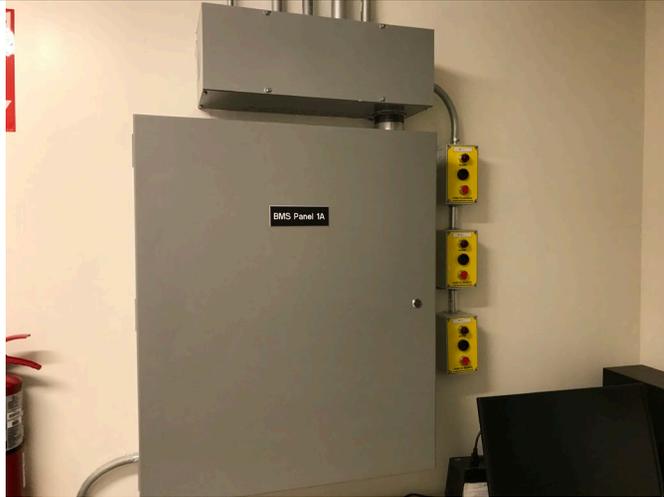
Photo 5: Inspection of alarm indication stations for SSDS.

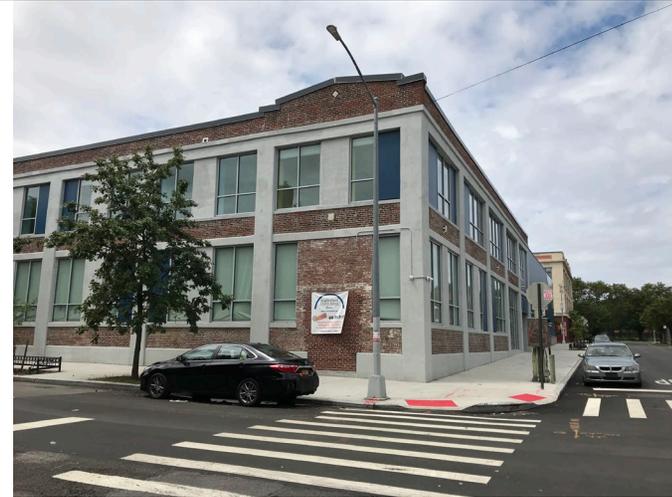
Photo 6: Inspection of composite cover system for Site.

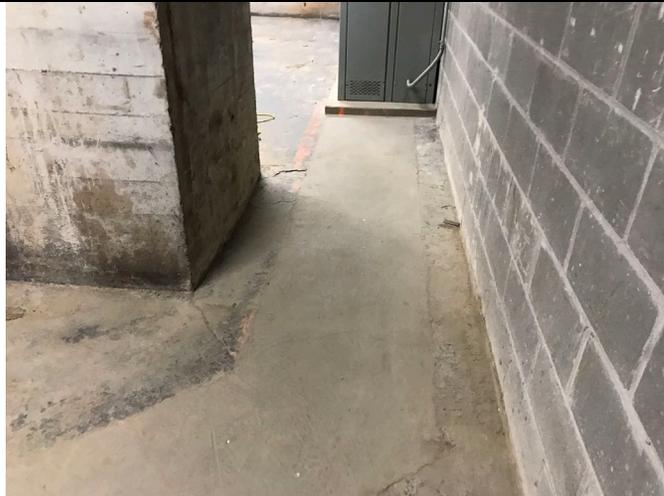
Photo 7: Cellar of building inspected for cracks and holes. No deficiencies noted.

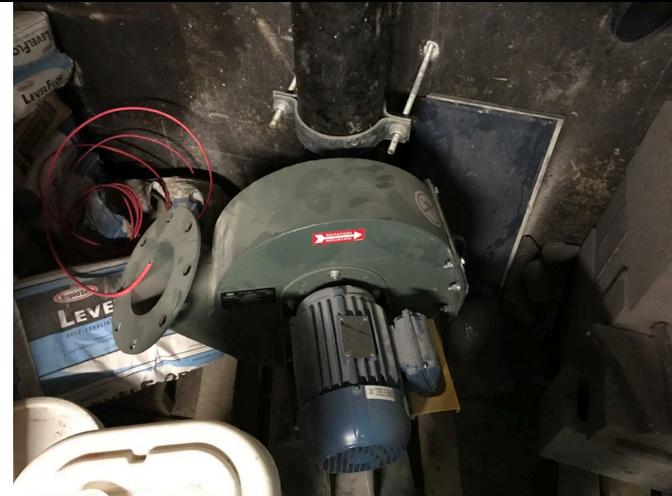
Photo 8: Spare SSDS fan stored in cellar of school building.
