**Project Name:** 853 Lexington Avenue, Brooklyn, NY

**Project Number:** 13EHAN562K

**Inspection Date:** June 14, 2023 & September 28, 2023

### **Site Inspection and Certification Letter Report**

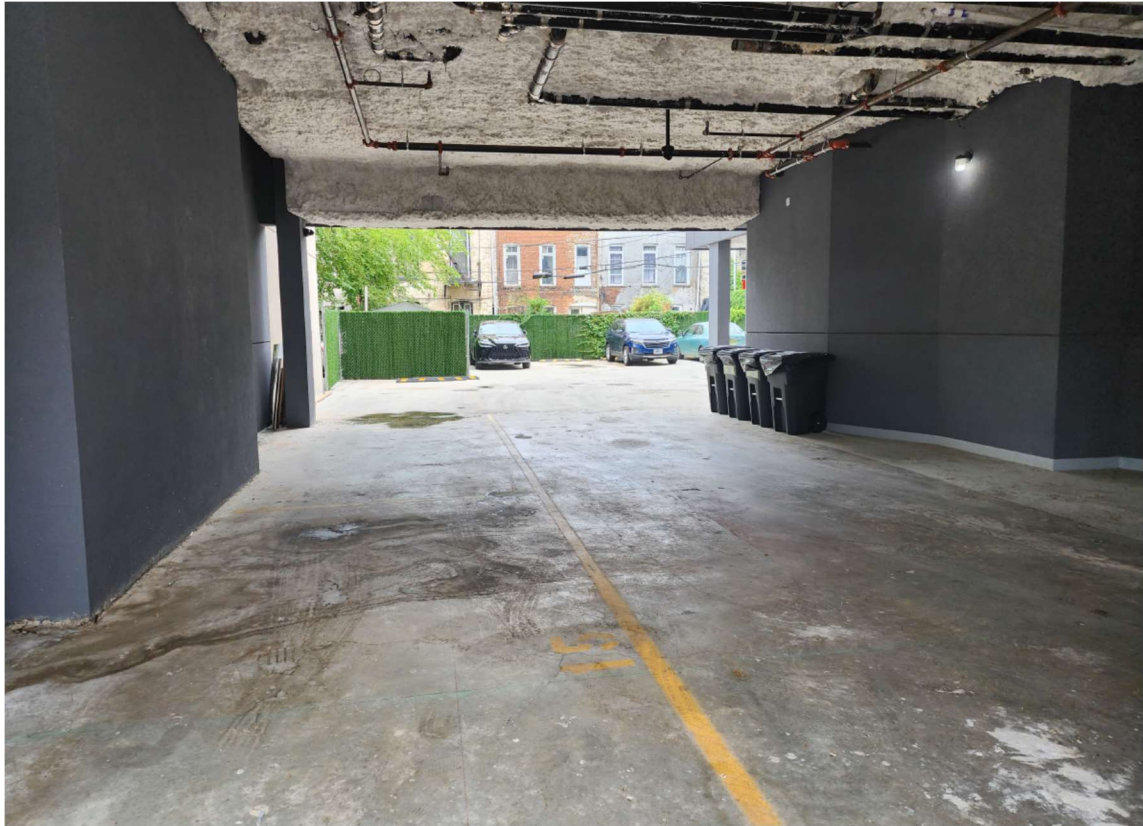
*Parking Area:* The at-grade parking area consists of exposed concrete. No significant cracks that required patching/filling were observed. No evidence of recent repairs/replacement was observed.

Photo 1 – View of parking lot composite cover

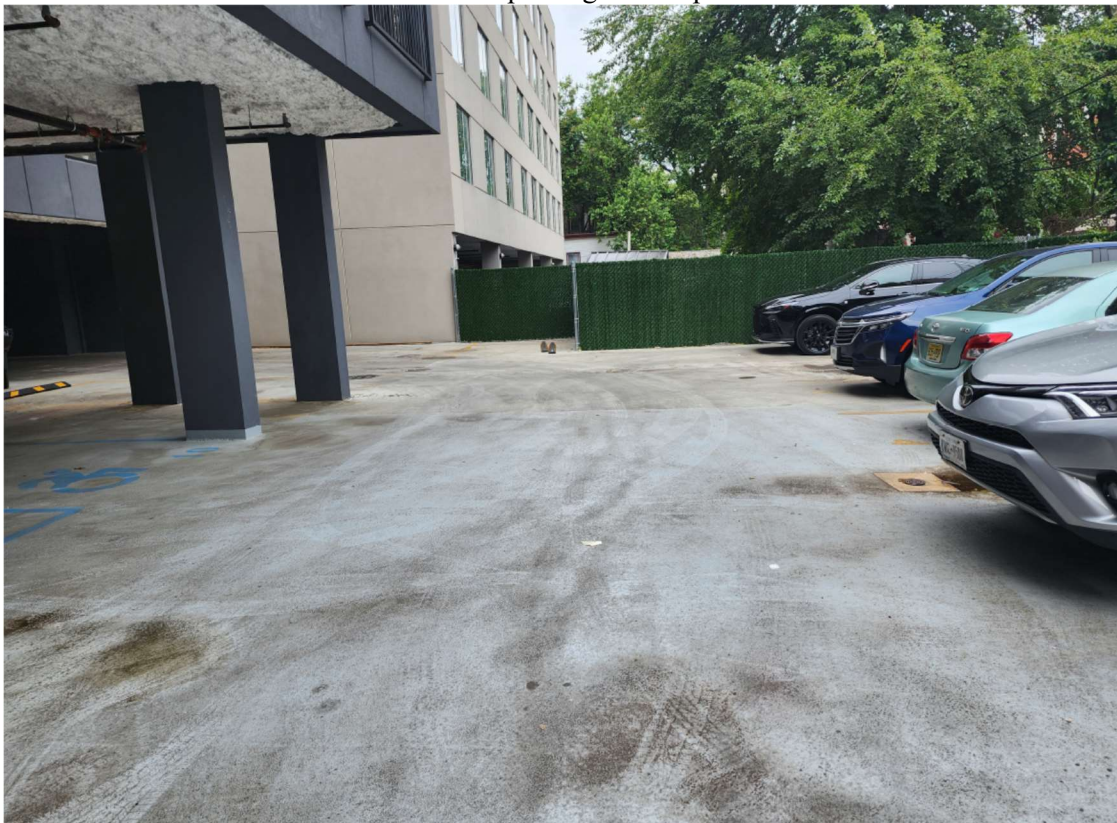
Photo 2 – Additional view of parking lot composite cover.

Exterior slab in  
good condition. No  
cracks or penetrations

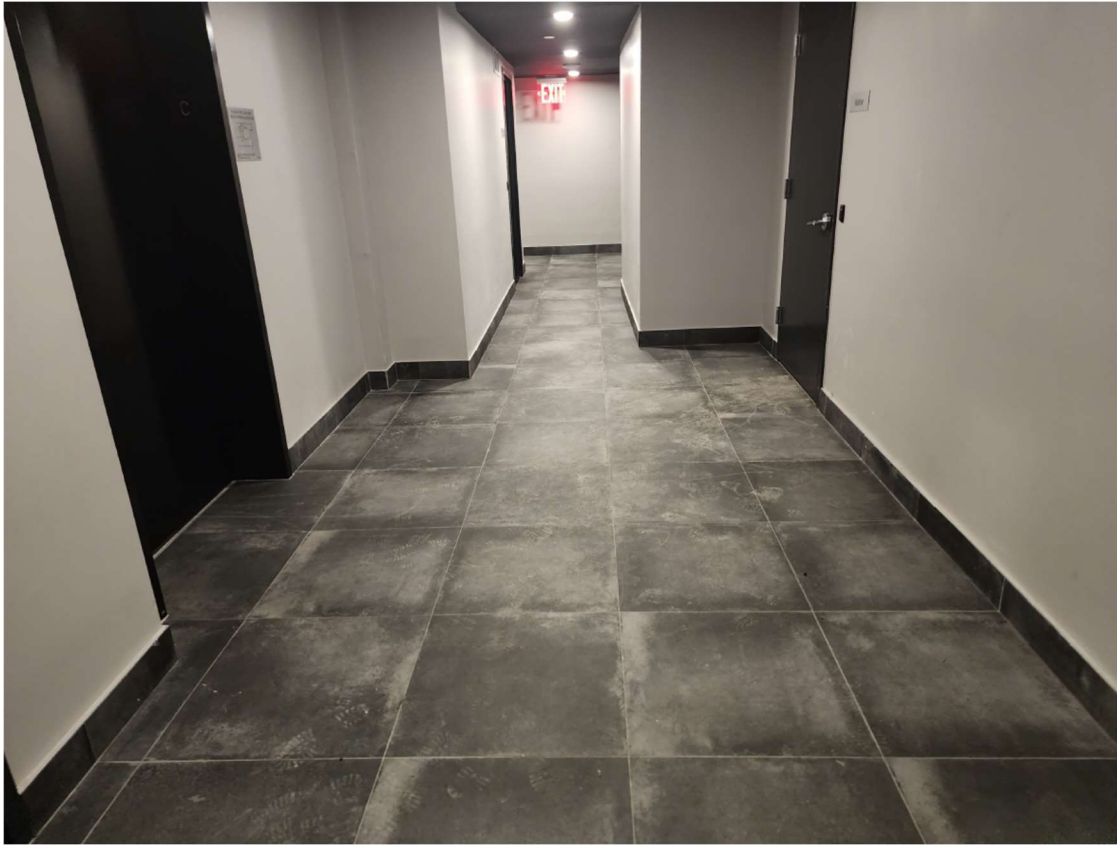
*Cellar Slab:* The partial cellar consists of exposed concrete slab in some accessory rooms and ceramic tiles within the hallway and other recreational spaces. Other than the void in the cellar slab for the ejector pit, no other significant cracks that required patching/filling were observed. The repair of the vapor barrier in the location of the ejector pit is further explained in the following section.

Photo 3 – View of tile covering the cellar slab.

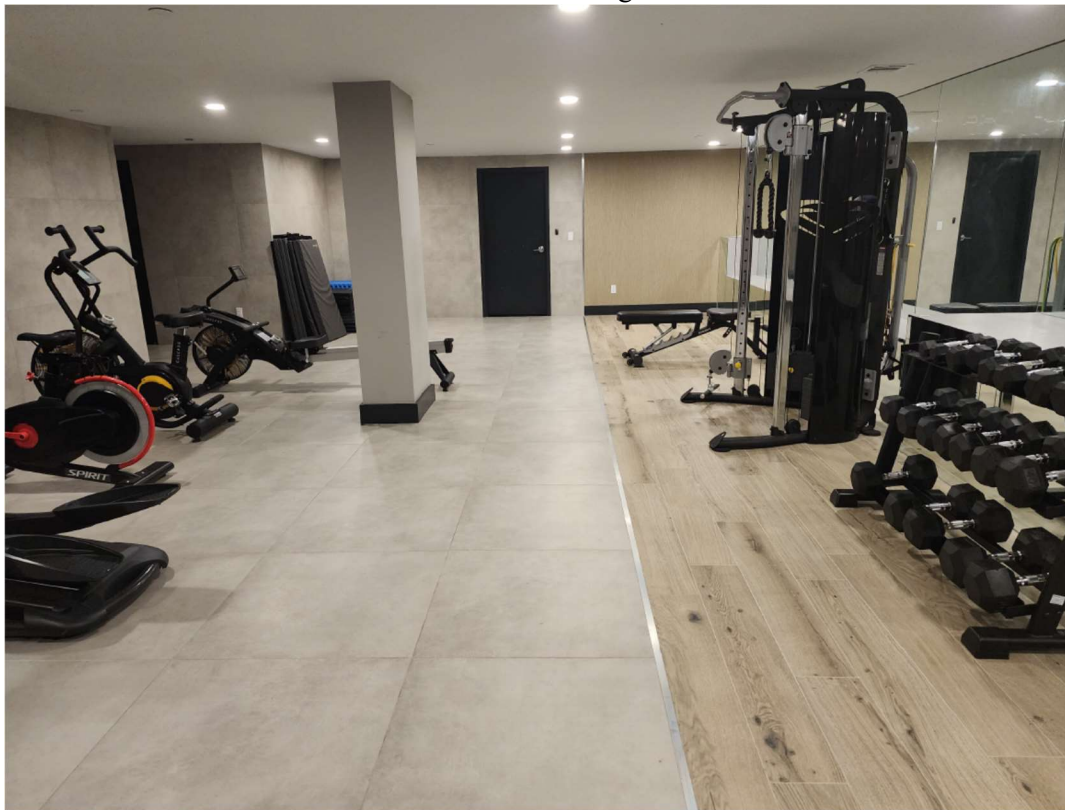
Photo 4 – View of floor covering in accessory spaces in the cellar area.

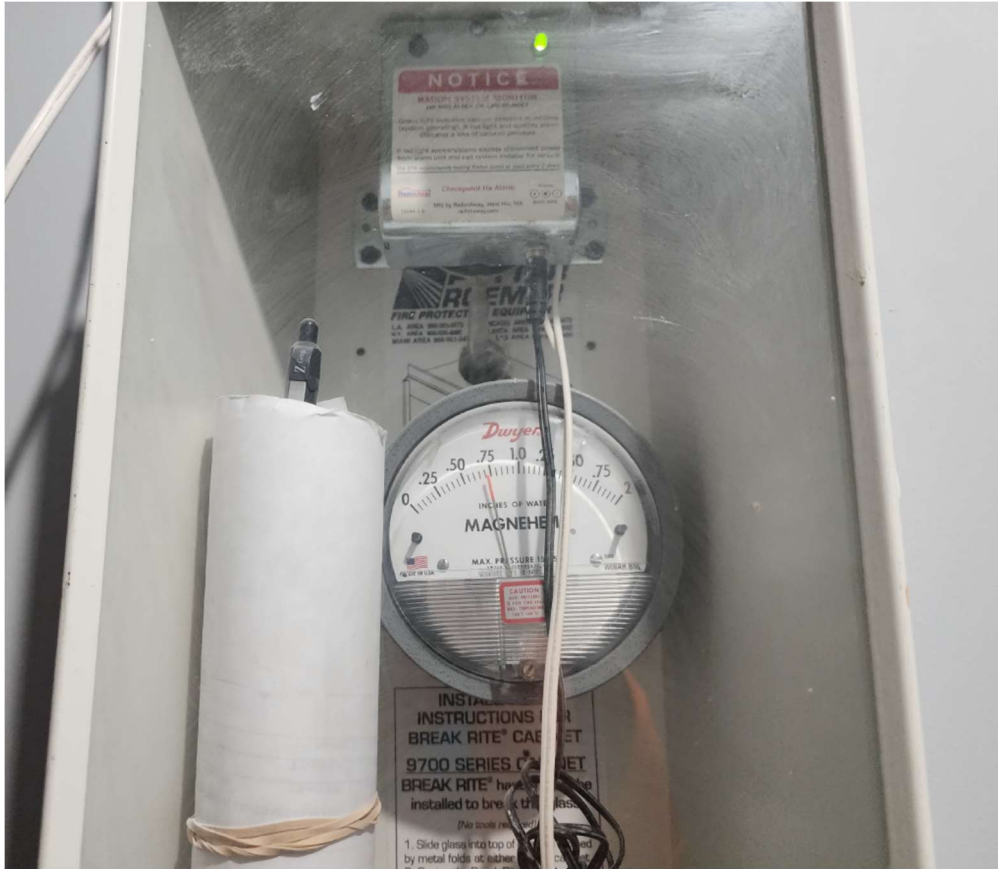
The blower for the active SSD system was inspected on June 14, 2023 and found to be operating. The vacuum gauges installed within the building recorded vacuum readings of approximately 0.70" of water. The alarm was not sounding and the alarm light was green. Photos showing the vacuum gauge and alarm are attached.

Photo 5 – View of SSDS meter and alarm.

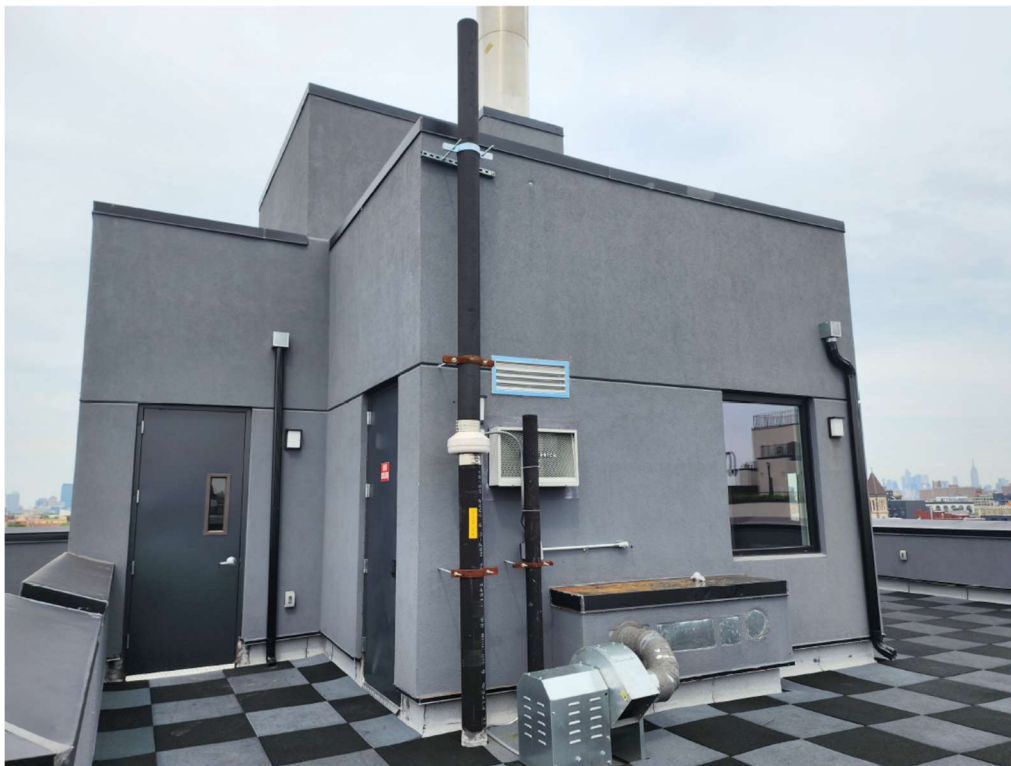
Photo 6 – View of the SSDS riser and fan on the roof.

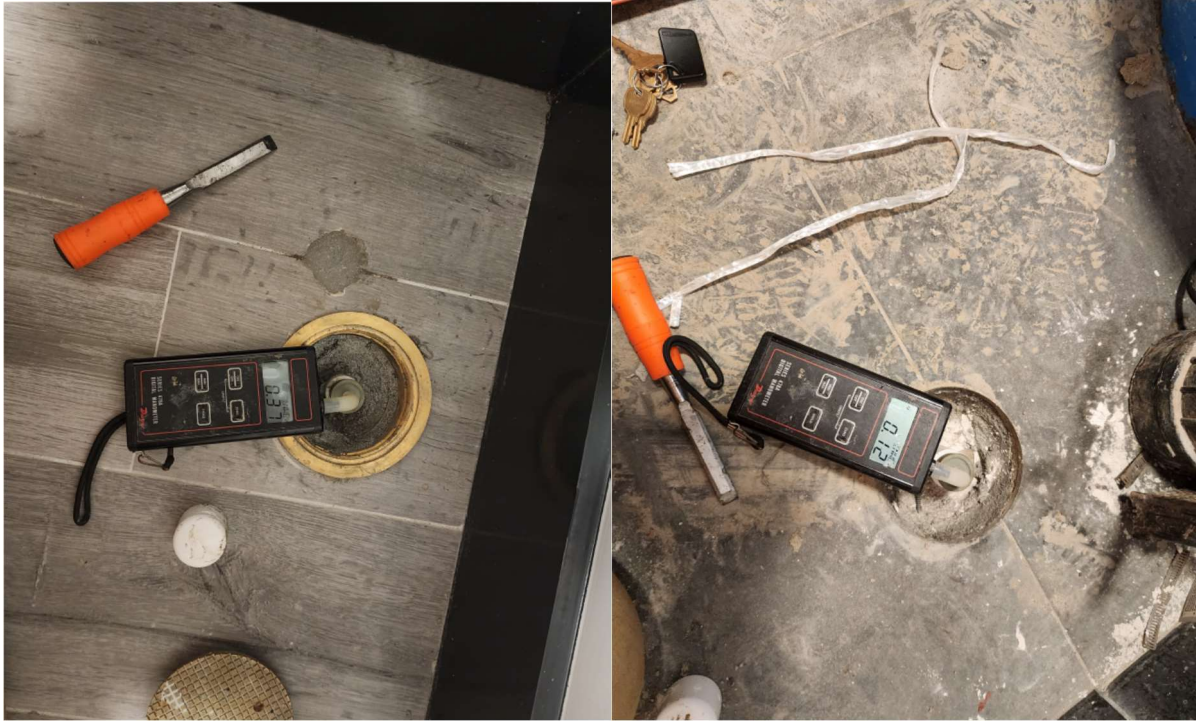
Photo 7 and 8 – View of manometer readings from the two monitoring points on Site for the SSDS.

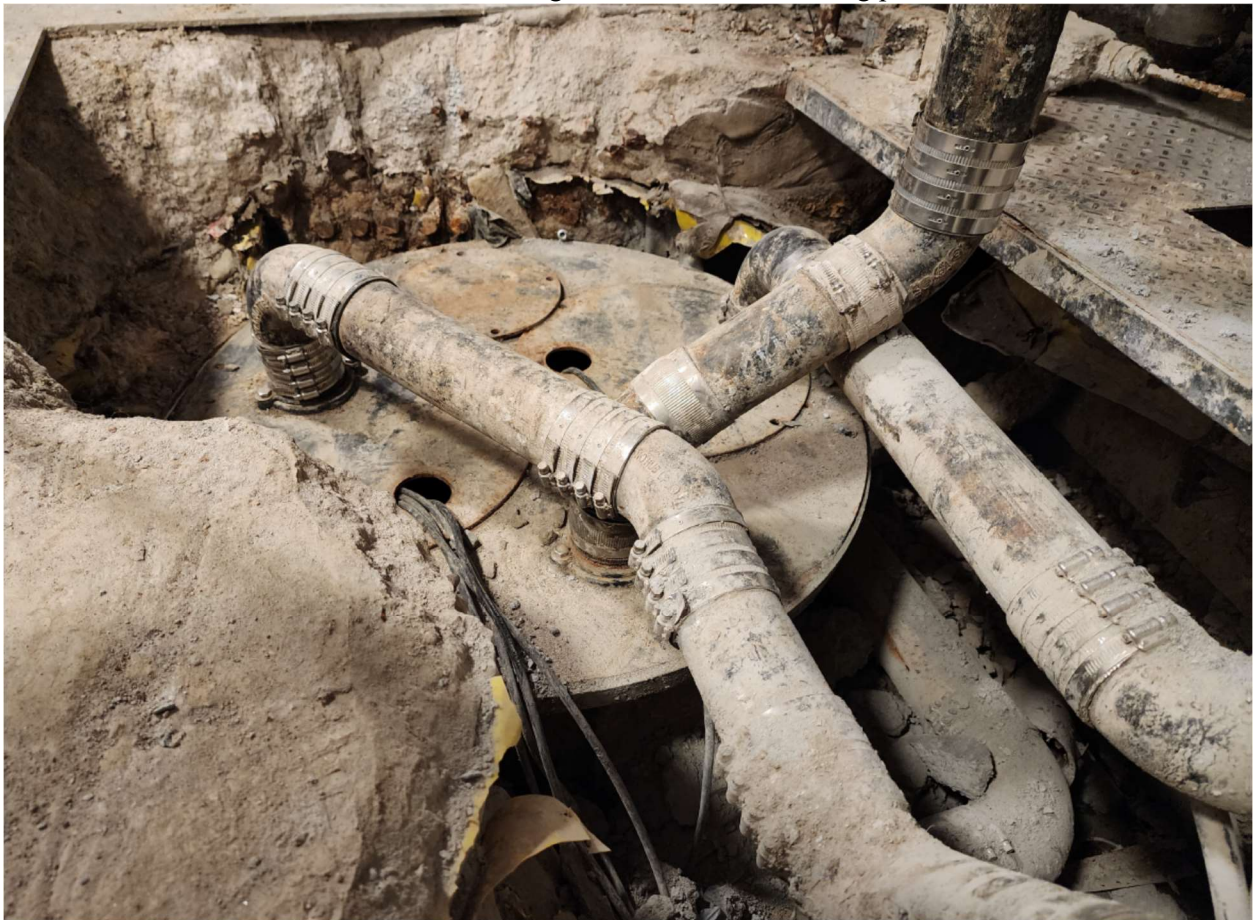
The vapor barrier installed below the building slab does not appear to have been disturbed with the exception of the installation of an ejector pit within the cellar of the building. The vapor barrier was voided during the installation and required the installation of a new vapor barrier around the ejector pit. The previous vapor barrier was cut jaggedly and was not able to be connected to the new vapor barrier. A new flex board frame was installed around the ejector pit that was then sealed with Ames Blue Max liquid rubber waterproofing material. After the rubberized waterproofing cured the Stego Wrap 20-mil Vapor Barrier was over the board and extending over the ceramic tile, which is currently still underlain with the remaining Stego Wrap 20-Mil Vapor Barrier. The vapor barrier remains exposed.

Photo 9 – View of ejector pit installation with vapor barrier voided during initial inspection in June 2023.

vapor barrier / concrete slab  
in water room needs repair  
around sump pit.

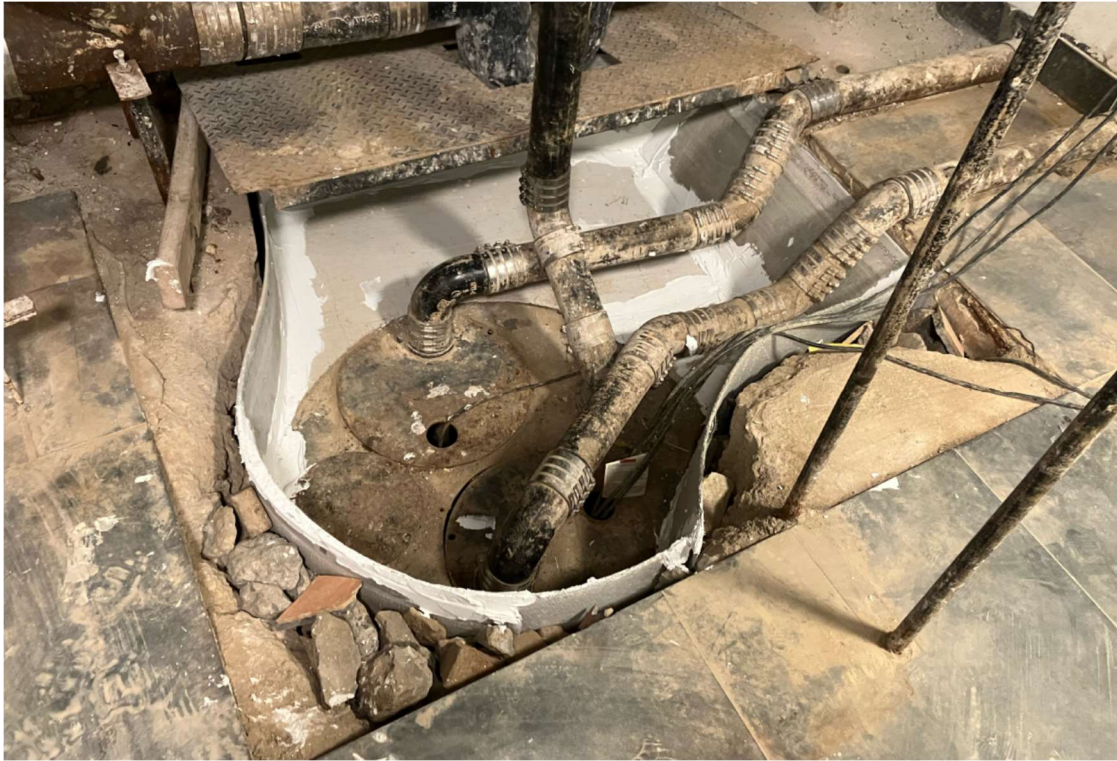
Photo 10 – View of form board installed around the ejector pit area.

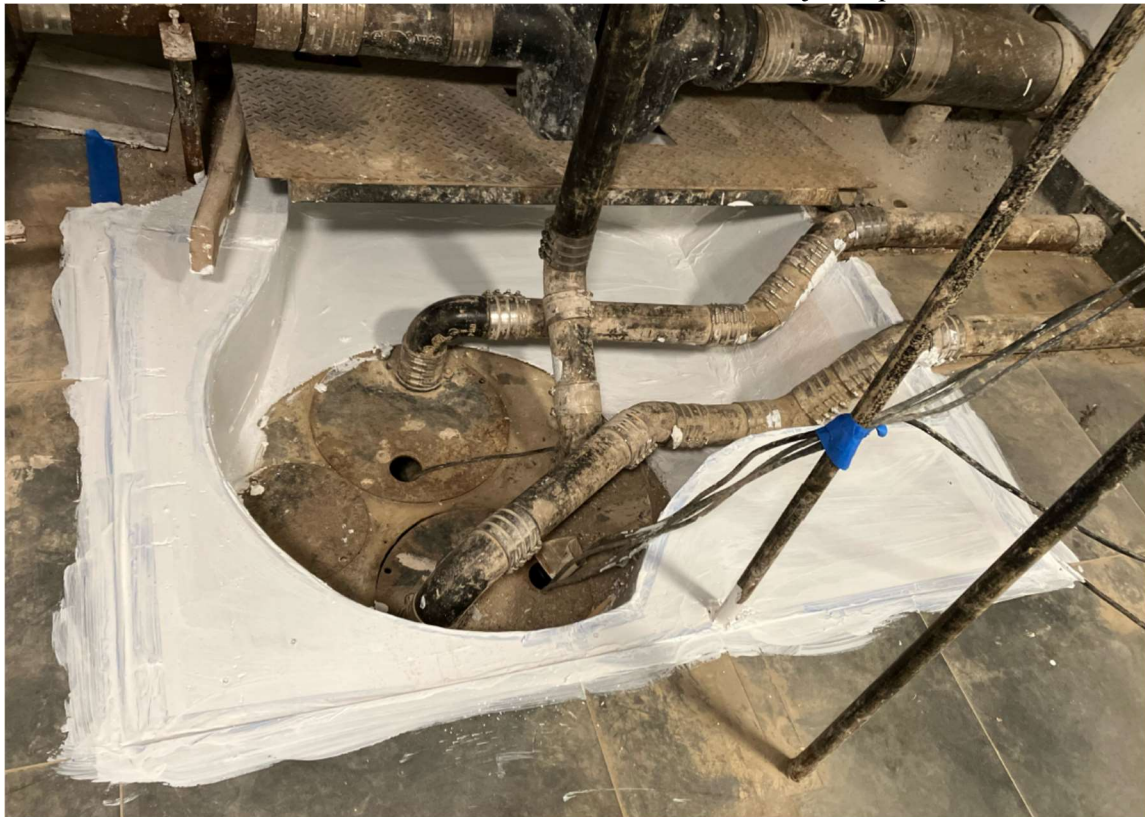
Photo 11 – View of Ames Rubberized Waterproofing applied around the form boards and over the floor in the area of the ejector pit.

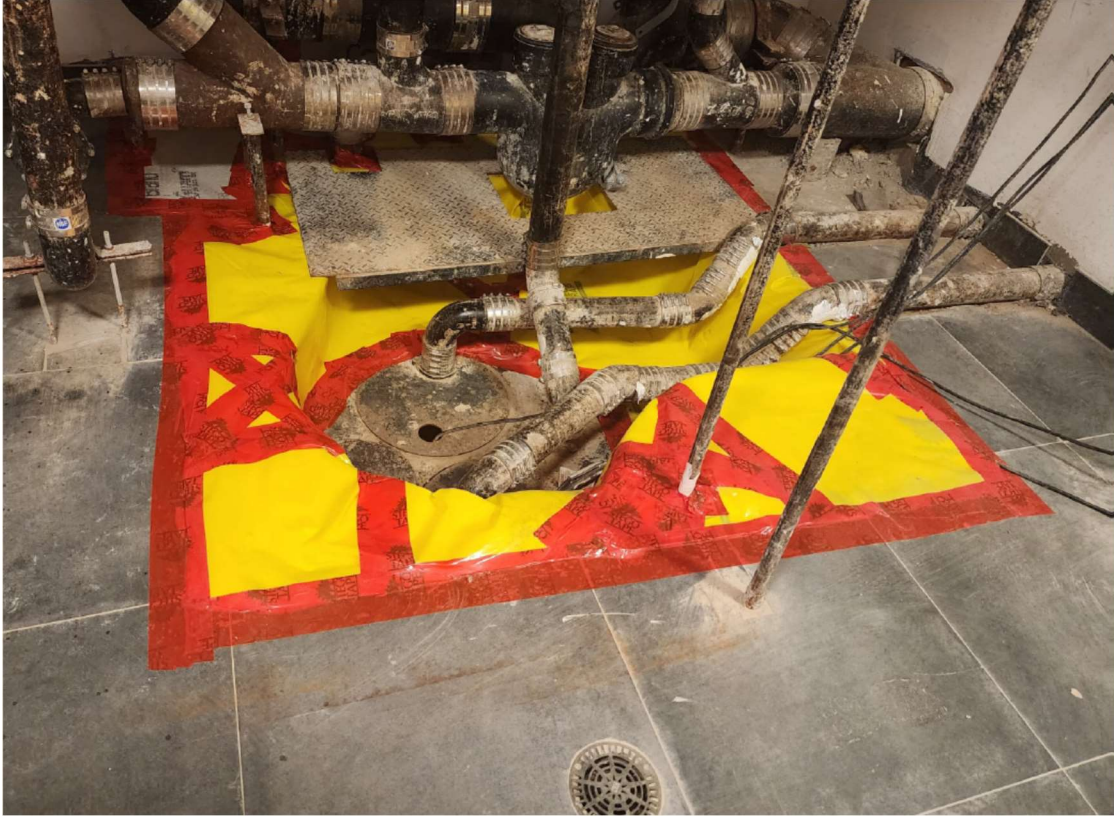
Photo 12 – View of Stego Wrap 20-Mil Vapor Barrier above the rubberized waterproofing extending over the tile, where vapor barrier remains under the tile in place.

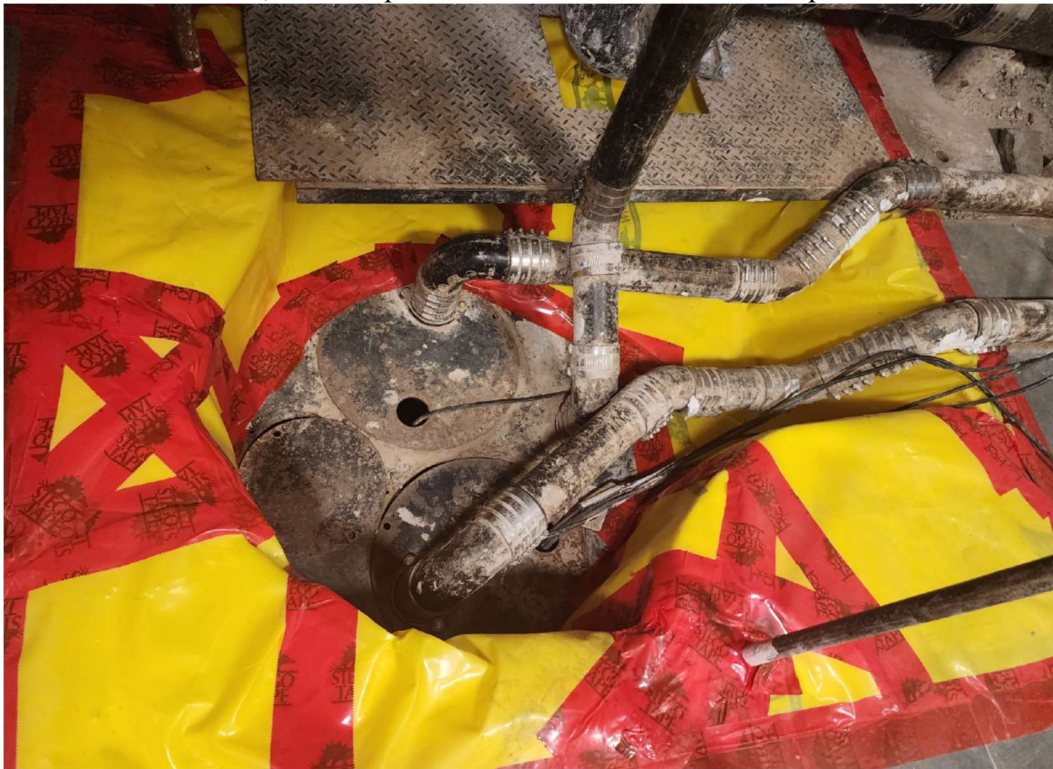
Photo 13 – Additional view of ejector pit.
