Project Name: 873 East 228 Street, Bronx

Project Number: 20TMP1422X, 20EHAZ280X, 21CVCP028X

Inspection Date: April 9, 2025

Site Inspection and Certification Letter Report

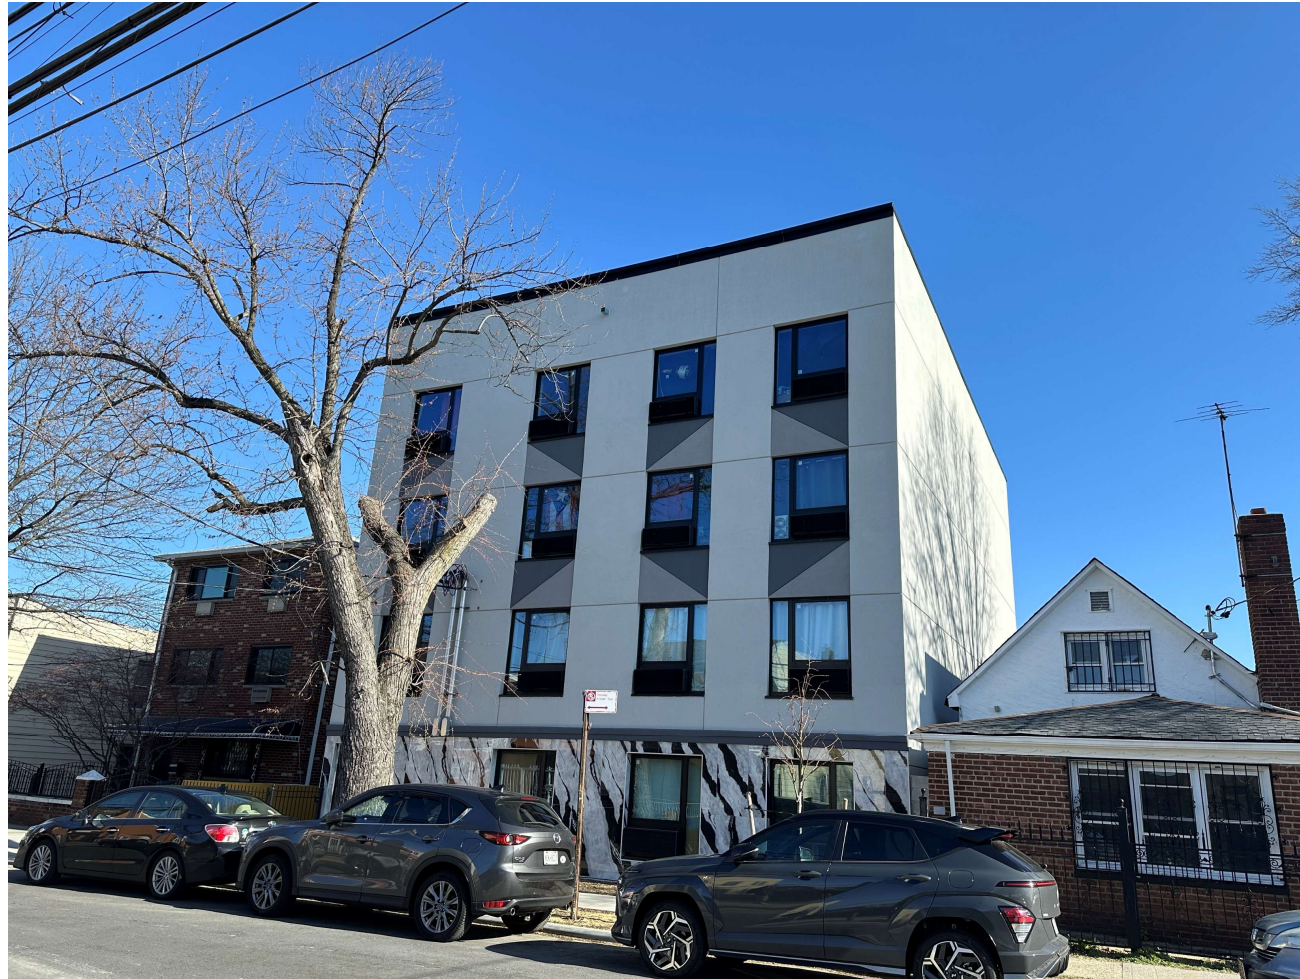
Front Façade of the Building

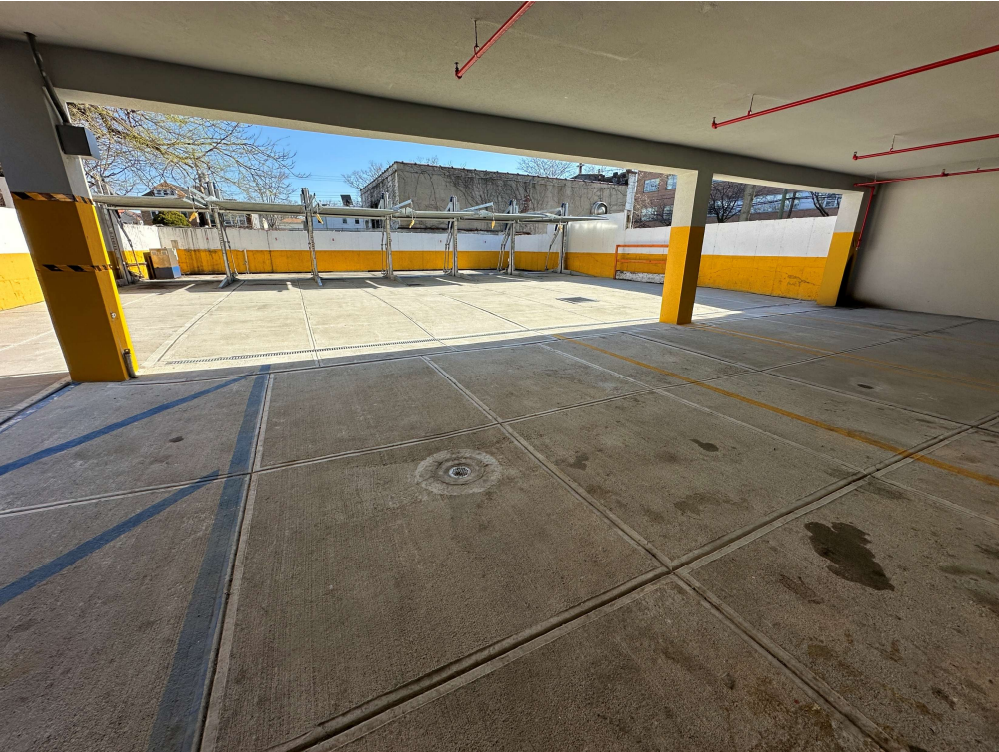
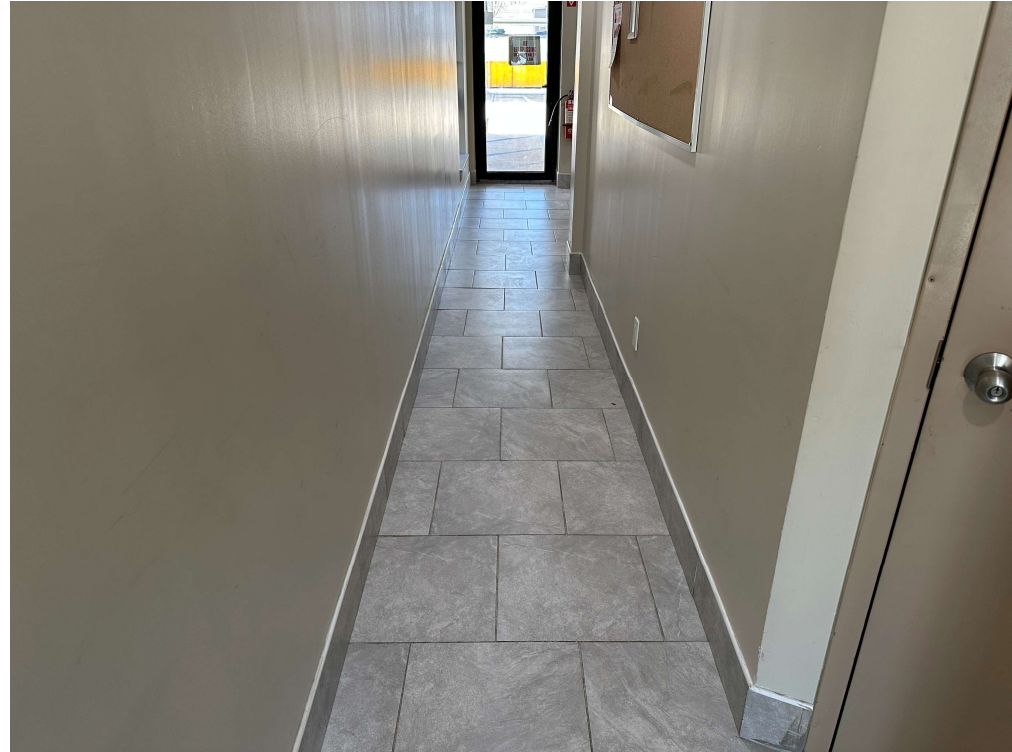
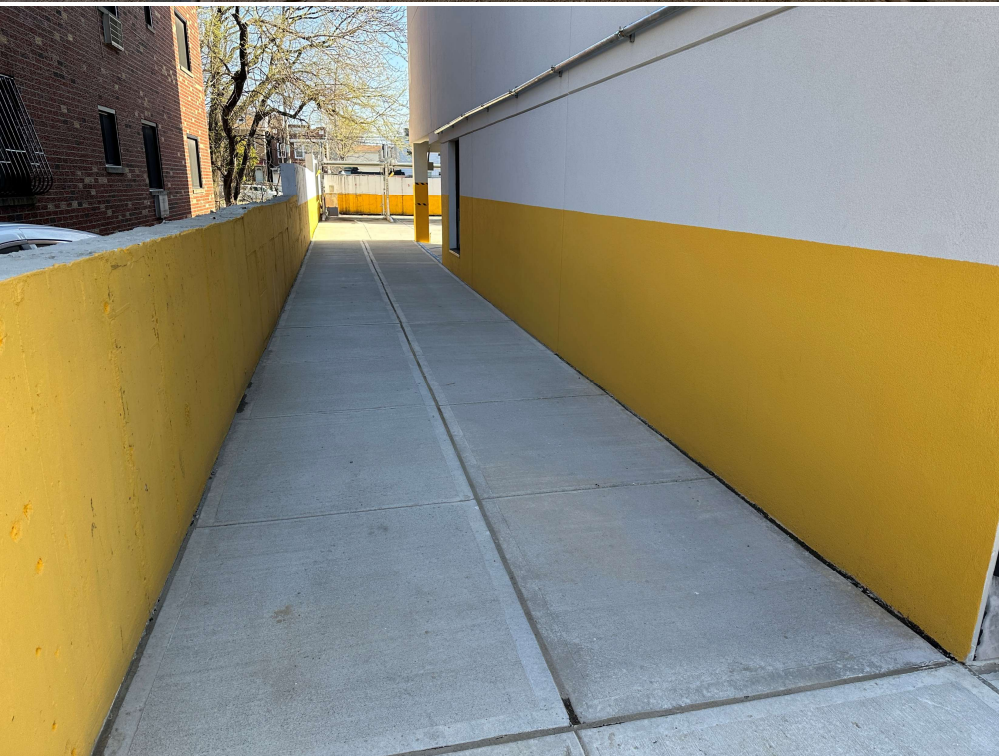
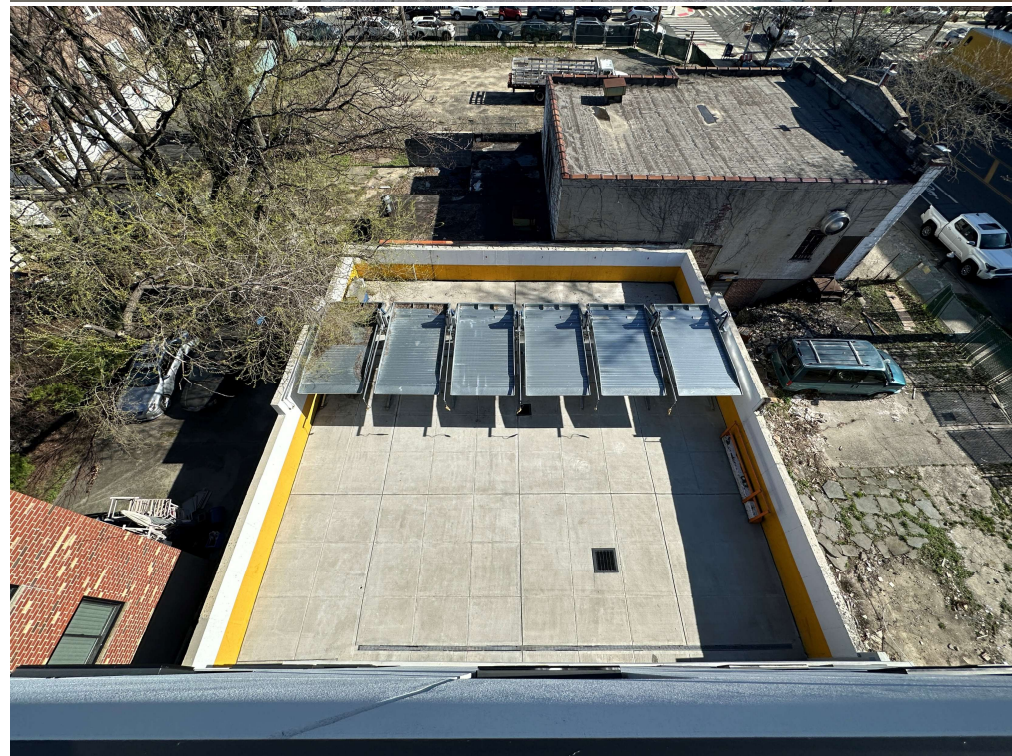
All accessible portions of the composite cover system were visually inspected during the site inspection. The composite cover system at the Site appears to be in sound condition. The concrete slab in the hallway is observed to be further covered with a layer of tiles. In the mechanical and storage space, fine and minor cracks were observed. These fine cracks should not represent a risk for soil vapor intrusion impact since migration of vapors is prevented by a vapor barrier membrane installed underneath the slab. The rear yard appears to be covered with concrete and maintained in the same condition as documented in the closure report for the site. Based upon the site inspection, the ECs present appear to be in sound condition and functioning properly. The Site is protective to human health and the environment. **Attachment #1** provides photographs of inspected building slabs. **Attachment #2** provides the annual inspection checklist.

Typical Slabs/Covers on First Floor and in Rear Yard

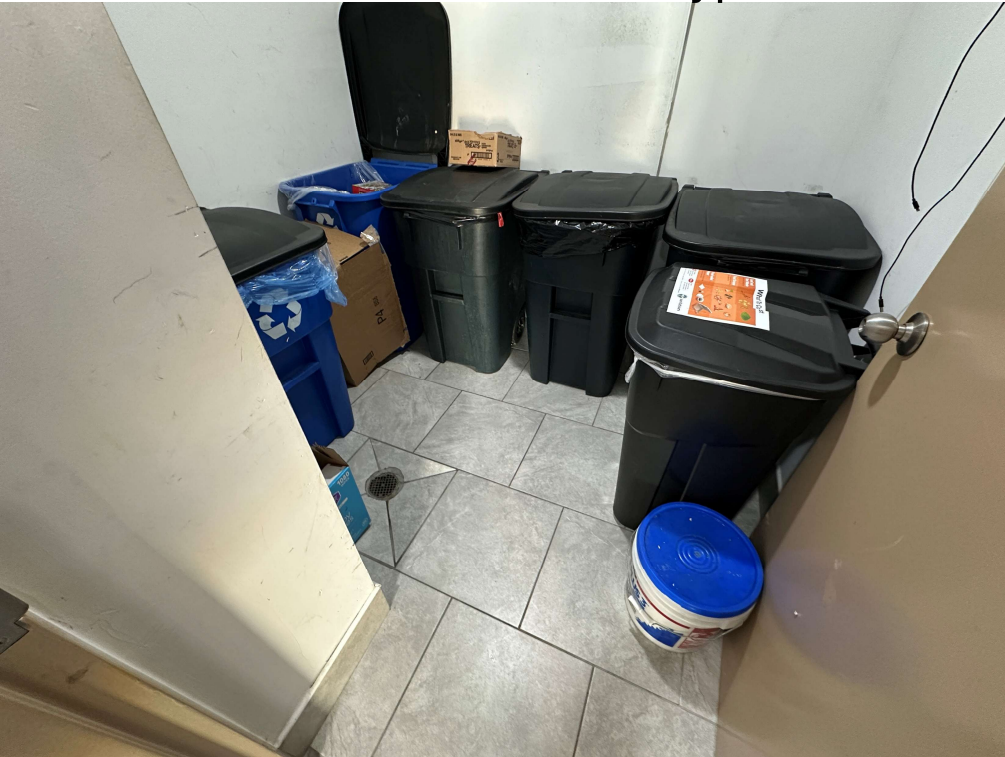
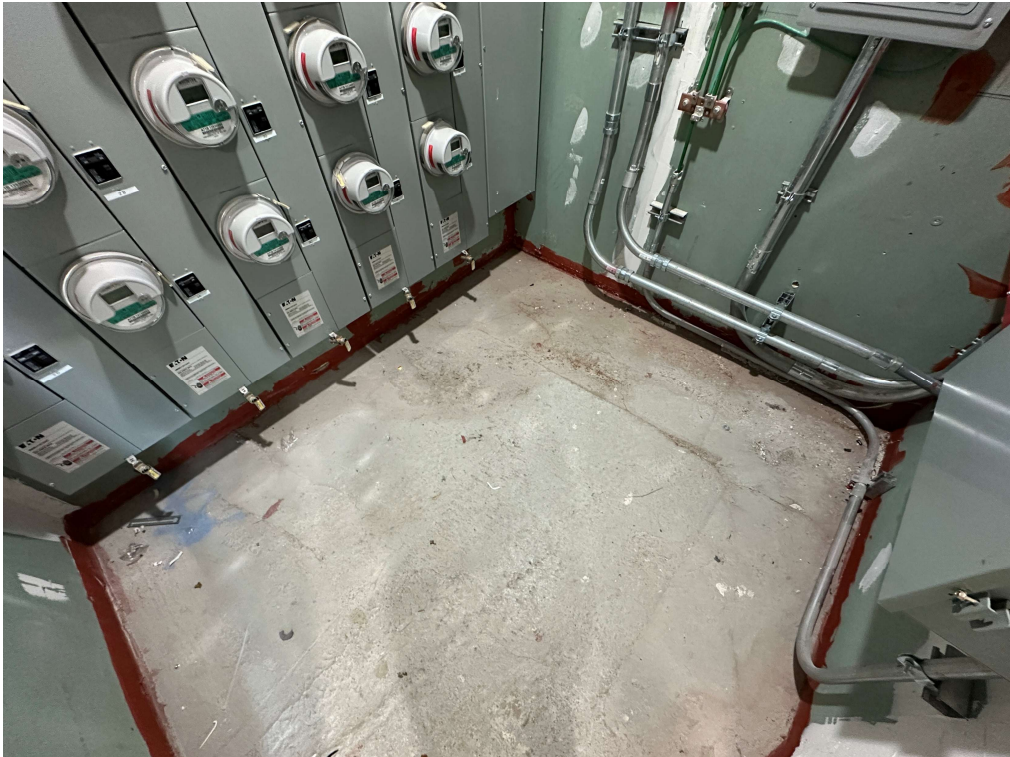
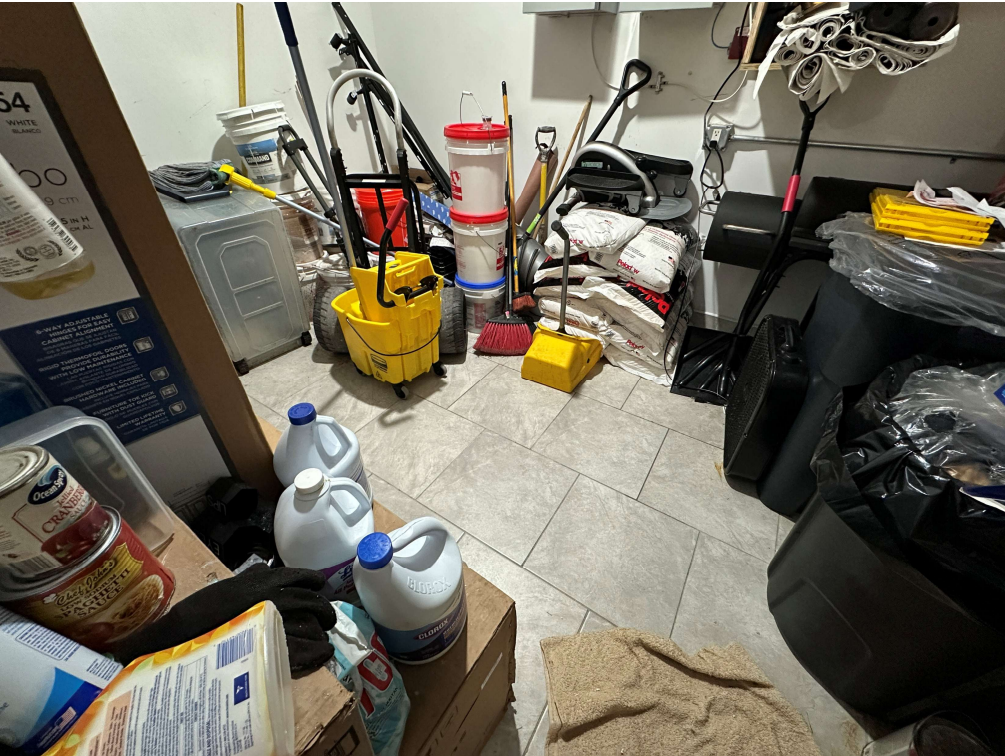
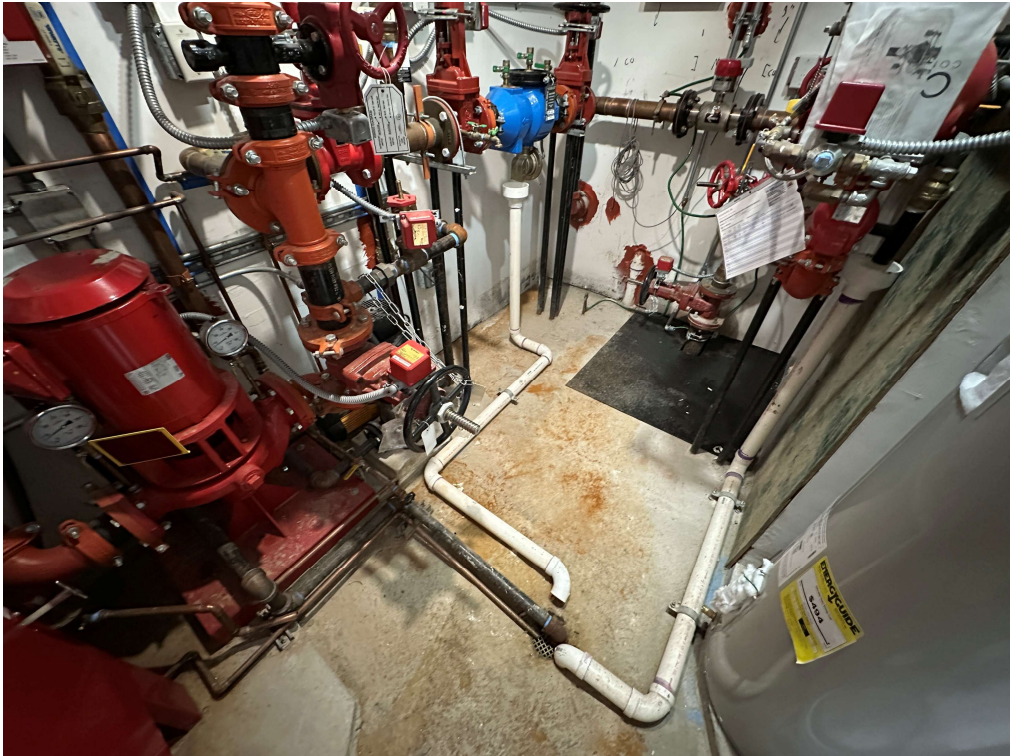
Typical Slabs/Covers on First Floor

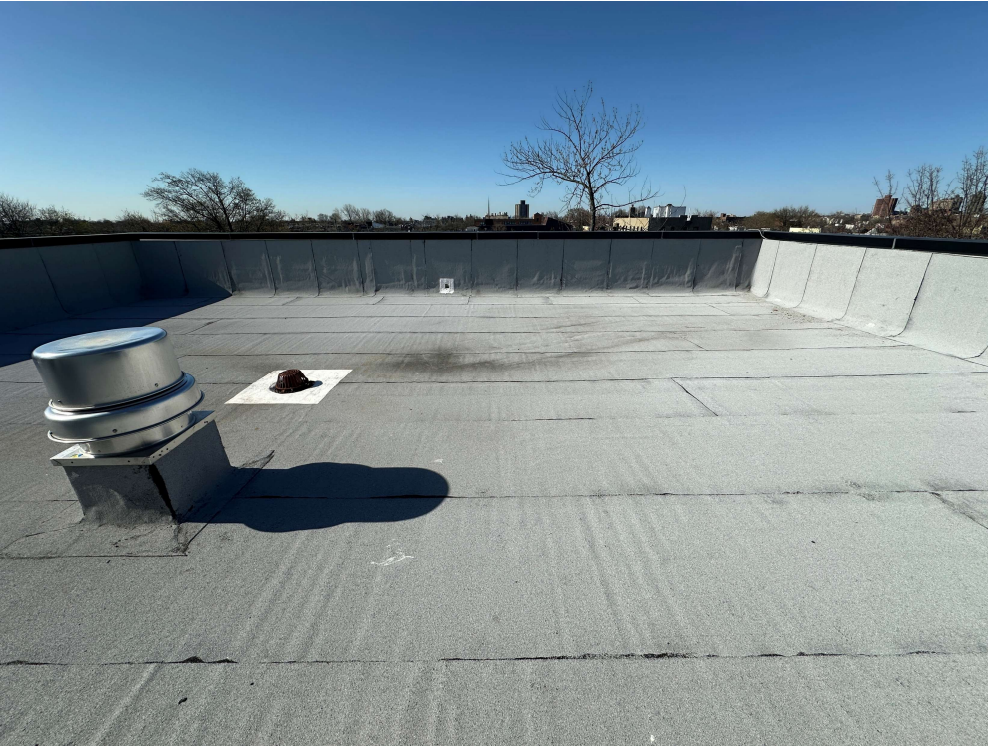
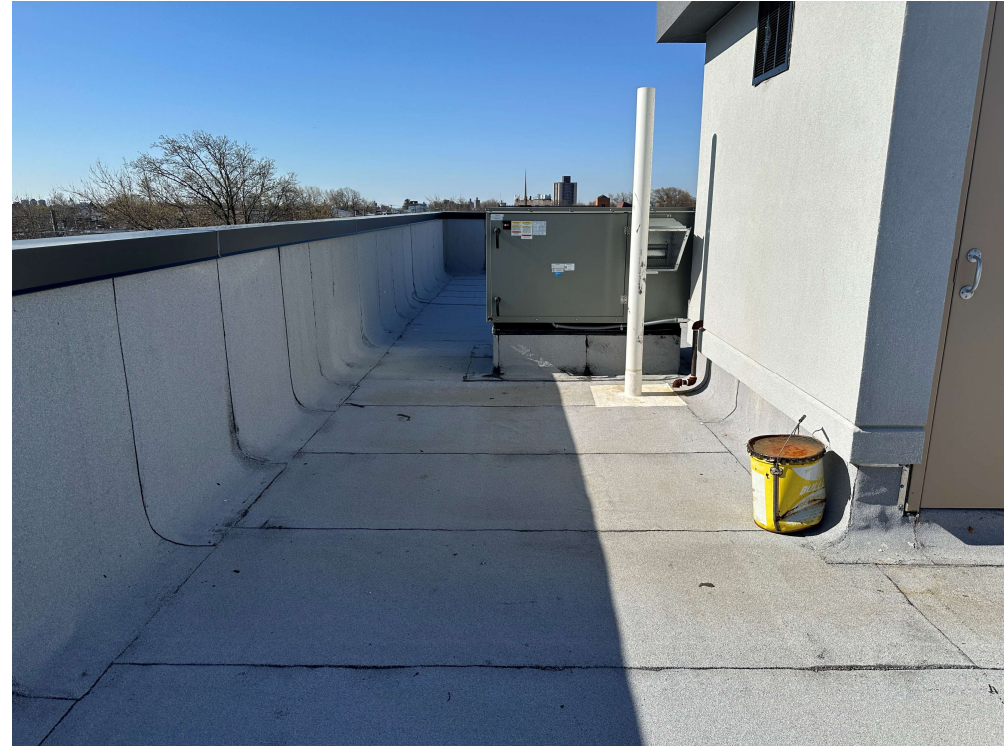
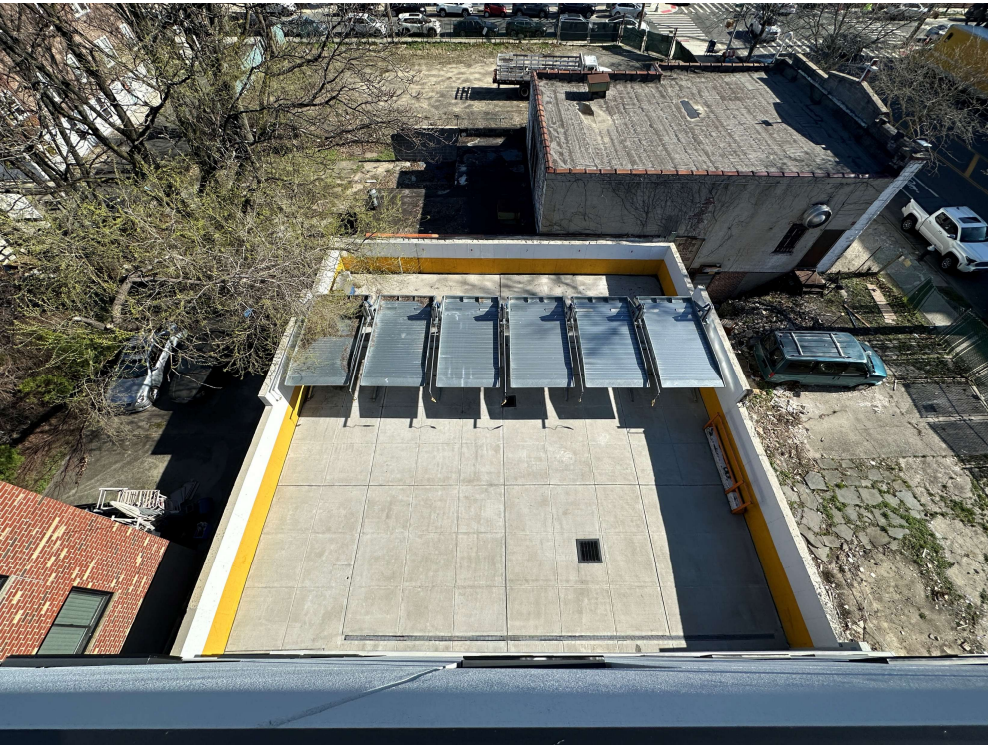
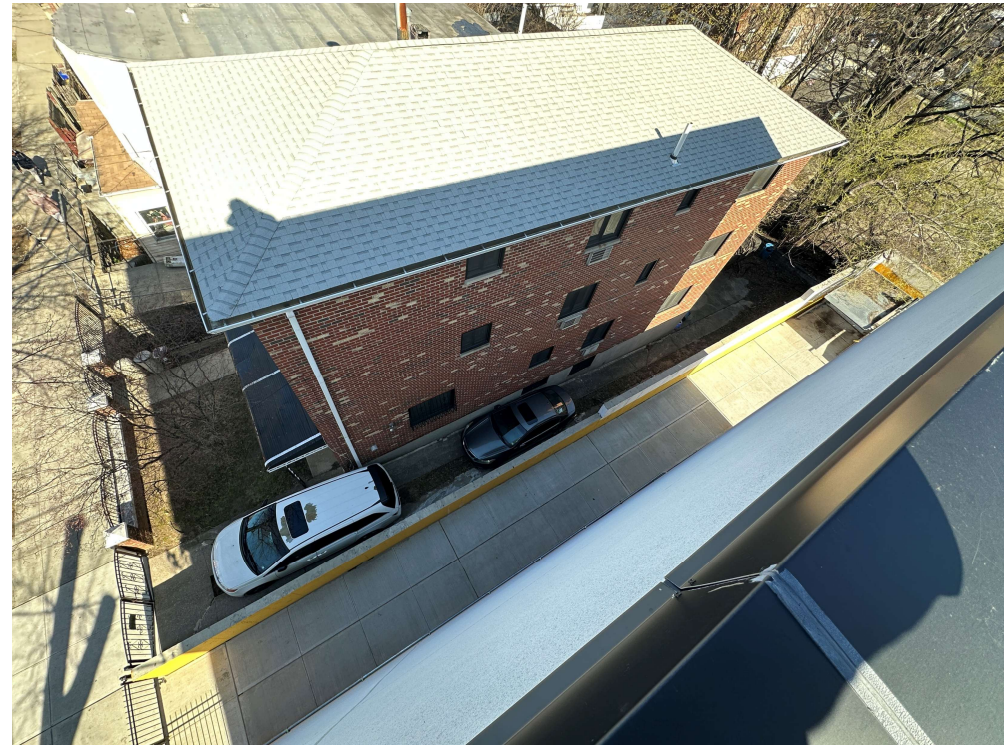
Roof View
