Project Name: 103 North 10th Street, Brooklyn, NY

Project Number: 12EHAZ535K

Inspection Date: August 2, 2023

Site Inspection and Certification Letter Report

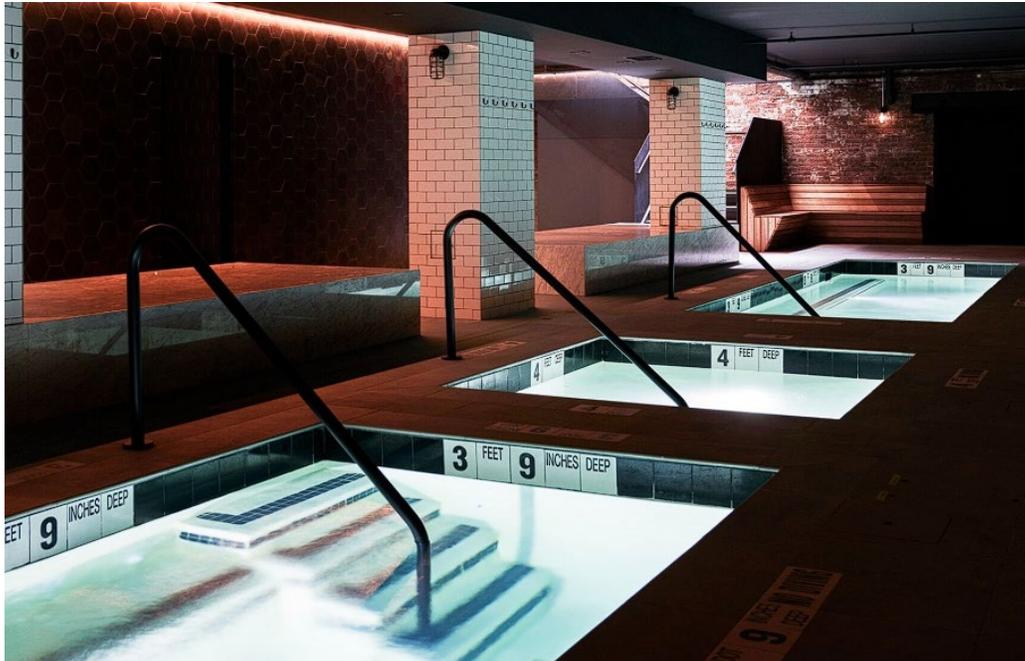
Accessible portions of the floor coverings and exposed concrete slab across the interior of the cellar were inspected. No significant cracks that required patching/filling were observed. However, BEC noted significant recent slab disturbance activities. The current tenant "Bathhouse" installed three hot-tub/pools below the cellar slab which required removal of sections of the cellar slab and excavation to a depth of approximately 4 ft. In addition, trenched excavation was likely performed for the water and drain connections for both the pools and showers installed in the cellar.

The vapor barrier applied to the surface of the cellar slab appears to have been significantly disturbed as large sections of the slab were removed to allow for installation of the current tenant's pools and showers.

In addition, the vapor barrier system for the cellar (application of Elite Crete Systems E100-PTTM Clear Epoxy sealant and E100-VB5TM Waterborne Epoxy Vapor Barrier to the surface of the cellar slab) was damaged when sections of the cellar slab were removed by Bathhouse.

Photo 1 – View of cellar with new pools installed in the cellar for Bathhouse.

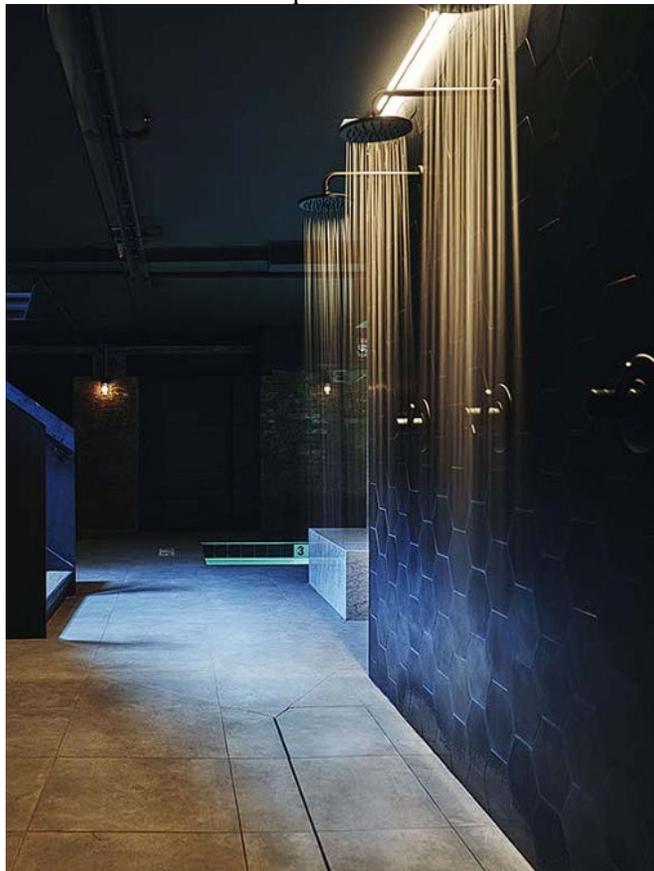
Photo 2 – View of new showers and drains installed in cellar for Bathhouse.

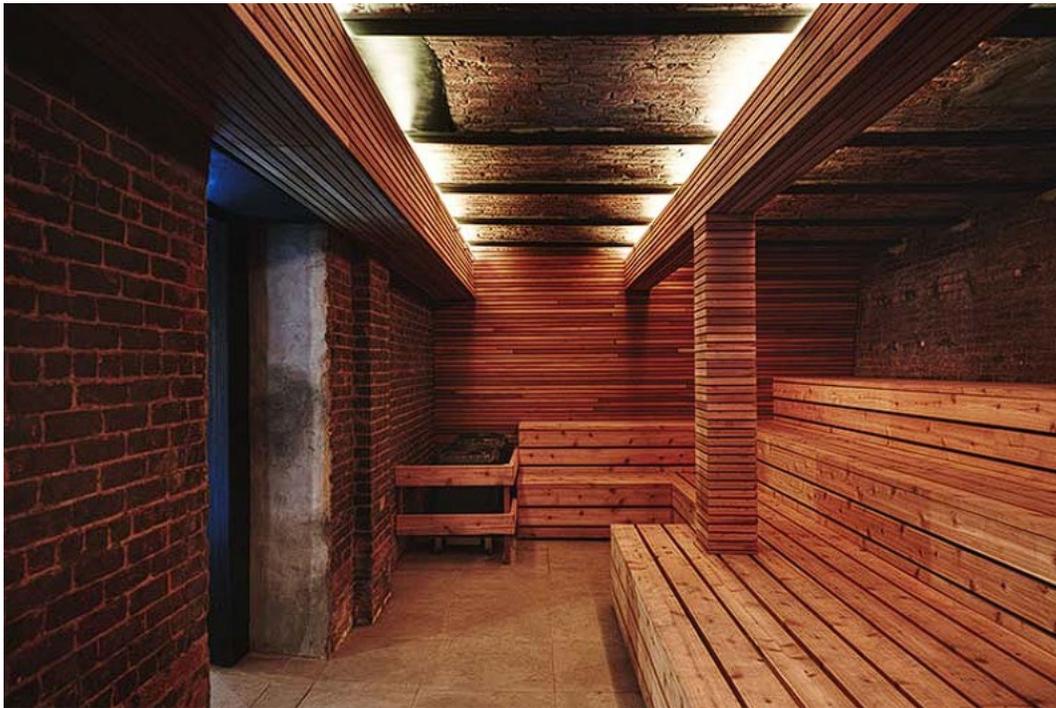
Photo 3 – View of sauna installed in cellar for Bathhouse.

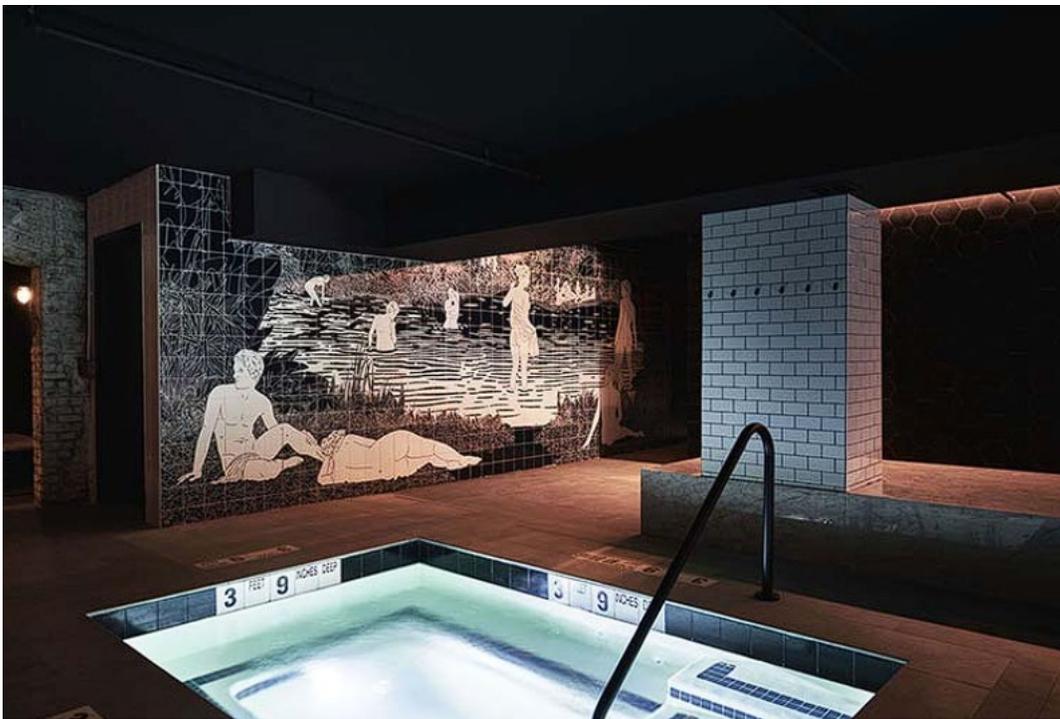
The active SSDS piping below the cellar slab may have damaged during installation of the pools and associated lines/piping. Bathhouse provided photos and verbally stated that care was taken to avoid damaging the SSDS piping below the slab, but BEC cannot confirm as the work was done without BEC oversight. The alarms/gauges connected to the cellar's active SSDS were not accessible for inspection as they appear to have been buried behind a finished wall.

Photo 4 – Additional view of pools installed in cellar for Bathhouse.

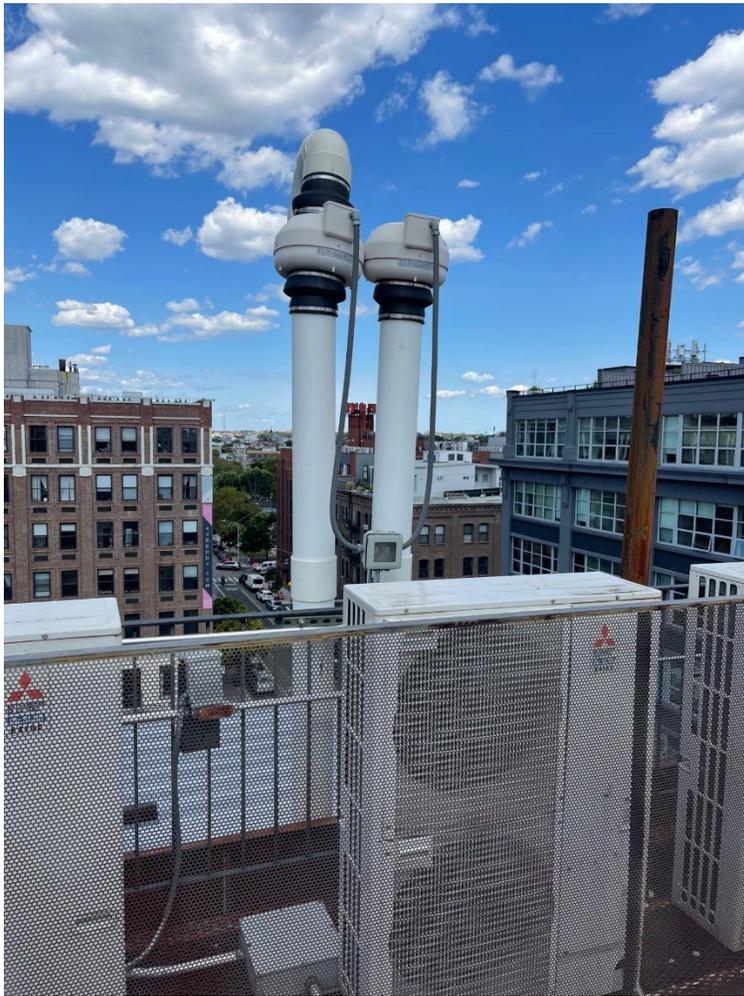
The blower for the active SSD systems for the cellar of the 5-story building were inspected on August 2, 2023 and found to be operating. However, magnahelic manometer vacuum gauges and alarms formerly located in the cellar could not be located as they appear to have been buried behind a finished wall.

Photo 5. View of active SSDS risers/blowers installed on roof for cellar portion of building.

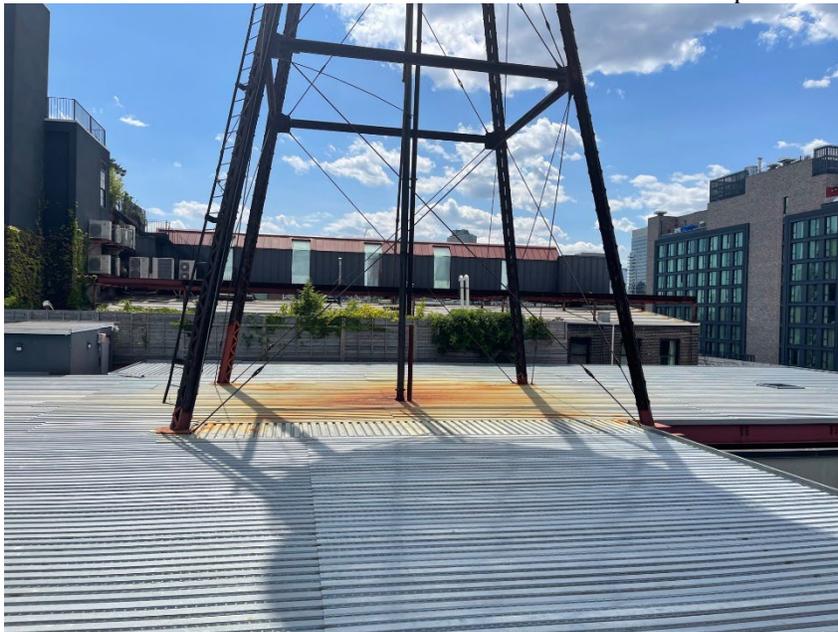
Photo 6. View of passive SSDS risers installed on roof for slab-on grade portion of building.
