Project Name: 10 Jay Street, Brooklyn, NY

OER Project Number: 14EH-N547K

Inspection Date: June 21, 2021

Site Inspection and Certification Letter Report

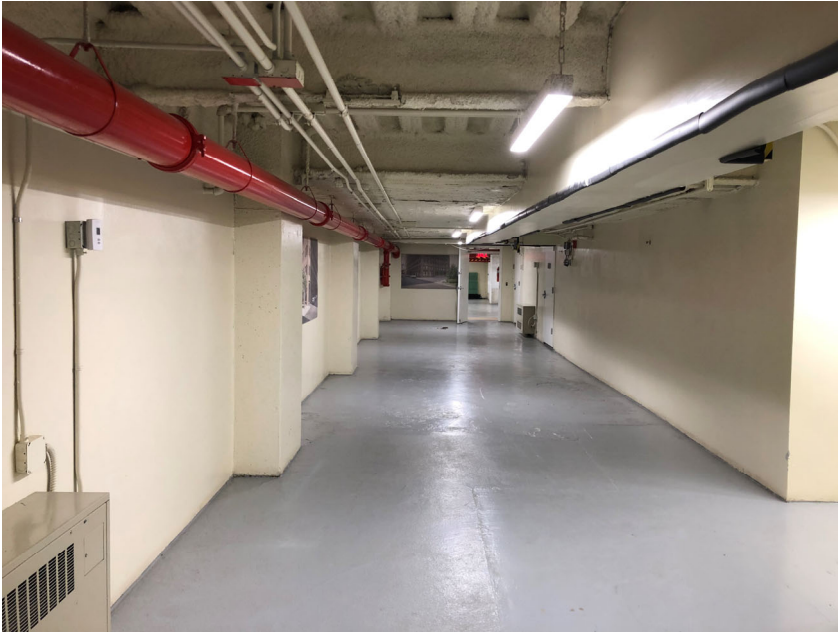
Basement Floor - 1

Accessible portions of the composite cover system were visually inspected during the site inspection. The composite cover system at the Site appears to be in sound condition. No cracks were observed in the concrete slab in the basement.

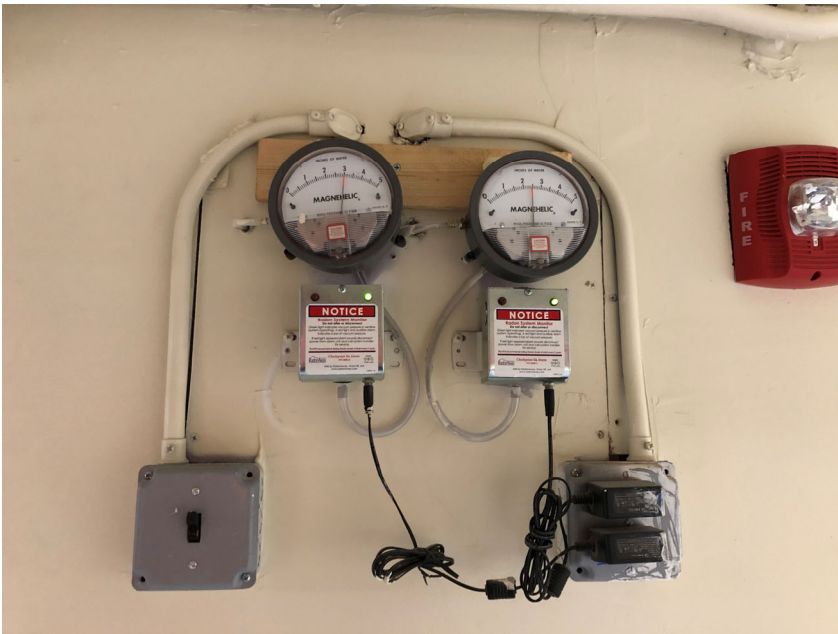
Alarm and Gauge Set

Any potential impact associated with potential vapors seeping into subgrade basement at the Site is mitigated by the active SSDS. Visual observation of the active SSDS indicates that the suction fans are working properly. The alarms were tested and confirmed to be in working in audible condition. The magnehelic readings of the two pressure gauges located in the central portion of the basement are 3.0 inches of H₂O for SSDS #2 and 2.5 inches of H₂O for SSDS #1. Differential pressure readings were obtained from each of the pressure probes designated as pressure probe #1 through pressure probe #6 except pressure probe #5. Pressure probe #1 indicated negative pressure of -0.07 inches of H₂O, pressure probe #2 indicated negative pressure of -0.05 inches of H₂O, pressure probe #3 and pressure probe #6 indicated negative pressure of -0.01 inches of H₂O and pressure probe #4 indicated negative pressure of -0.02 inches of H₂O. Pressure probe #5 could not be located due to obstruction by material storage in the mechanical room and hence, no pressure reading was obtained from this pressure probe. However, based on the negative pressure readings of the other pressure probes indicates that there is communication across the slab in the vicinity of the SSDS pits and verifies proper functioning of the system.
