Project Name: 235-237 Kent Avenue, Brooklyn, NY
Project Number: 14TMP0314K, 14EHAZ314K
Site Management Reporting Period: 2022-2023
Inspection Date: July 14 and August 15, 2023
Inspector and Certifier: Patrick Recio
Report Submittal Date: August 30, 2023
Report Preparer: Brussee Environmental Corp on behalf of DAX Real Estate

Site Inspection and Certification Letter Report

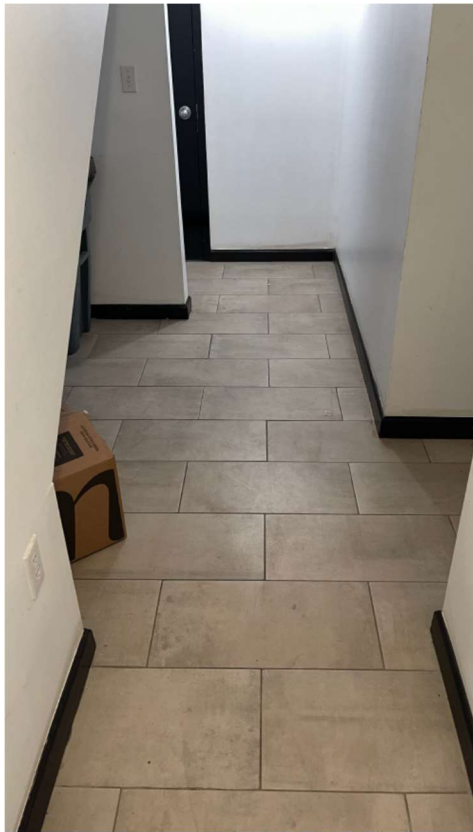
No significant cracks that required patching/filling were observed. No evidence of recent repairs/replacement was observed.

Photo 1 – View of hallway in cellar of 235 Kent Avenue covered with tile.

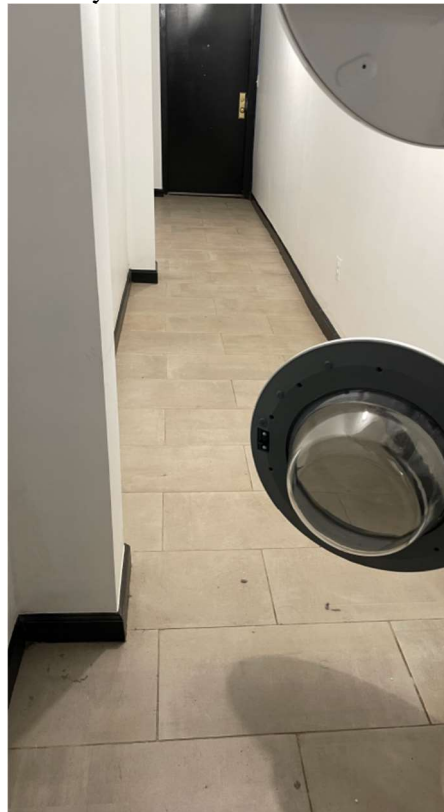
Photo 2 – Additional view of tile covered slab within the cellar of 235 Kent Avenue.

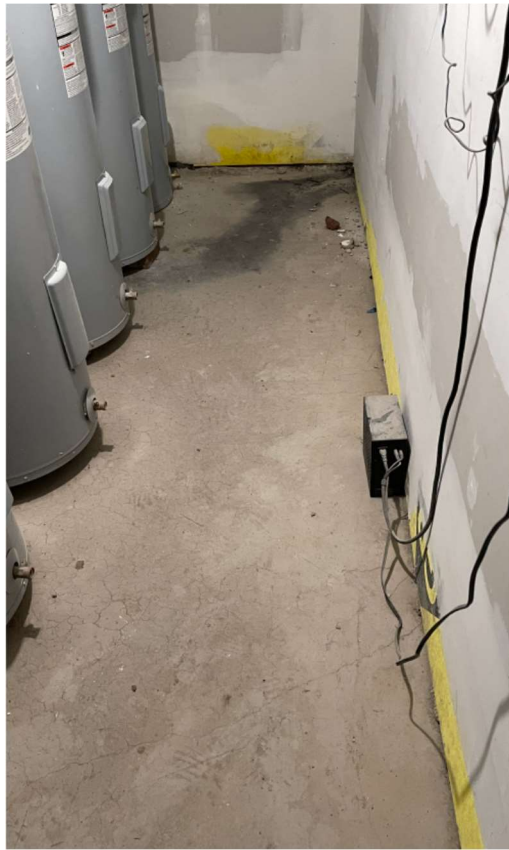
The vapor barrier installed below the building slab does not appear to have been disturbed as no evidence of slab disturbance was observed during the Site inspection. The building slab was able to be directly observed because there were no floor coverings in the observed spaces.

Photo 3 – View of exposed slab within a utility room in the cellar of 235 Kent Avenue.

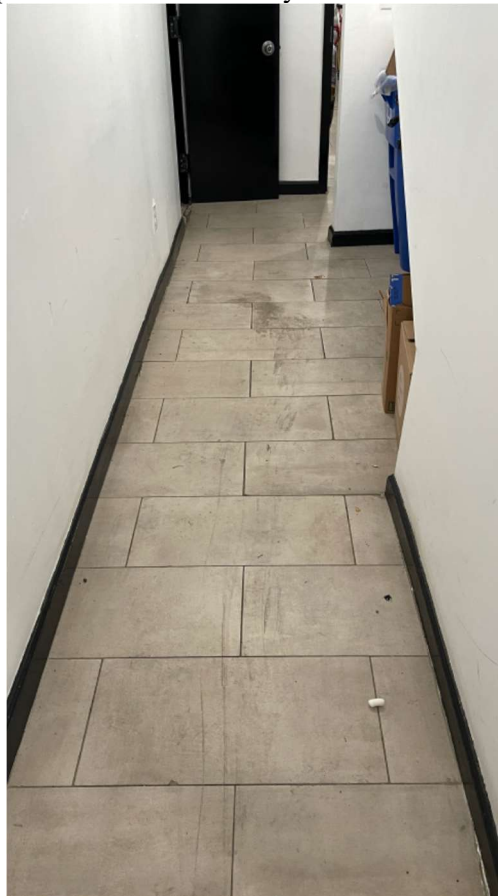
Photo 4 – View of tile covered slab in the hallways of 237 Kent Avenue.

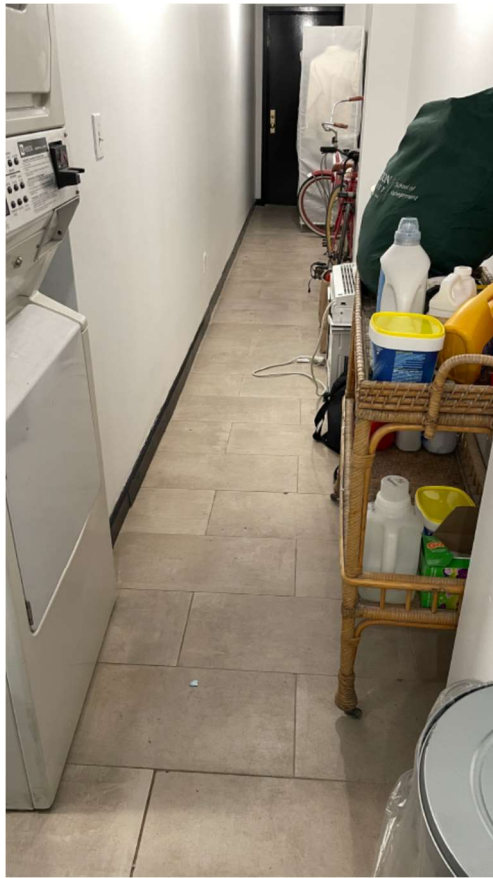
Photo 5 – Additional view of tile covered slab in the hallways of 237 Kent Avenue.

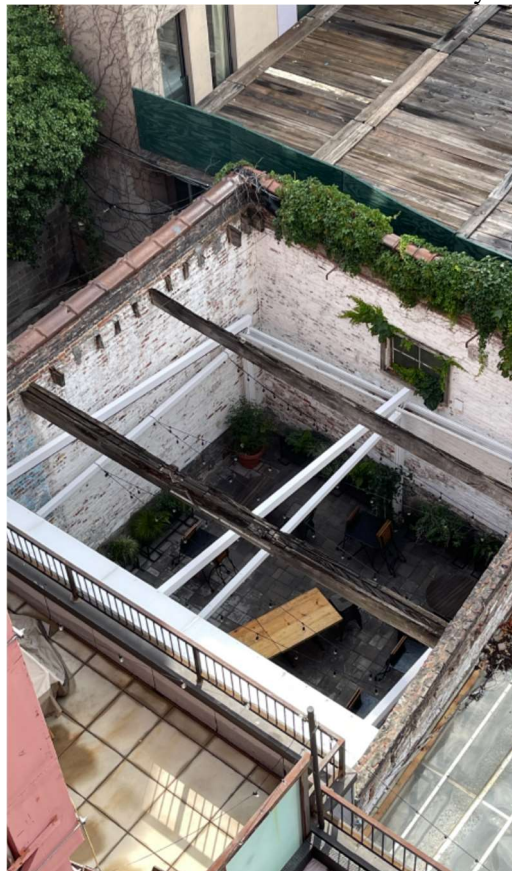
Rear Courtyard: The rear courtyard consists of concrete pavers. No missing pavers or other damage was observed that required action.

Photo 6 – View of concrete paver capped rear yard.

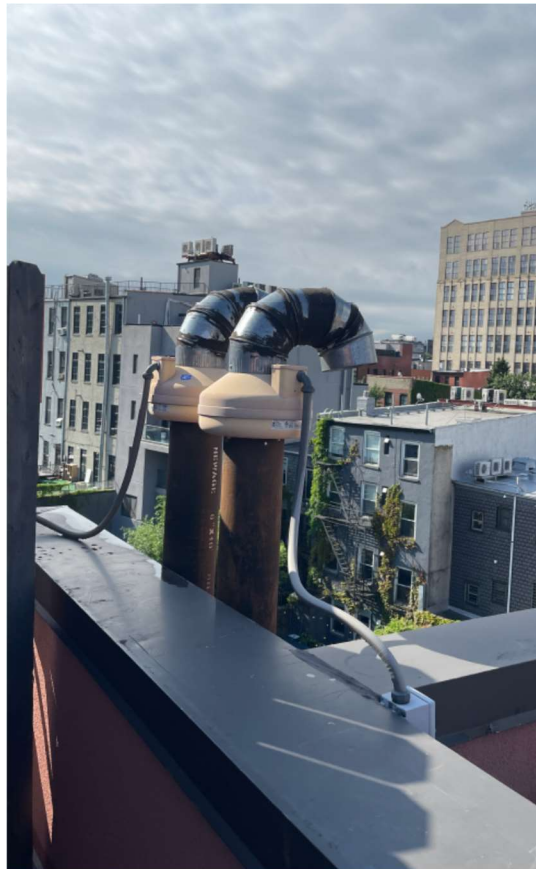
Photo 7 – View of blowers and risers on the roof of the 235-237 Kent Avenue

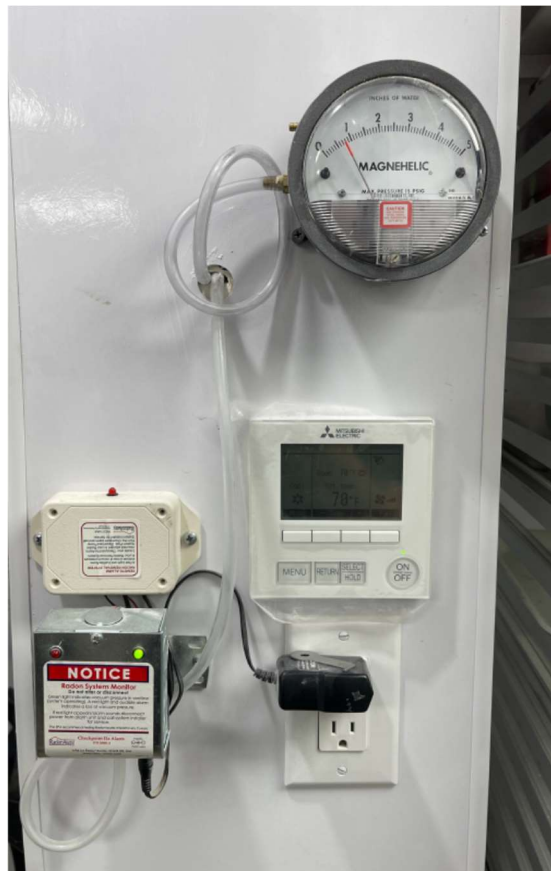
Photo 8 – View of manometer and alarm for the 235 Kent Avenue SSDS Loop.

Vacuum Reading: 0.80" - 8/15/2023

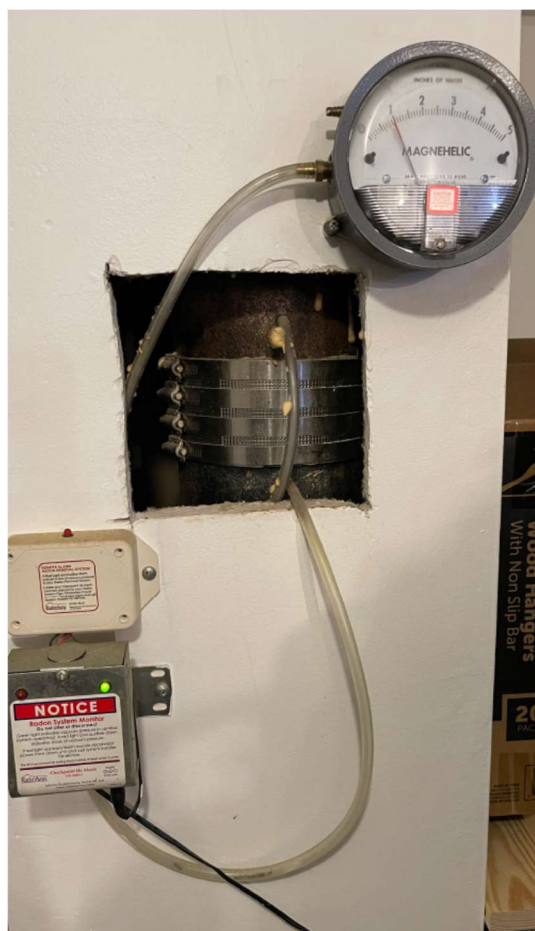
Photo 9 – View of the manometer and the alarm for the 237 Kent Avenue SSDS Loop.

Fan 1 :	yes	no	Fan Model No. Manufacturer:
Operational?	X		
Observed Leaks at Seals?		X	
Air Flow at Exhaust Stack?	X		Other Comments / Observations
Vacuum Reading:	0.90" - 8/15/2023
