Project Name: 1007 Atlantic Avenue, Brooklyn, NY

Project Number: 14EH-N345K

Inspection Date: June 14, 2023

Site Inspection and Certification Letter Report

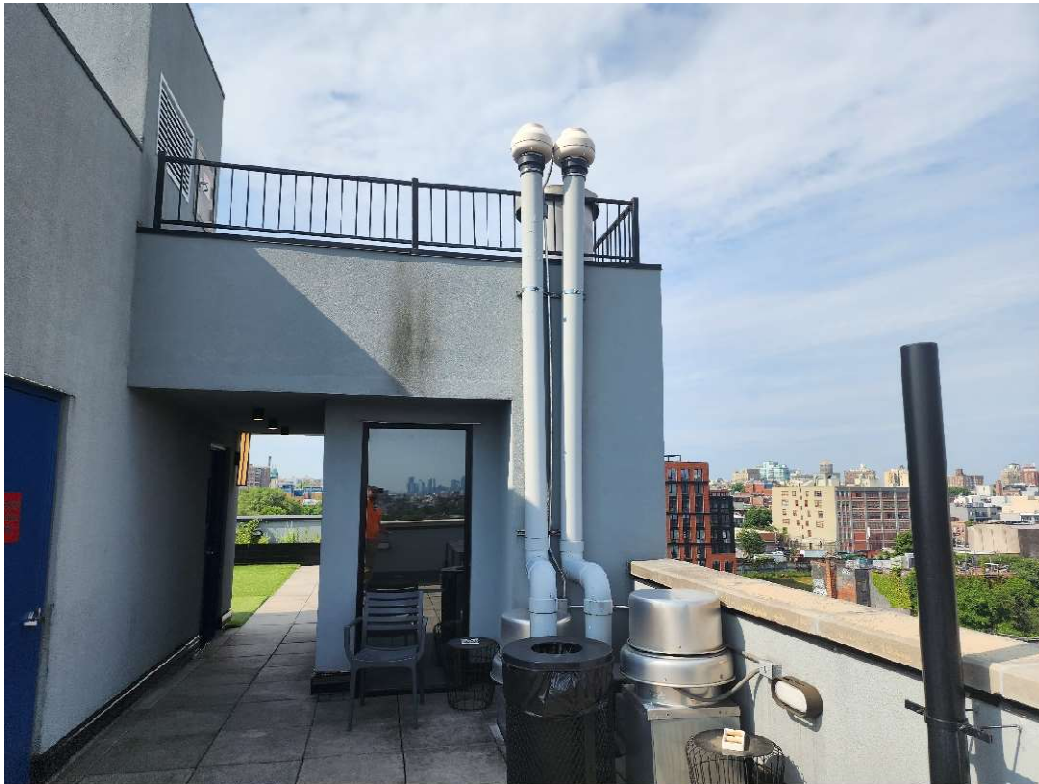
Photo 1: Risers and Fans for Loop 1 and Loop 2

The blowers for the active SSDS systems were inspected on June 14, 2023 and found to be operating. The vacuum gauges installed within the building recorded vacuum readings of approximately 0.6 to 1.1" of water. None of the alarms were sounding and each of the alarm lights was green. Photos of the SSD system risers are included in the photo log.
