Project Name: 470 Driggs Avenue, Brooklyn, NY 11211

Project Number: 12CBCP021K

Inspection Date: 7/19/23

Site Inspection and Certification Letter Report

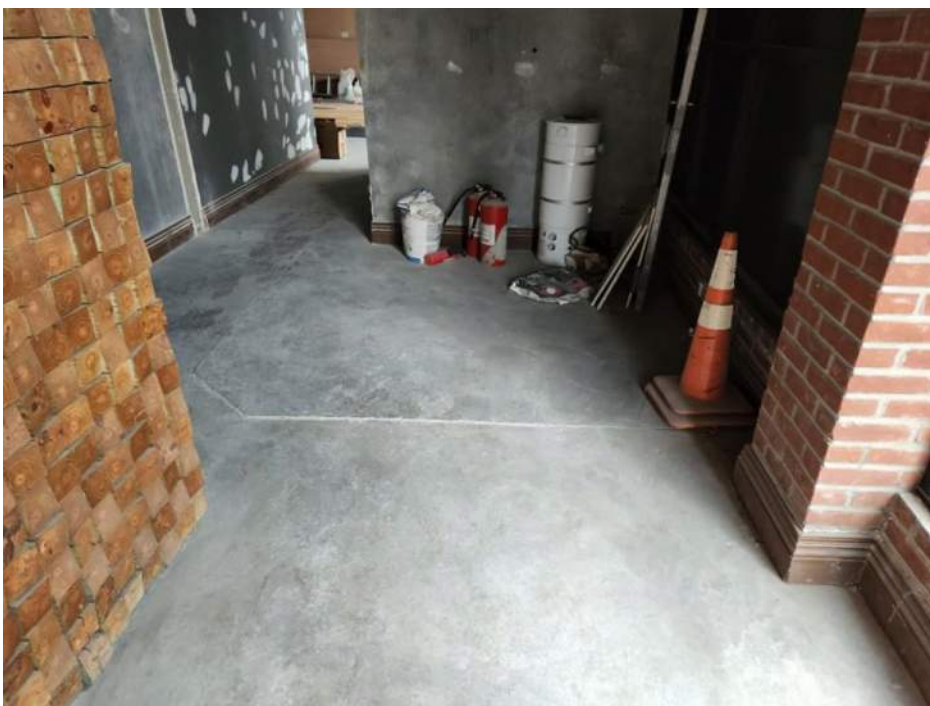
Photograph 2: Capped hot spot area at entrance to the building at Driggs Avenue

Four discrete areas of “hot spot” fill material contaminated by arsenic and chromium was formerly present beneath the Site building floor slab; these areas were excavated to varying depths. Vapor barriers were installed and covered by poured concrete at these four areas as engineering controls. No evidence of floor slab disturbance at any portion of the Site building interior was observed and the composite cover is intact at the four formerly excavated areas. No cracks or other evidence was observed indicating that the integrity of the composite cover system has been compromised.

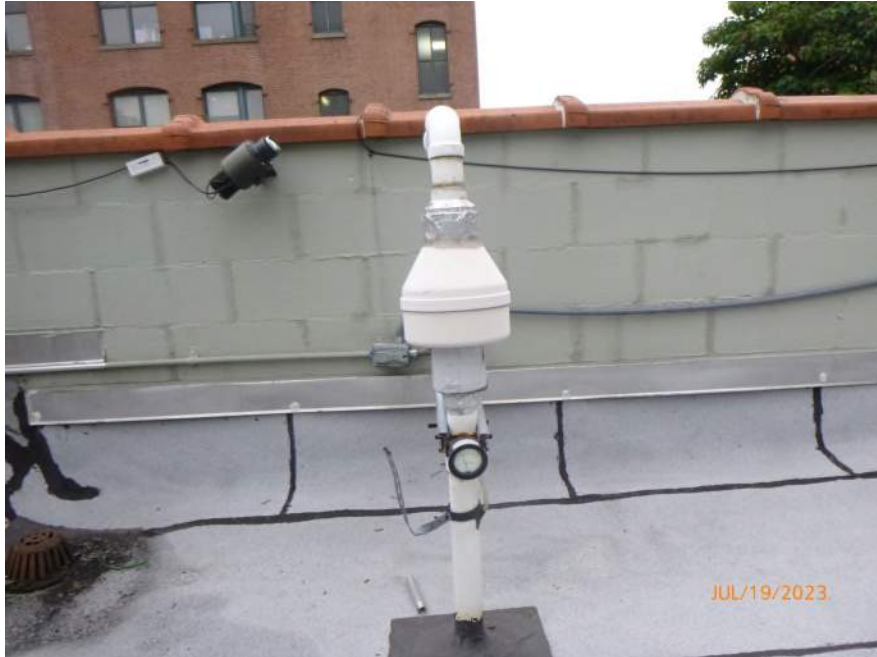
Photograph 3: South SSDS blower.

The SSDS consists of two separate two-inch diameter PVC riser pipes extending from beneath the ground floor slab and through the roof of the building. A blower fan is affixed to the top end of each riser on the roof. Both blowers were operational and no obstacles to air flow were present. Vacuum readings at the SSDS gauges located on the south rooftop riser is 1.5 inches of water. The gauge on blower fan at the north SSDS riser measured 0.5 inches of water. The system shutoff alarm was not accessed, which is located in a utility room in the north tenant space (tenant locked the door). The Site owner has instructed the tenant to remove the lock. The blower mount seals on the roof are intact. Aside from the new restaurant tenant, there have been no changes to Site conditions over the past year.

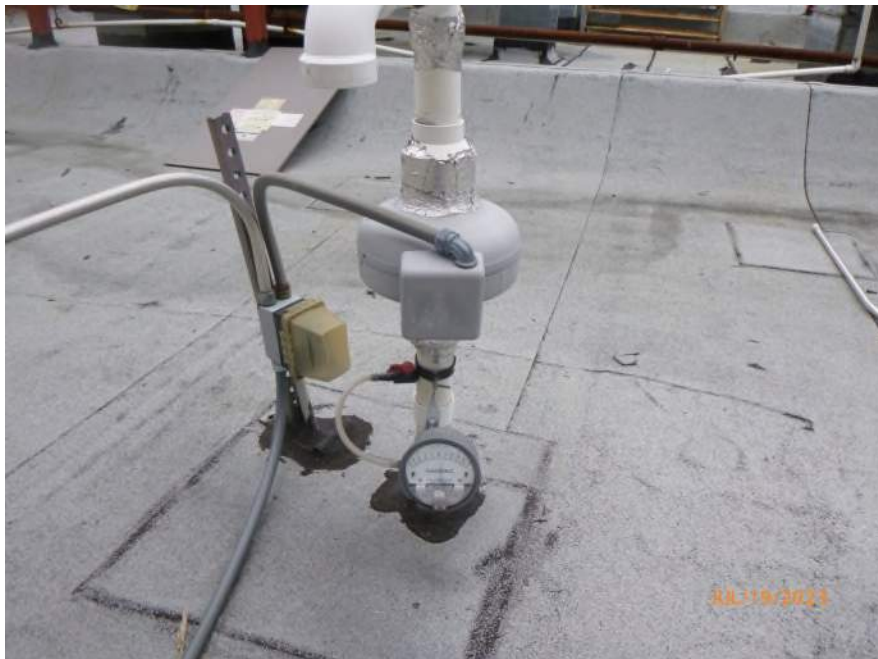
Photograph 4: North SSDS blower.

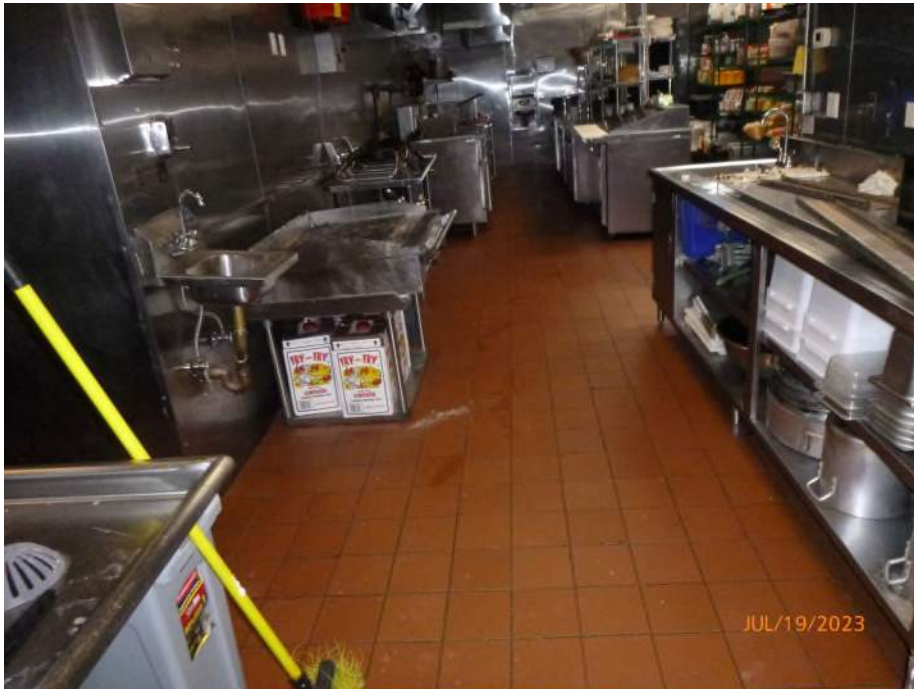
Photograph 5: Capped hot spot at north-central building section.

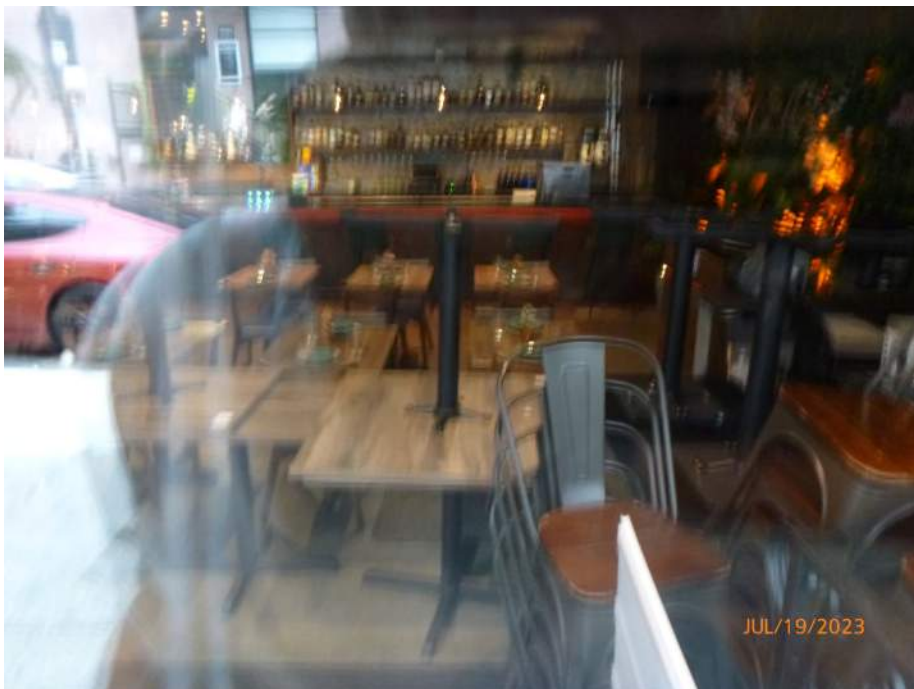
Photograph 6: Capped hot spot at south side of the building.

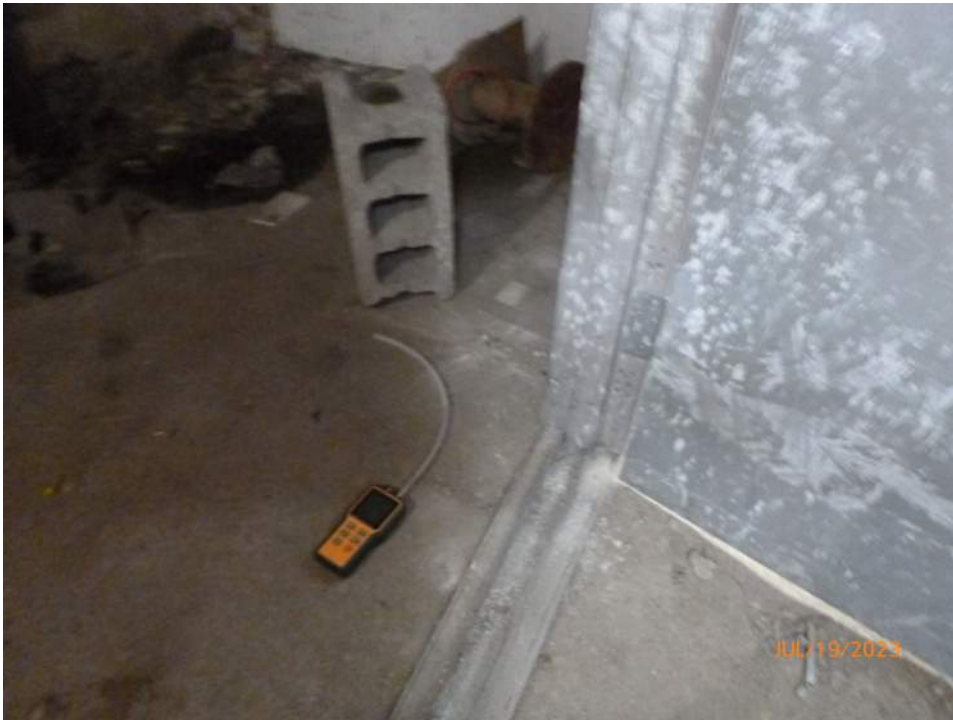
Photograph 7: Monitoring point in the partial basement at the south side of the Site building.

Three sub-slab monitoring points had been installed in the past year as they were not present as reported by the 2021-2022 Inspection Certification. During this current inspection, two of the three monitoring points had been removed by tenants, and the only remaining monitoring point is present in the partial basement at the south side of the Site building. MECC has instructed the owner that the two vapor points need to be reinstalled; this activity is in progress.
