Project Name: 504 Myrtle Avenue

Project Number: 13CVCP110K

Inspection Date: June 23, 2021

Site Inspection and Certification Letter Report

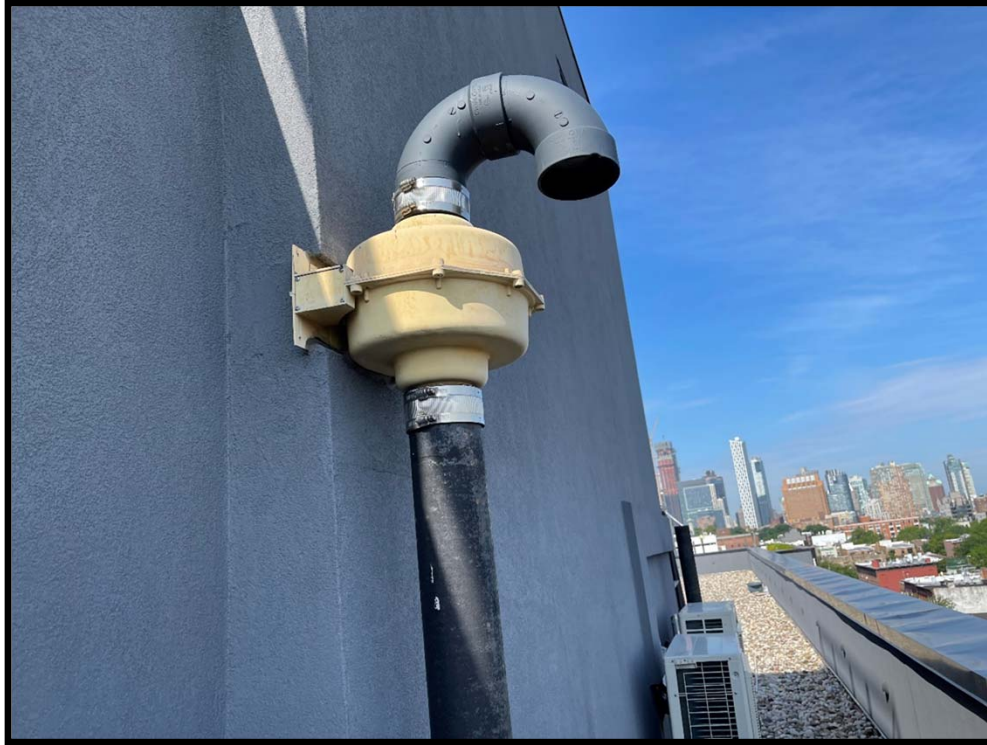
The vent pipe located on the roof of the building was located a minimum of 10 feet from accessible areas and from any air intakes. No leaks were observed, and the fan appeared to function to its design capacity.

View of the blower fan on the roof.

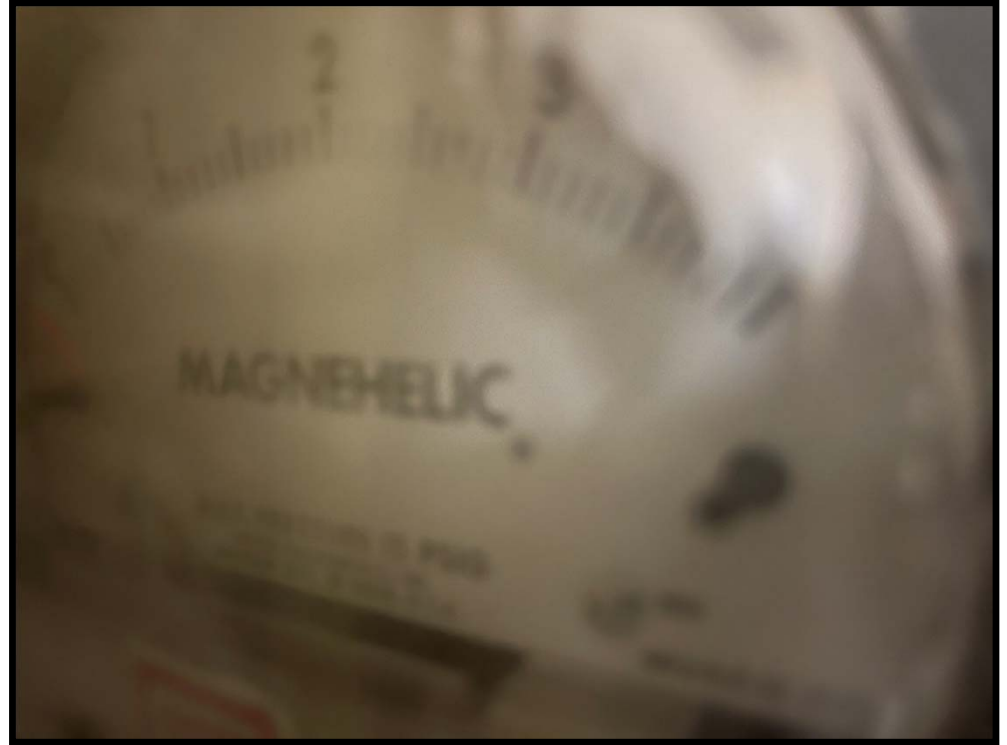
All accessible components of the active SSDS were inspected, including the Magnehelic vacuum gauge, pressure alarm, riser pipes, radial fans, and vent pipes. The vacuum reading at the gauge was observed to be -0.6 inches water column, indicative of sufficient vacuum pressure. At the time of inspection, the alarm unit appeared to be disconnected and non-functional. Athenica reconnected the alarm during the inspection; the alarm was determined to function correctly. During the inspections, the two sub-slab monitoring points were not accessible.

View of the magnehelic gauge.

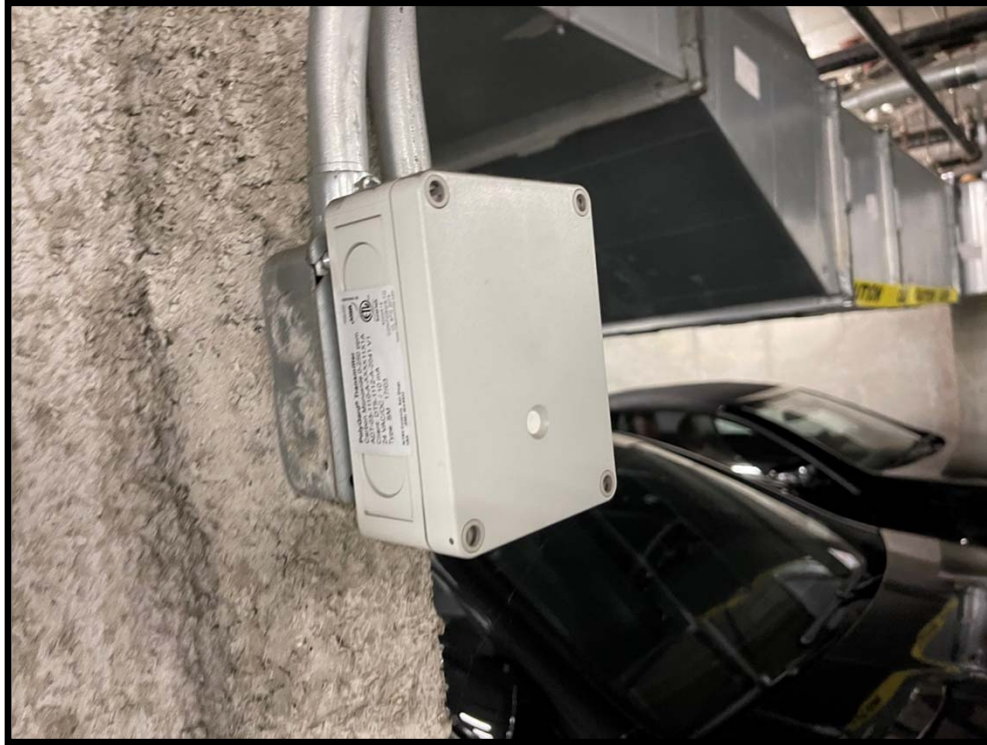
View of the ventilated parking garage alarm unit.

Response: No. The alarm unit needs to be plugged in at all times.

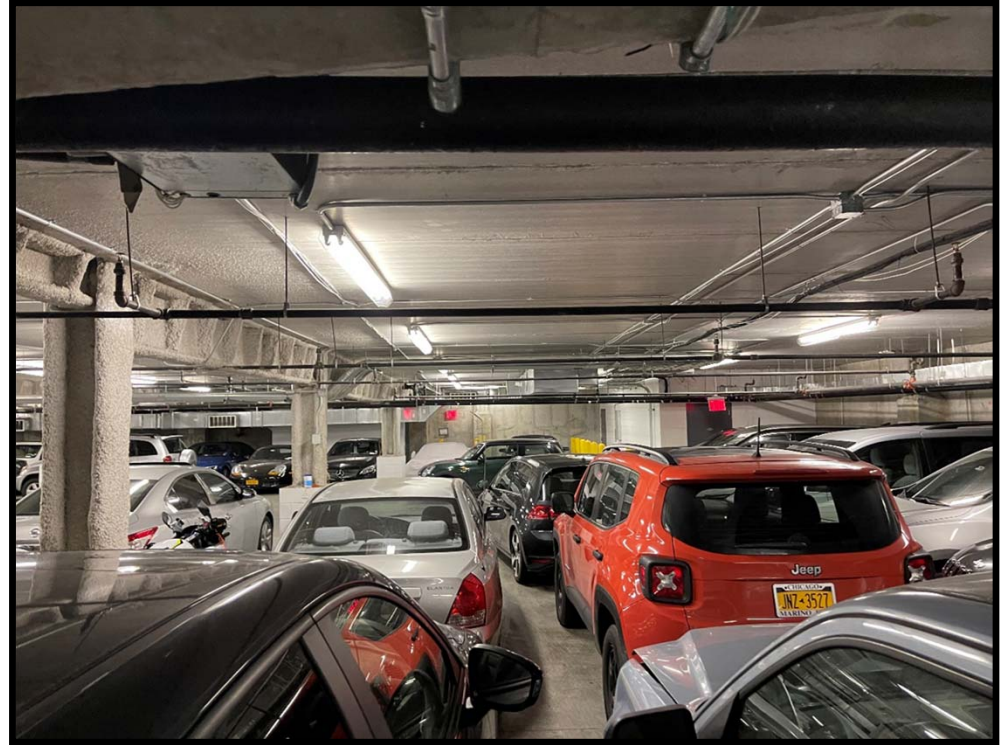
All accessible components of the sub-grade ventilated parking were inspected, including the vents, ducting, and exhaust fans, located on the roof of the single-story portion of the Site. No leaks were observed around any of the exhaust fans. Carbon monoxide detectors were inspected, and found to be operational.

View of the ventilated parking garage.
