**Project Name: 50 North 5<sup>th</sup> Street**

**Project Number: 12EHAZ127K**

**Inspection Date: August 25, 2023**

## **Site Management Inspection and Certification Report**

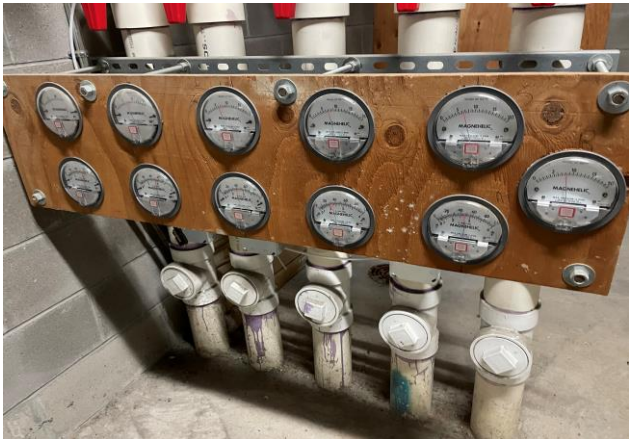
The vacuum and air flow rate gauges were observed for each individual SSDS leg to determine if the system was operating as designed. Vacuum measurements ranged from approximately 6.5 to 7.5 inches of water column (inH<sub>2</sub>O) on the individual SSDS lines and the manifolded riser pipe. Air flow rate measurements ranged from approximately 120 to 160 cubic feet per minute (cfm). All vacuum measurements were within typical system ranges. No visual evidence of breaks or leaks in the aboveground SSDS piping were noted.

Photograph 1: SSDS Air Flow and Vacuum gauges.

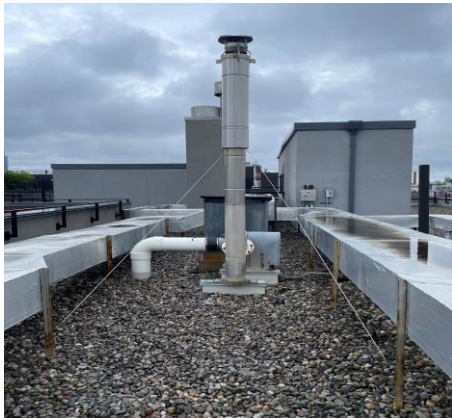
The SSDS fan was noted operating and discharging air through the adjacent exhaust stack. The SSDS alarm was tested by shutting the fan off using the local electric switch. The audible alarm

Photograph 2: Exhaust stack on the roof.

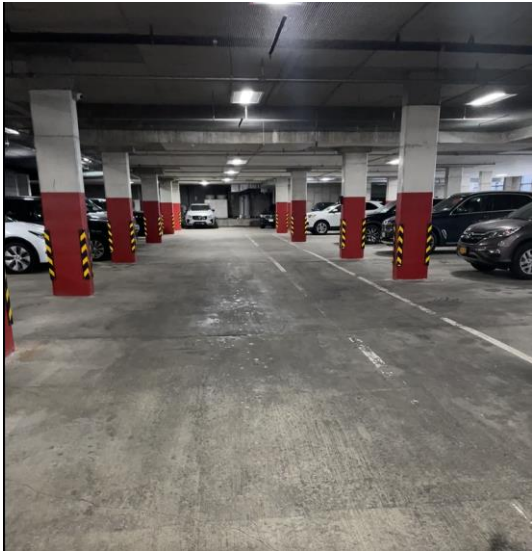
A visual inspection of the Composite Site Cap was conducted in all accessible areas, including the courtyard, garage, hallways, and lobby area. No significant cracks, holes, or other openings were identified.

Photograph 3: Typical concrete slab in the garage space.

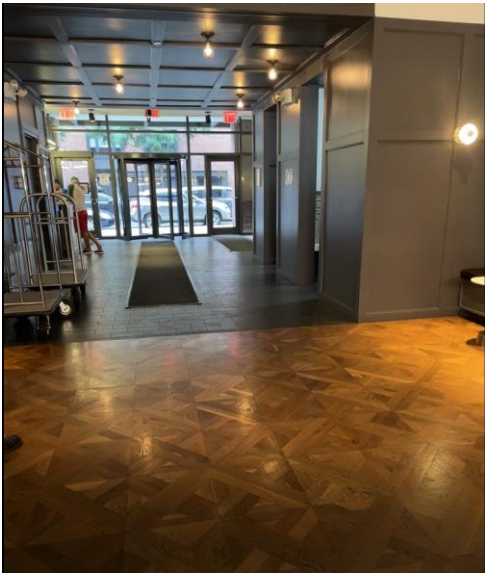
Photograph 4: Typical floor in lobby space.
