33 4TH STREET

BROOKLYN, NEW YORK

Remedial Action Report

NYC VCP Project Number 23CVCP055K

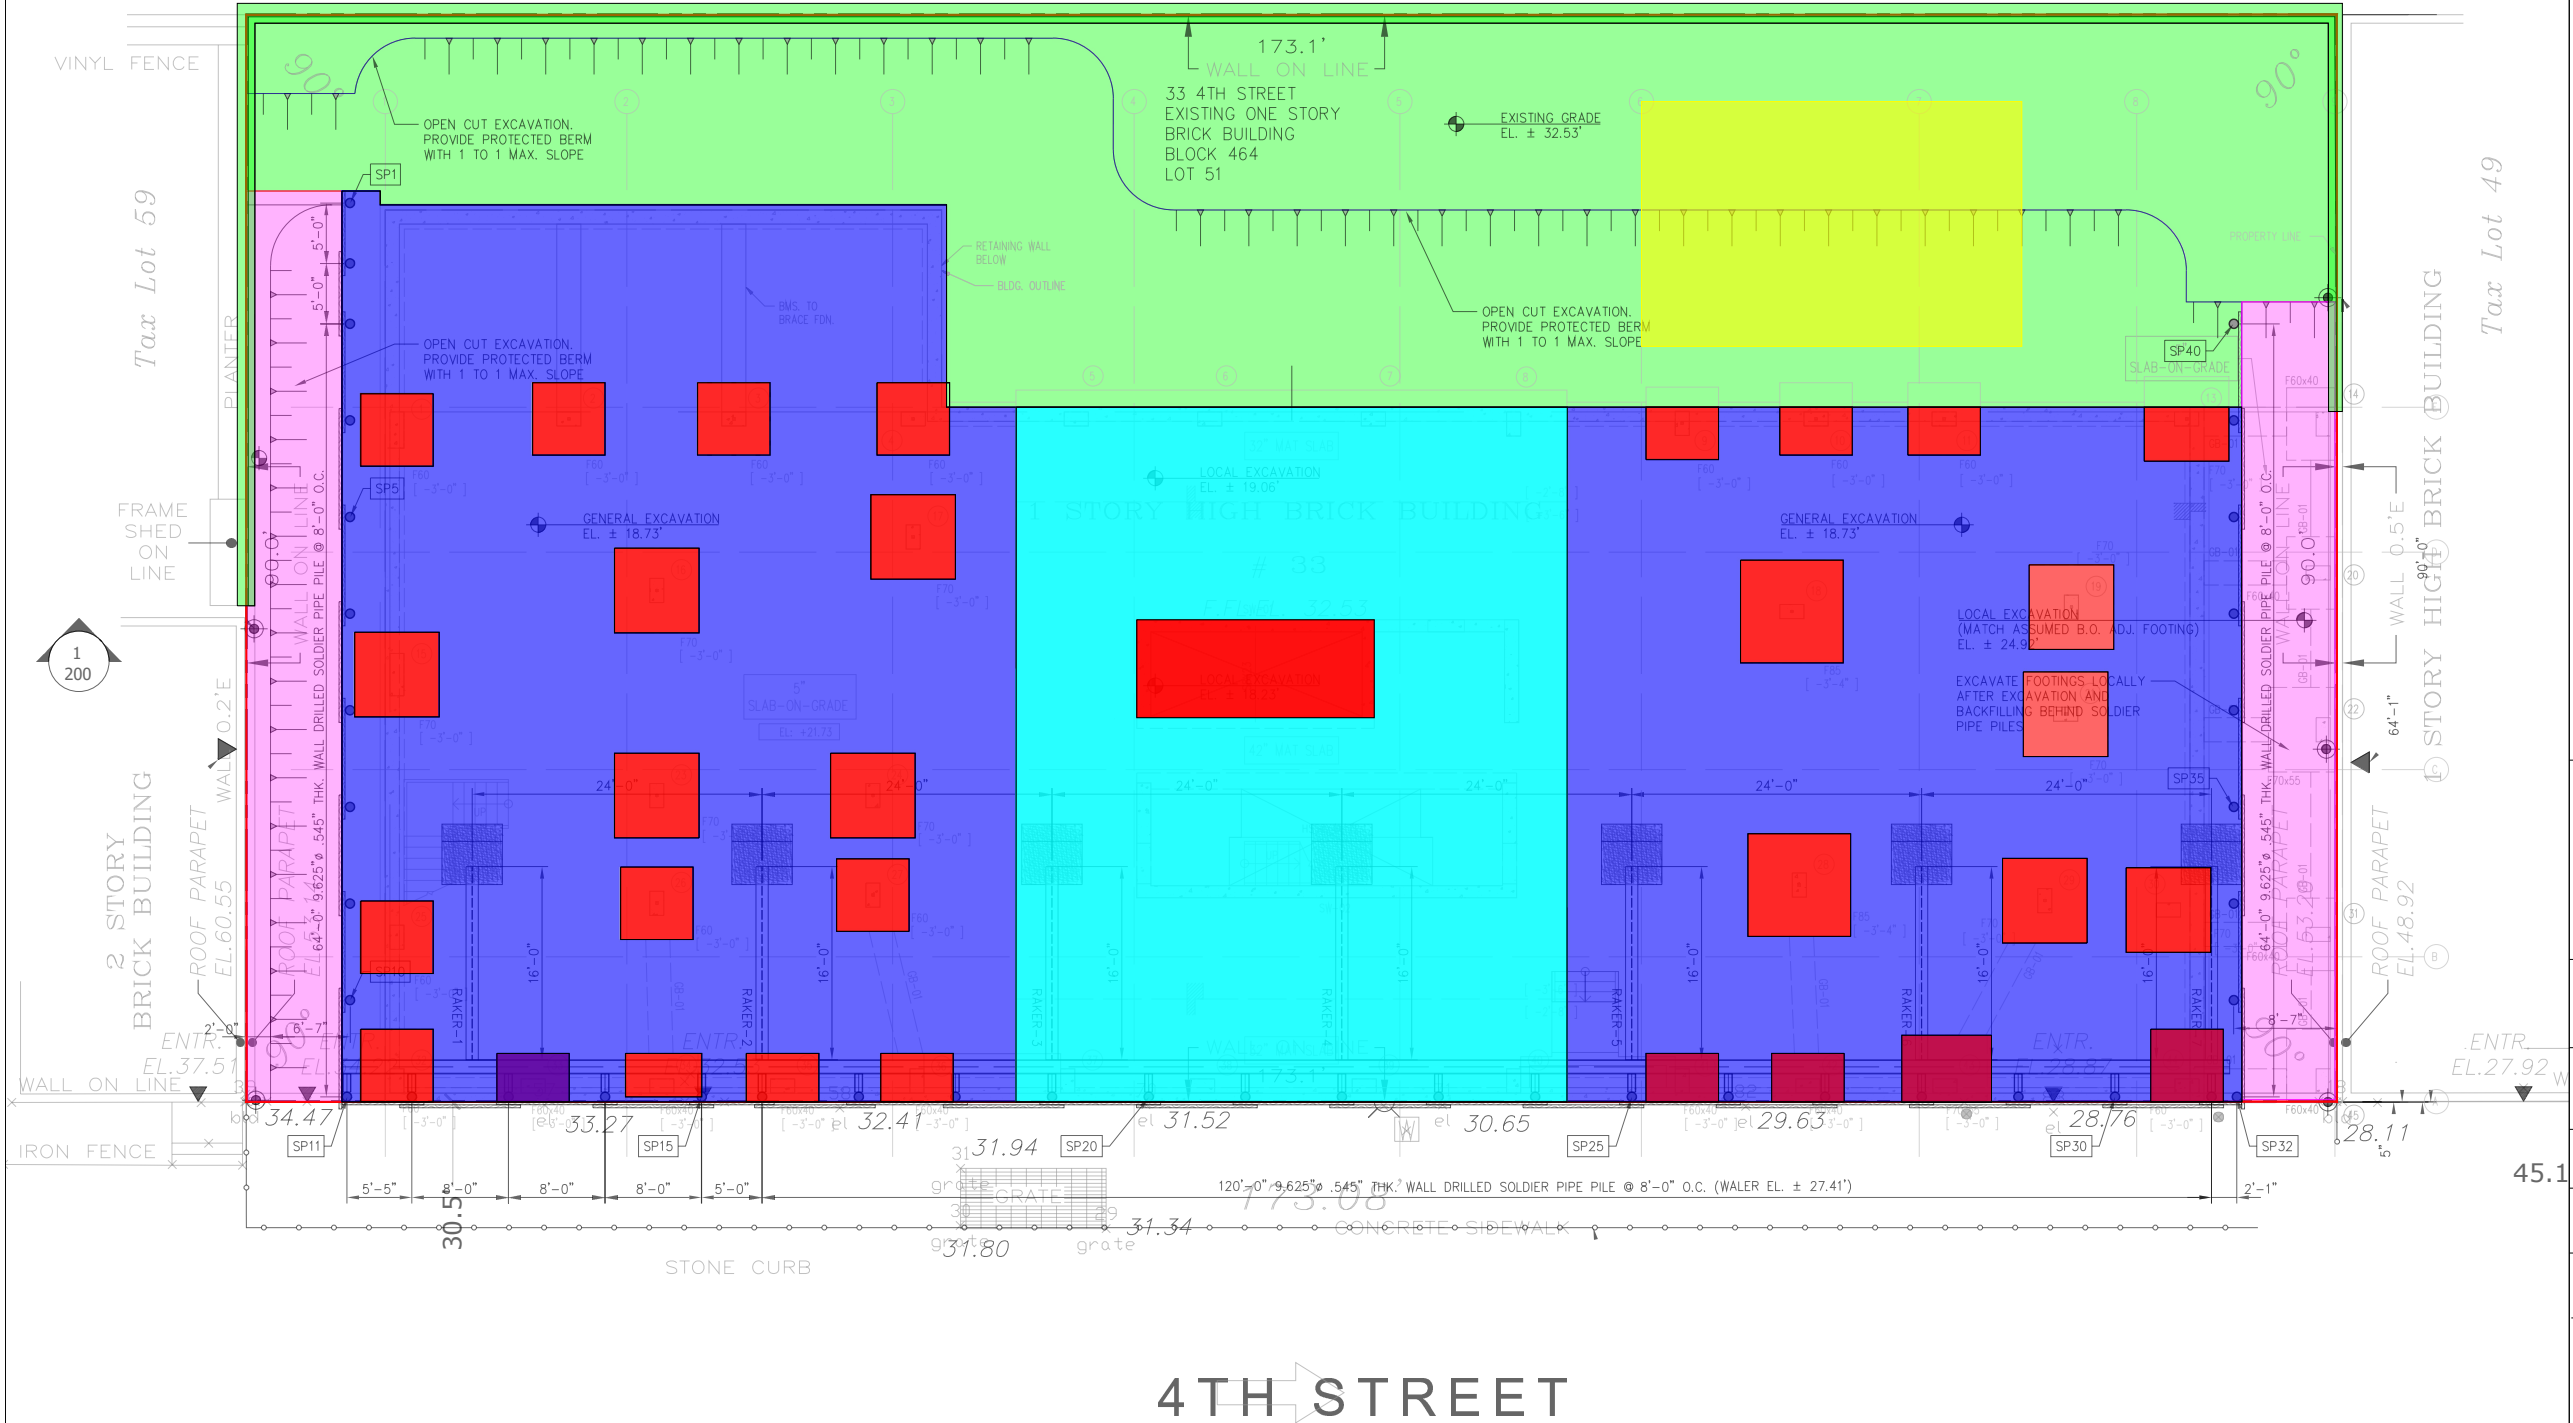
Figure No.	4
Figure Name:	Excavation Plan
Report:	Remedial Action Report
Date:	10/21/24
Drawn By:	KB
Site Address:	33 4TH STREET BROOKLYN, NY

A map showing the approximate locations where excavations were performed, and approximate thickness of excavated material is shown in Figure 4. The Removal Action was performed under the oversight of Ezgi Karayel, QEP.

A map showing the plan for excavation depths is shown in Figure 4.

deeper foundation elements (footings) were excavated to a depth of approximately 15 feet bgs; and the detention tank in the northwest corner of the Site in the rear yard was excavated to approximately 12 feet bgs. A total of 12,072.03 tons of soil/fill was excavated and disposed of off-site as follows:
