Project Name: 865 Grand Street, Brooklyn, NY – Block 2290, Lot 42
Project Number: 12EH-N225K
Site Management Reporting Period: 2024-2025
Inspection Date: June 24, 2025
Inspector and Certifier: Patrick Recio
Report Submittal Date: July 29, 2025
Report Preparer: Brussee Environmental Corp on behalf of Grand Canyon USA

Site Inspection and Certification Letter Report

3.0 INSPECTION NARRATIVE

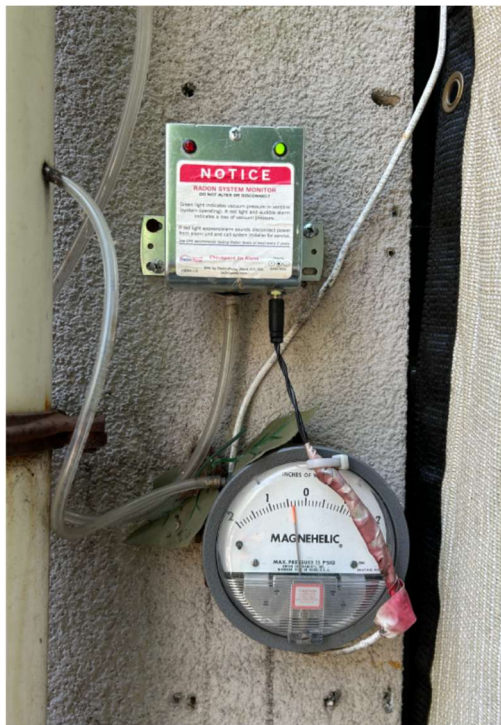
The blower for the active SSD system was inspected on June 24, 2025 and found to be operating. The vacuum gauge installed on the rear exterior building wall recorded a vacuum reading of approximately -0.50" of water. The alarm was not sounding, and the alarm light was green. A photo of the protective case, alarm and vacuum gauge is attached.

Photo 1: View of alarm and magnehelic

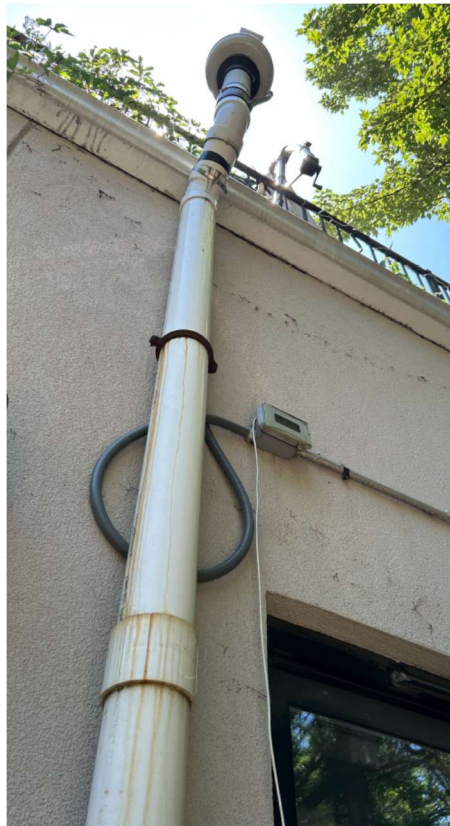
Photo 2 – View of riser included. Due to access issues, couldn't get a photo of the blower at the roof. However, vacuum was observed within the magnehelic and the blower was operable.

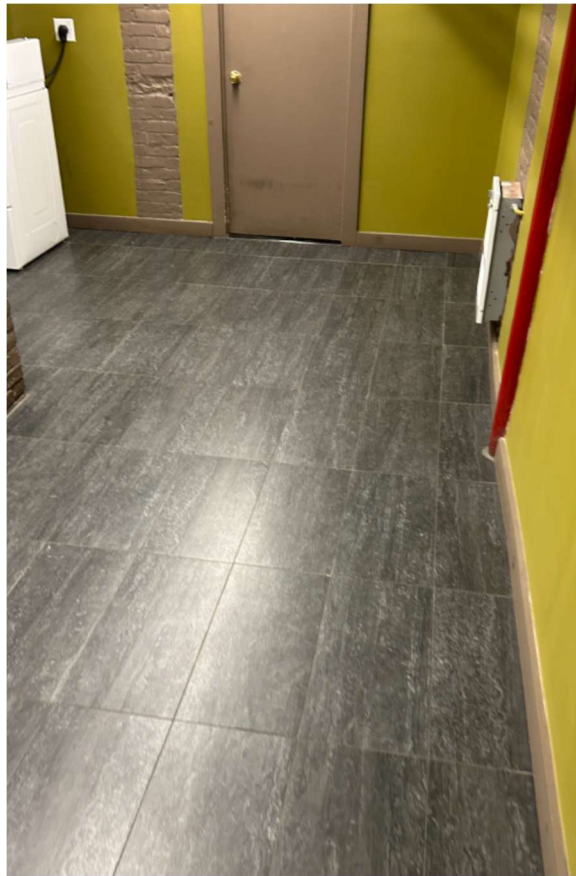
Interior: The floor coverings across the interior of the building were inspected. No significant cracks that required patching/fill were observed.

Photo 3: Cellar Slab
