40-05 CRESCENT STREET
QUEENS, NEW YORK

Remedial Action Report

NYC VCP Number: 15CVCP021Q
NYC OER Project Number: 14EHAZ208Q

REMEDIAL ACTION REPORT

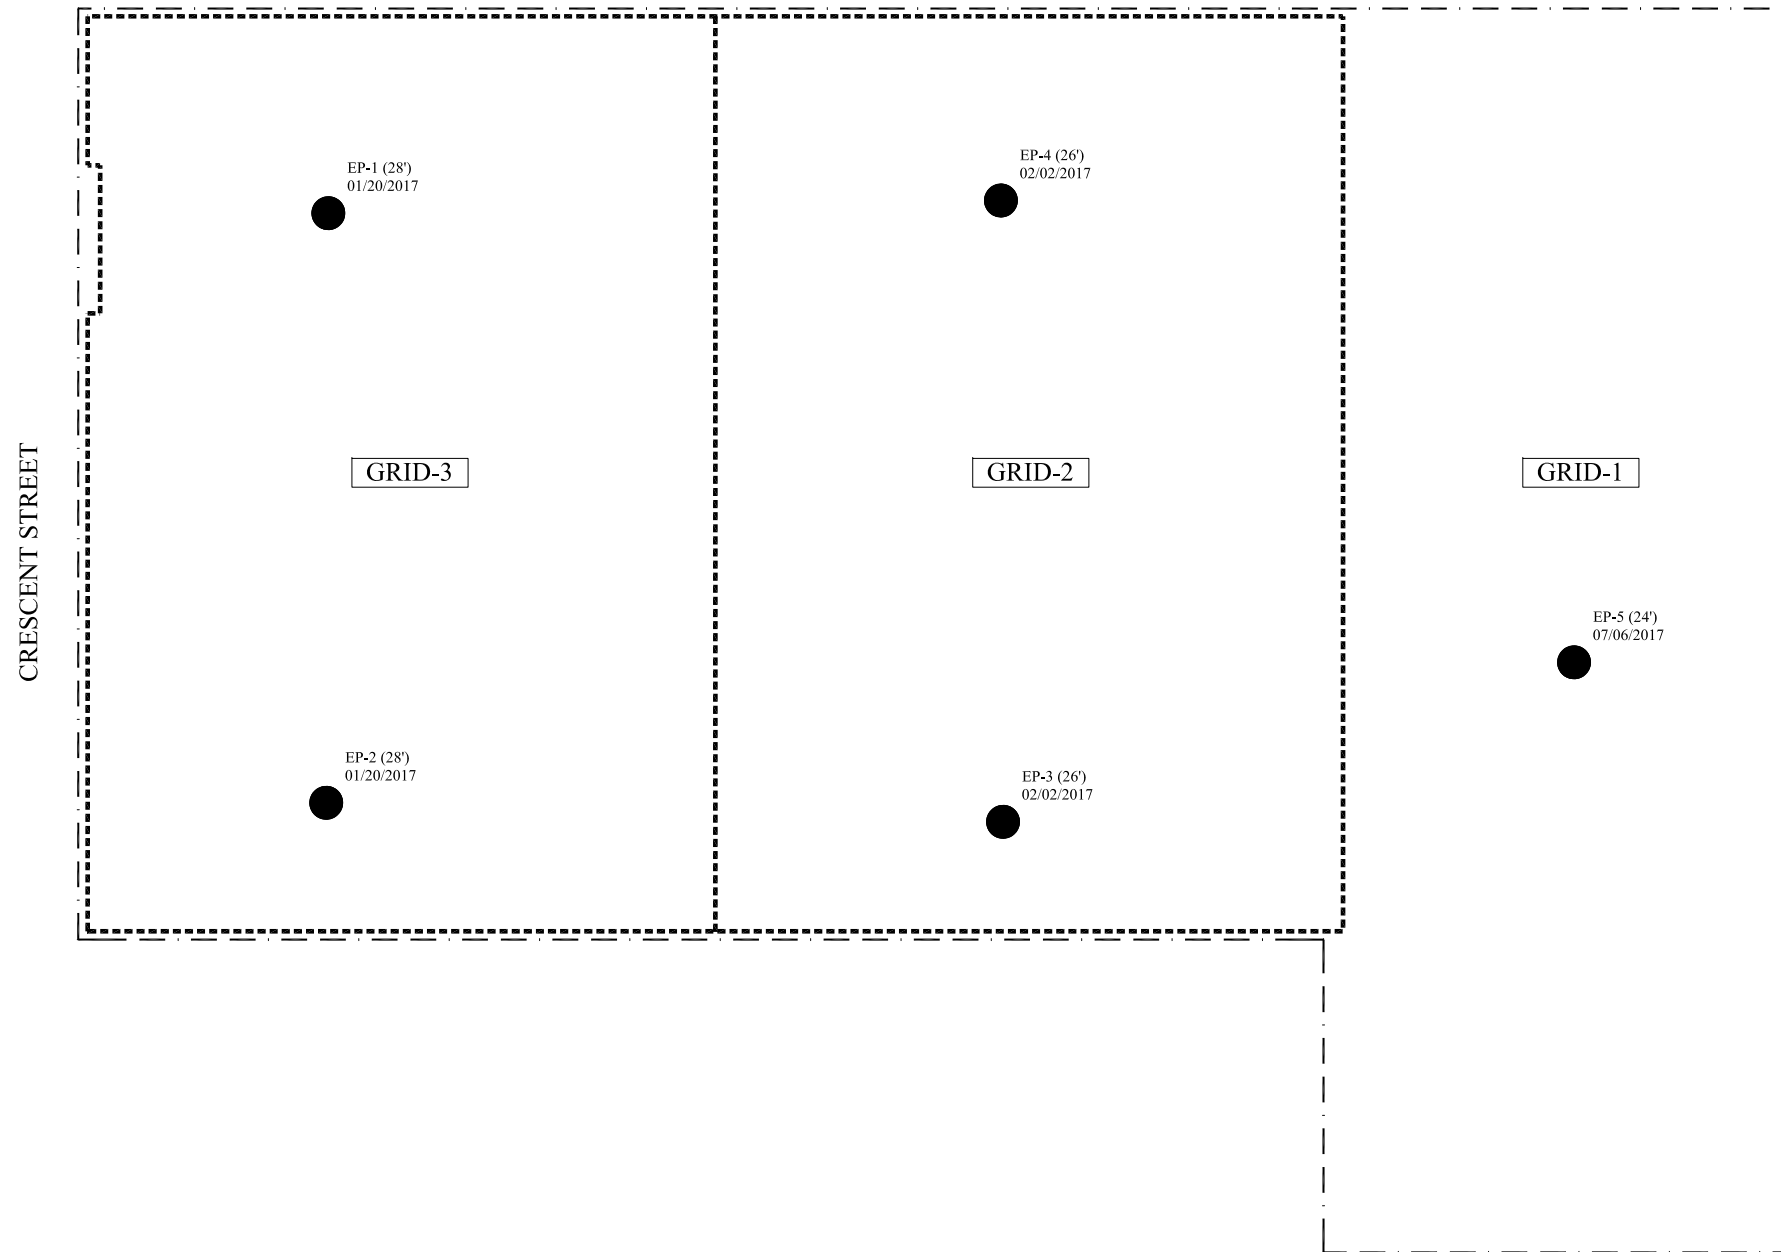
12. Collected and analyzed five (5) post-excavation confirmation samples to determine attainment of SCOs. Track 1 Unrestricted Use SCOs were achieved.

- - - - - SITE BOUNDARY
- - - - - GRID BOUNDARY
- ENDPOINT SAMPLE LOCATION

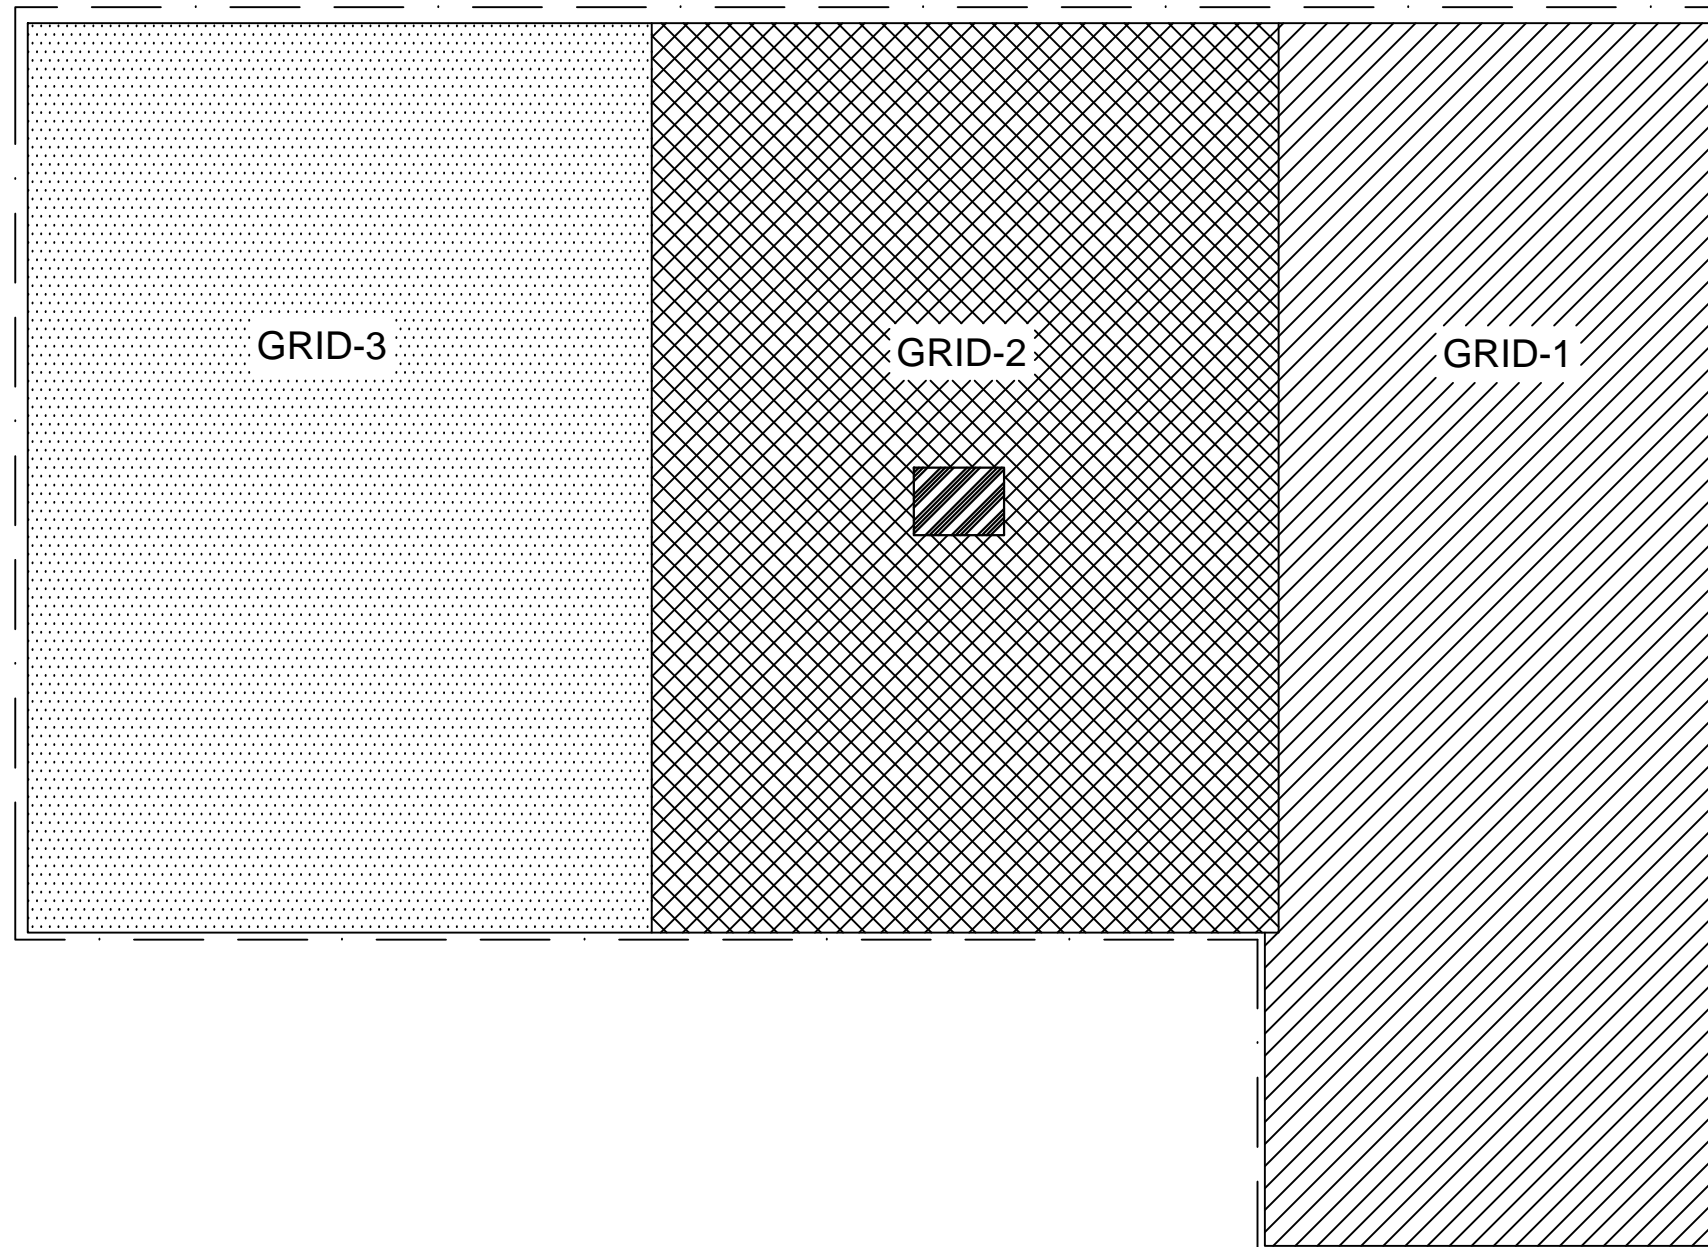
Soil and historic fill were excavated to a depth of approximately 24 to 28 feet below grade surface (bgs) throughout the Site, with an additional 5-foot of excavation for the elevator pit. Other excavated materials included boulders, construction and demolition debris from former on-Site building floor slab and foundation. A map showing the approximate locations where excavations were performed and approximate thickness of excavated material is shown in Figure 5.

* = THE SITE LIES ON A GRADIENT. EXCAVATION DEPTHS ESTIMATED.

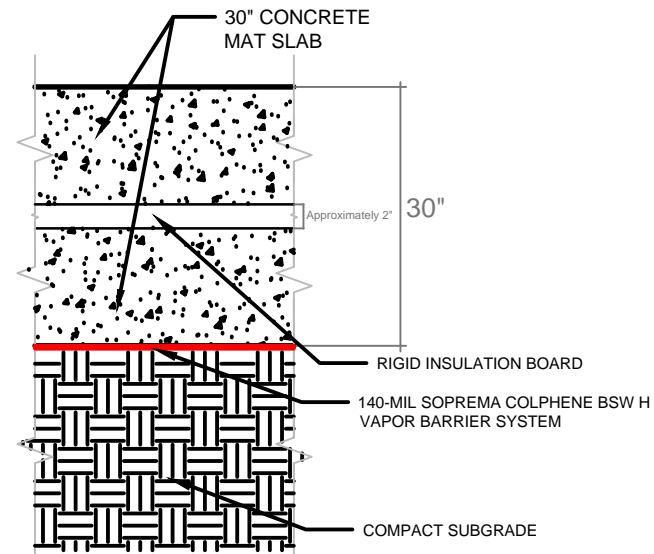
**AS-BUILT DESIGN DETAIL OF
COMPOSITE COVER AND VAPOR BARRIER SYSTEM
FOR BUILDING SLAB**

14. As part of development, constructed an engineered Composite Cover System consisting of 30 inches of reinforced concrete slab, including 2 inches of rigid insulation board, underlain by compacted native soil covering the entire footprint of the Site. The contractor for the Composite Cover System construction was Central Construction Management.

As part of development, a Vapor Barrier System (VBS) has been built at the Site. This Vapor Barrier System consists of Soprema Colphene BSW H, a 140-mil styrene-butadiene-styrene (SBS)-modified bitumen, self-adhered membrane which is sealed utilizing a heat welding device, below the building slab, and Soprema Colphene BSW V, a 120-mil barrier, behind foundation walls. The VBS was installed vertically behind the foundation walls and horizontally beneath the composite cover system. Perforations around structural supports were sealed using manufacturer approved polyurethane bitumen resin manufactured by Soprema. The entire system was installed according to manufacturer specifications and drawing details. The VBS installation complies with RAWP and manufacturer specifications. The professional engineer for the Vapor Barrier System was Spiro Dongaris. The contractor for the Vapor Barrier System construction was Central Construction Management.

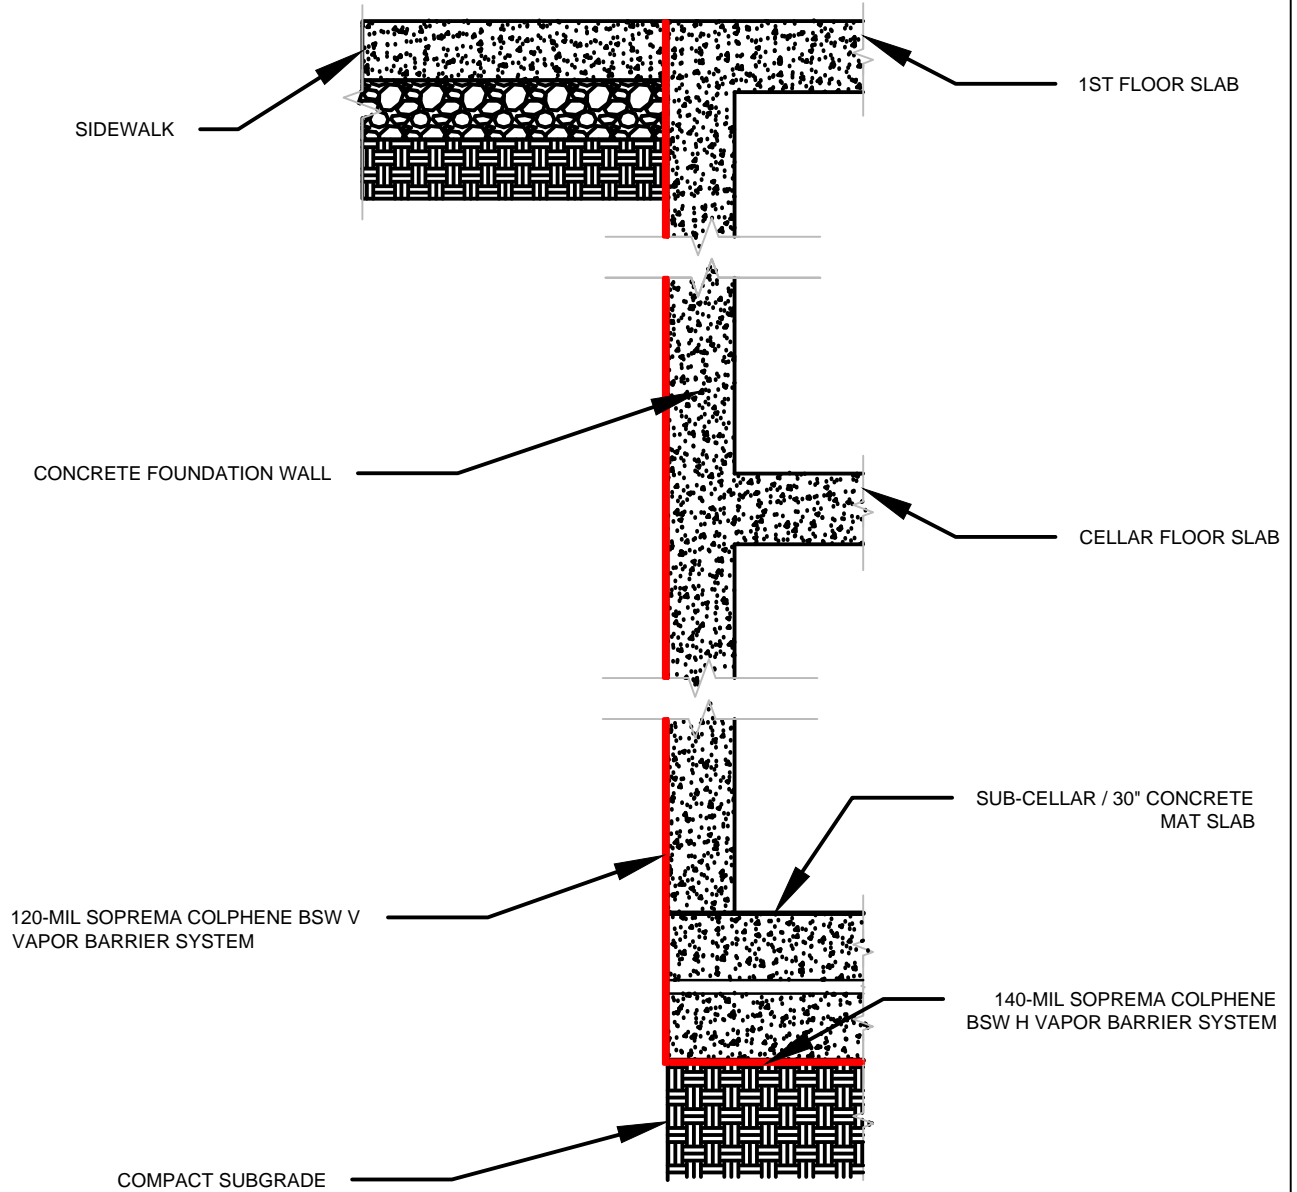
**AS-BUILT DESIGN DETAIL OF
COMPOSITE COVER AND VAPOR BARRIER SYSTEM
FOR SIDE WALL CROSS SECTION**

Date:	APRIL 9, 2018	Site:	40-05 CRESCENT STREET QUEENS, NY 11101
Drawn by:	ADIB RAHMAN	Figure:	7
Checked by:	A.J. INFANTE	Title:	AS-BUILT DESIGN DETAIL FOR COMPOSITE COVER AND VAPOR BARRIER SYSTEMS
Drawing Scale:	NOT TO SCALE		
Project No.:	13-1235
