**Site Inspection and  
Certification Letter Report**

**PERFORMED AT:**  
11-23 Montieith Street  
Brooklyn, NY 11206  
Block 3139, Lot 30

**ALC PROJECT NO. 500-1086**

**Inspection Date:** August 13, 2025

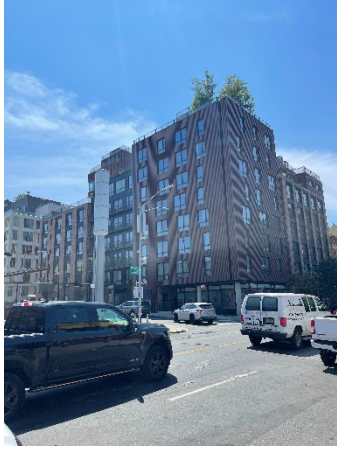
Subject Property

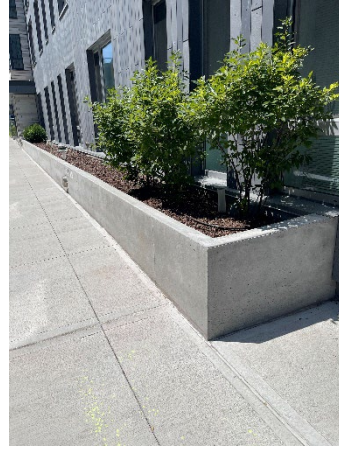
Mr. Mende conducted a perimeter walk of the entire property examining all exterior areas of the sidewalk and courtyard areas including planters for evidence of deterioration or cracking. No

evidence of cracking or deterioration was observed. A photographic log is presented in Attachment A.

Subject Property Walkway

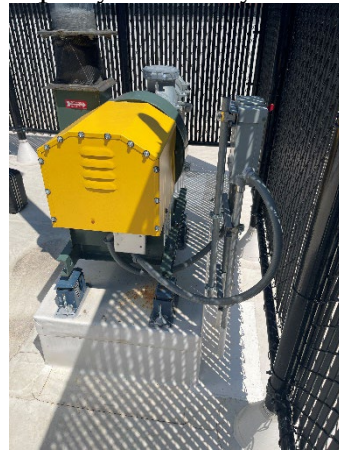
Mr. Mende then conducted an inspection of the engineering controls including the fan systems located on the roof. The roof fan was identified to be operating as per specifications. The inspection then included the basement area of the building to inspect for visible cracking of the entire basement area as well as the community room which is not located above a basement area. No cracking or deterioration was observed.

SSDS Fan

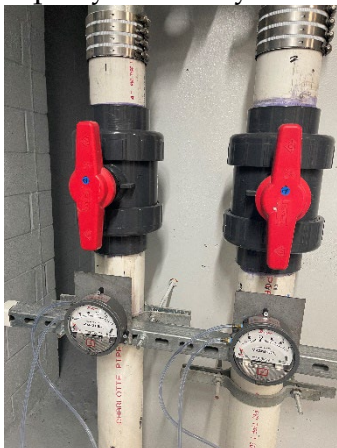
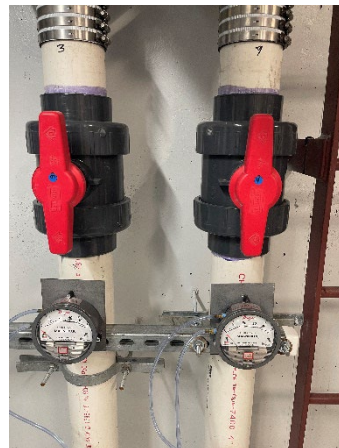
Mr. Mende then inspected the piping and all manifolds including all pressure gauges. All systems were functioning in accordance with specifications.

SSDS Manifold Piping and Pressure Gauges

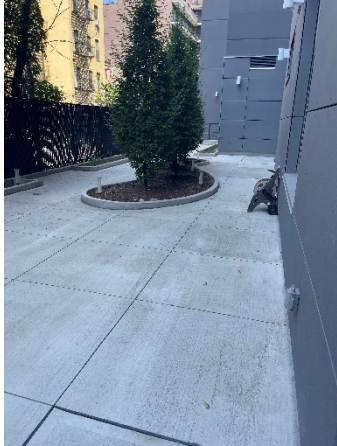
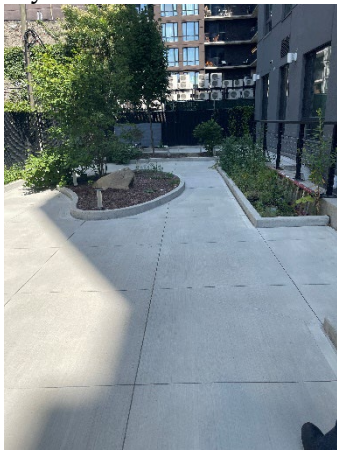
Rear Courtyard Area

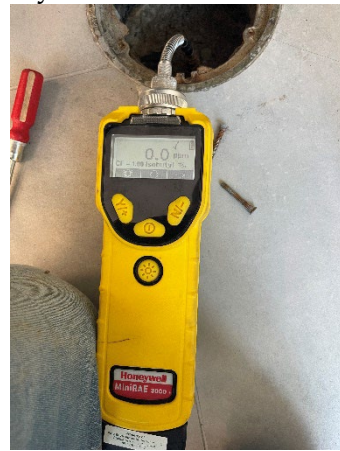
Mr. Mende then located and inspected each of the four (4) vapor monitoring points. A Photoionization Detector (PID) was then utilized to screen for volatile organic vapors in each of the monitoring points. No PID readings above 0.0 parts per million (ppm) were recorded.

Typical PID Reading

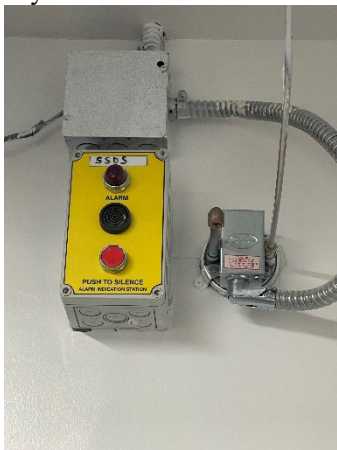
The alarm panel on the first floor is working and is activated when the blower shuts down for any reason, either a mechanical or electrical issue. Readings were obtained from the three monitoring points in the basement and the monitoring point on the first floor. The readings are presented on Table 1.

SSDS Alarm

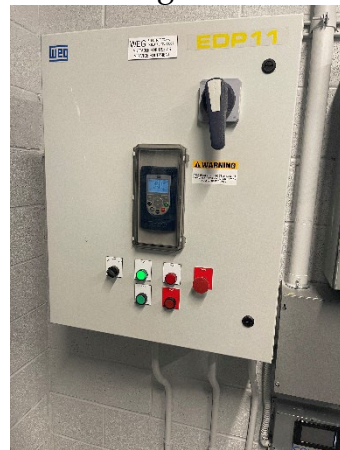
SSDS Power Panel
