October 4, 2013
Project: M10062A

RE: Focused Subsurface Site Investigation
21-01/19 31st Street
AKA 31-02/08 21st Ave
& 21-10/20 32nd St
Astoria, New York

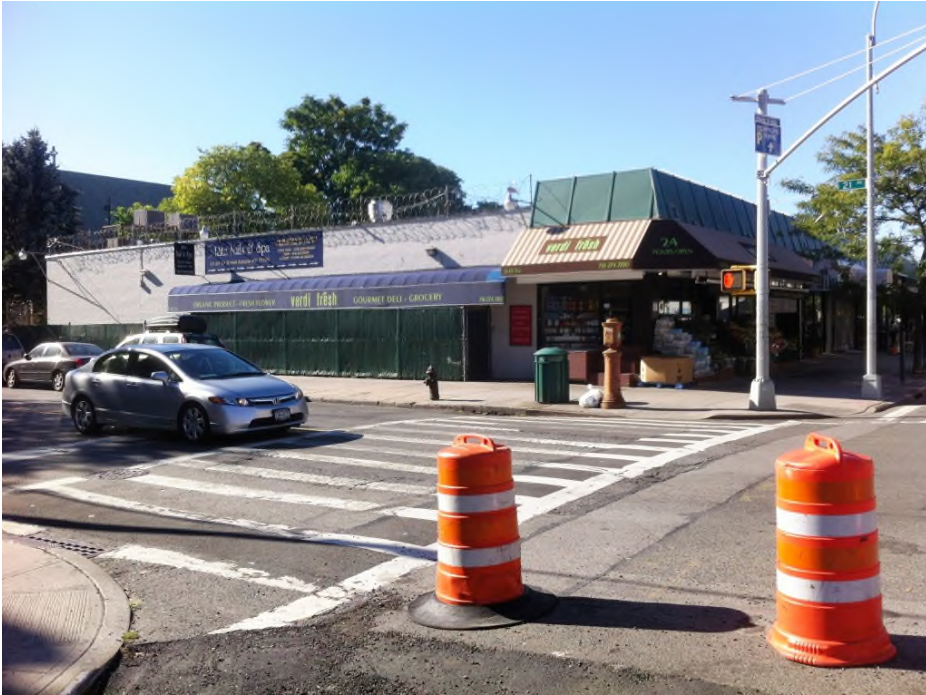
Photograph 1: View of the north section of the Site building looking south from across the intersection of 31st Street and 21st Avenue.

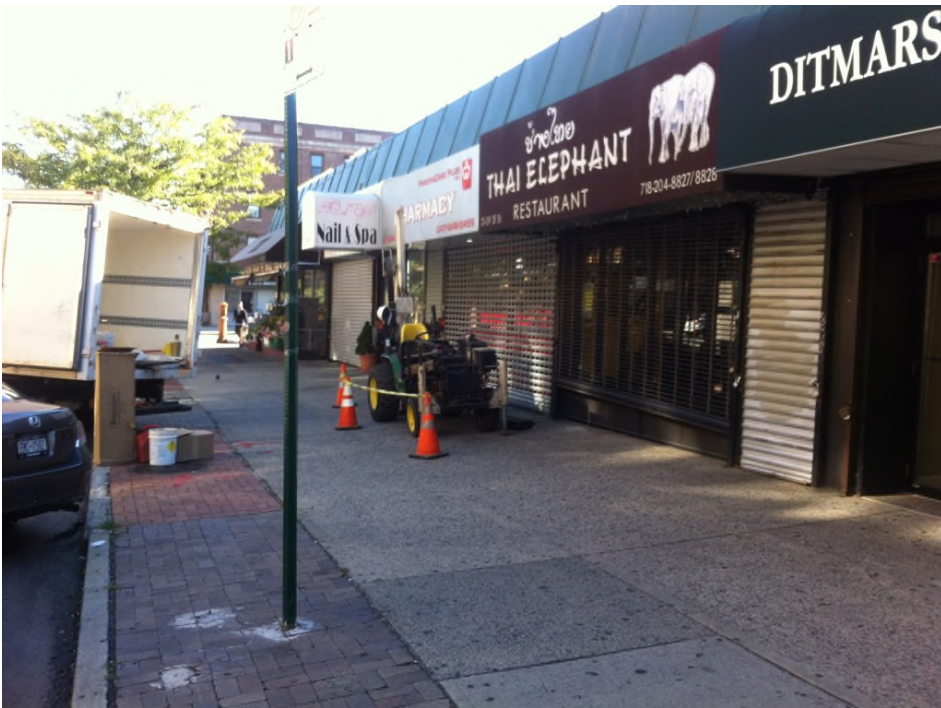
MECC employed an electric hammer drill equipped with a three foot length of solid stem auger to install B2. A slide hammer tipped with a stainless steel sample tube to collect a soil sample for laboratory analysis from a near-surface depth and from the bottom of this boring.

Photograph 2: Installation of Soil Boring B2. photographer looking north.

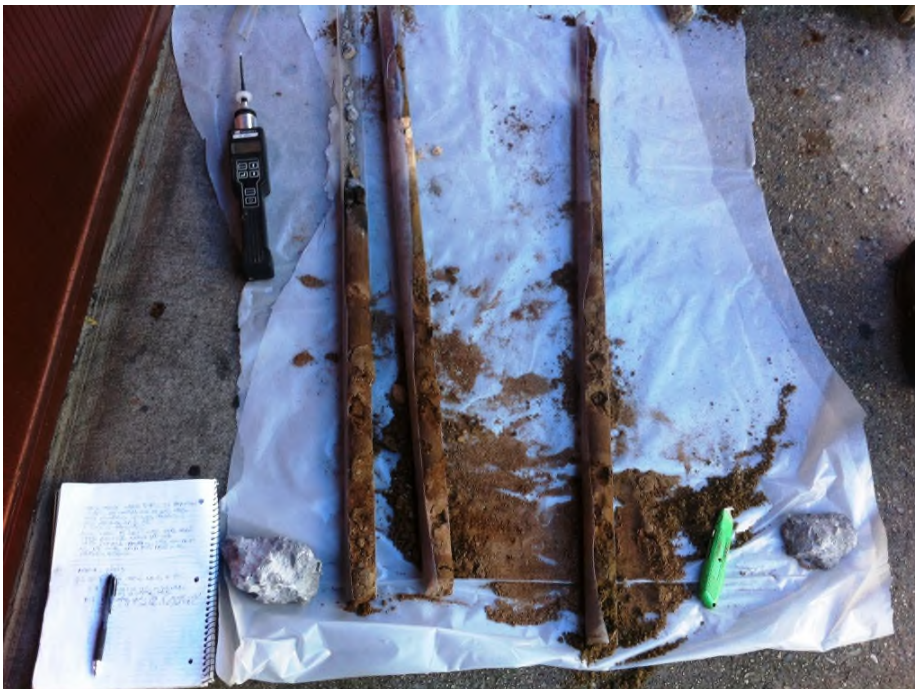
Soil sampling ceased at 14 feet bgs in B2 due to refusal of the soil sampling sleeve on cobbles and boulders. A groundwater sampling point was driven to a depth of 20 feet bgs but again refusal was encountered on cobbles/boulders.

Photograph 3: Typical sediment encountered in B2.
