5055 BROADWAY

NEW YORK, NEW YORK

Remedial Investigation Report

OER Project Number 21TMP1280M, 21EHAN270M

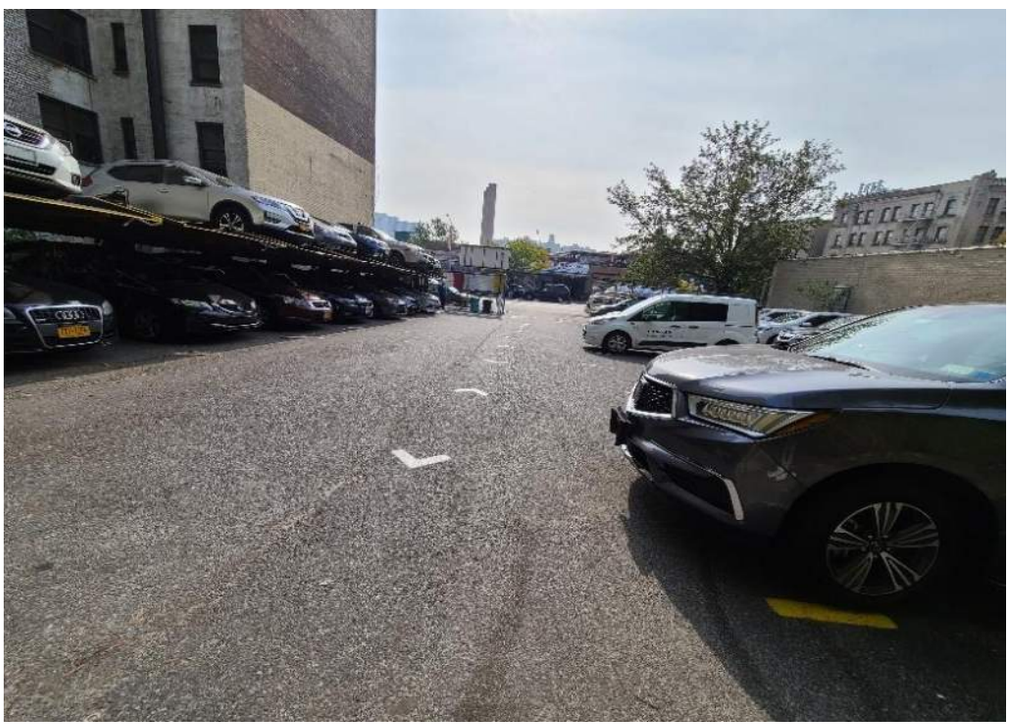
Photo 2: View of the Subject Property, facing southeast.

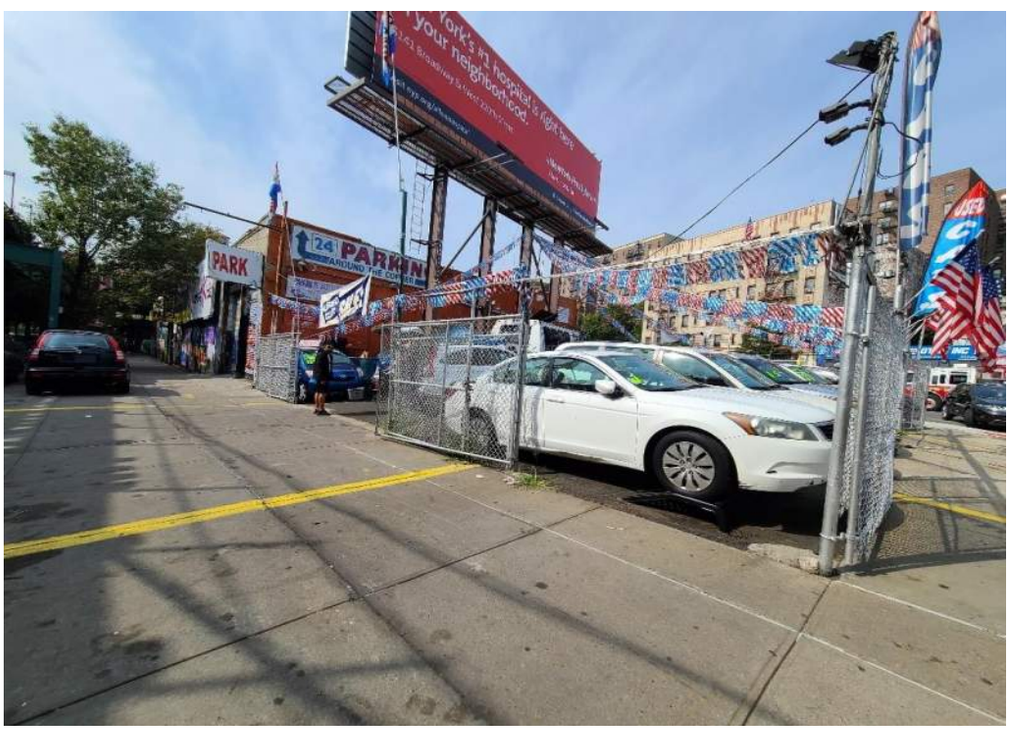
Photo 18: View of the northern portion of the southeastern adjacent property (5060 Broadway) consisting of a used car dealership, facing west.

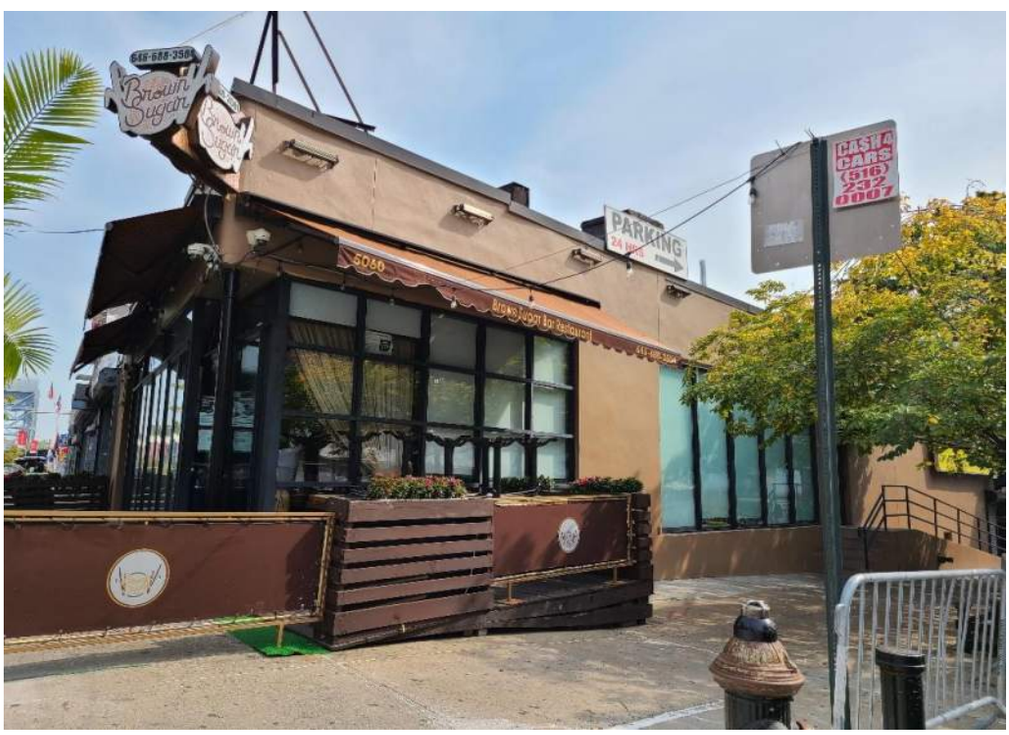
Photo 20: View of the southern portion of the southeastern adjacent property (5060 Broadway) consisting of a restaurant, facing northeast.

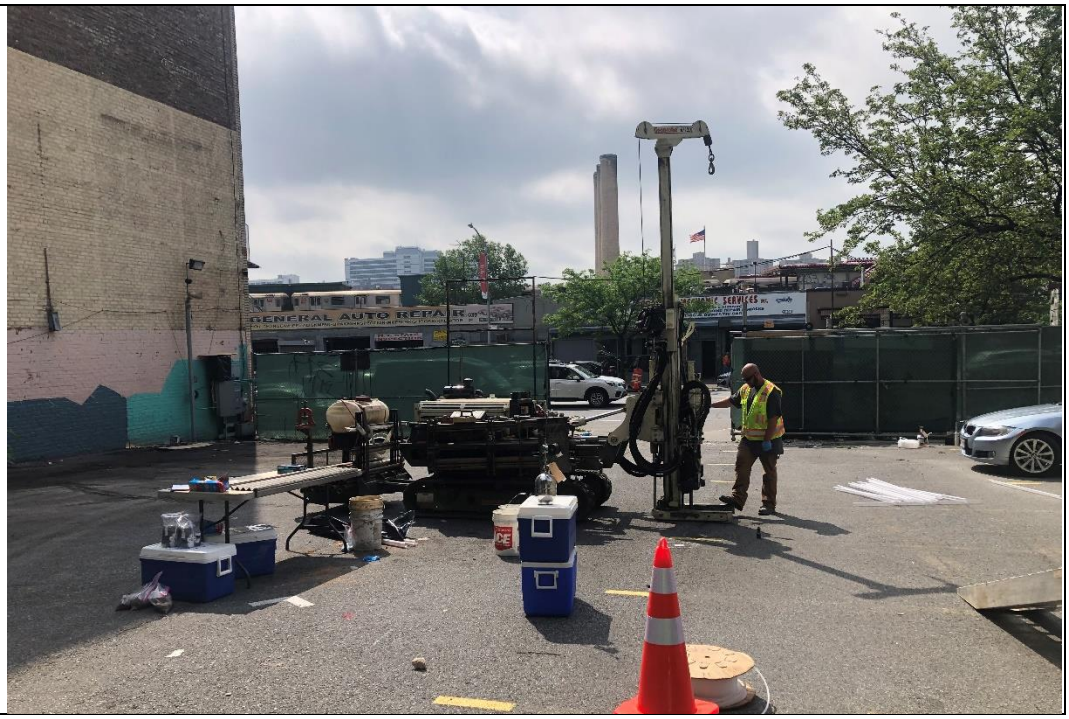
Photo No.: 3	Date: 6/21/2021
Direction Photo Taken: West	
Description: Drilling Contractor installing SB-04
